Manhole Inspection Report

O&M Index:	2.00	O&M Quick:	2100	O&M Rating:	2.00
Structural Index:	0.00	Structural Quick:	0000	Structural Rating:	0.00
Overall Index:	2.00	Overall Quick:	2100	Overall Rating:	2.00

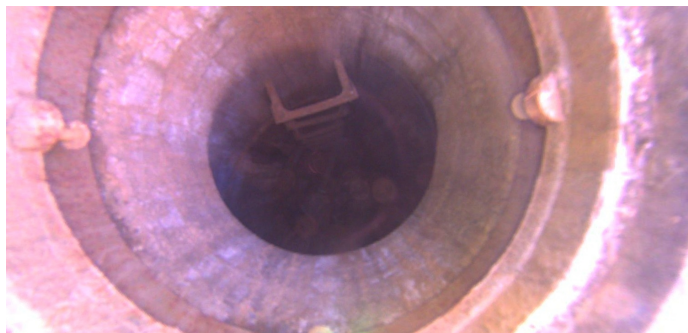
Code: **MGP**
Description: **General Photo**

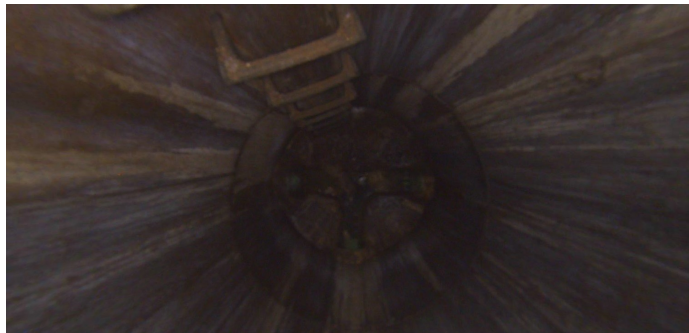
Code:	IS
Description:	Infil Stain
Distance (ft):	4.6
Structural Grade:	0
O&M Grade:	0
Clock Start/From:	12
Clock To:	12
1st Value:	
2nd Value:	
Value Percent:	
Step:	NO
Remarks:

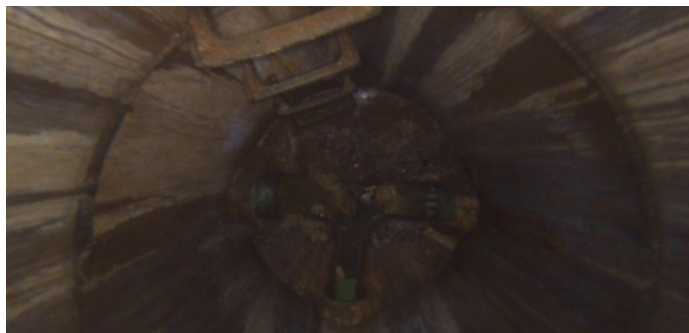
Code:	IW
Description:	Infil Weeper
Distance (ft):	7.1
Structural Grade:	0
O&M Grade:	2
Clock Start/From:	12
Clock To:	12
1st Value:	
2nd Value:	
Value Percent:	
Step:	NO
Remarks:
