Manhole Inspection Report

Date:	05/08/2018	Weather:		Coding:	RZMACP
MH#:	M-1004-032	Owner:	NA	Len. Surveyed:	8.7
P.O.#:		Surveyor:	Jen Costello	Rim to Invert:	9.9
Customer:		Cert. #:	U-907-5518	Wall Material:	Concrete (reinforced)

Street:	Cleveland Ave. 98' East of Union St.	Project:	Hobart, IN
City:	Hobart, IN	GPS Northing:	2912498.141
Location:		GPS Easting:	2912498.141
Drain Area:	Northeast	GPS Accuracy:	Sub-Meter
Cover Shape:	Circular	Evidence of Surcharge:	No
Cover Size:	22.5	Potential for Runoff:	None
Comments:

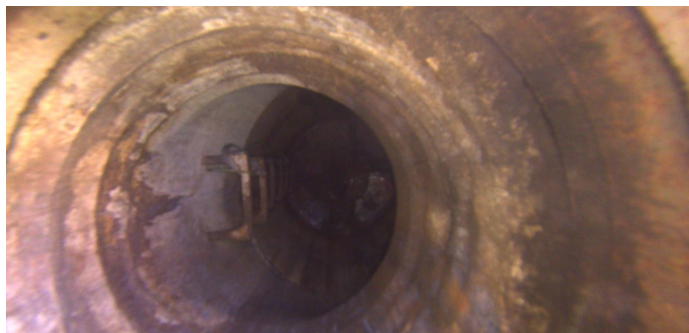
Code: **MGP**
Description: **General Photo**

Distance (ft): **.0**
Structural Grade: **0**
O&M Grade: **0**
Clock Start/From:
Clock To:
1st Value:
2nd Value:
Value Percent:
Step: **NO**
Remarks: **ACCESS MH**

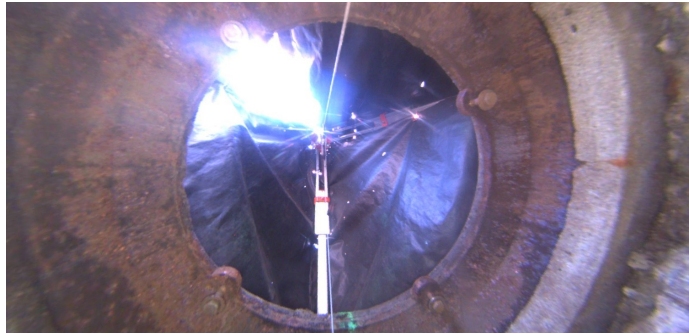
Code:	MGO
Description:	General Observation
Distance (ft):	1.7
Structural Grade:	0
O&M Grade:	0
Clock Start/From:	
Clock To:	
1st Value:	
2nd Value:	
Value Percent:	
Step:	NO
Remarks:	UNDERSIDE OF FRAME

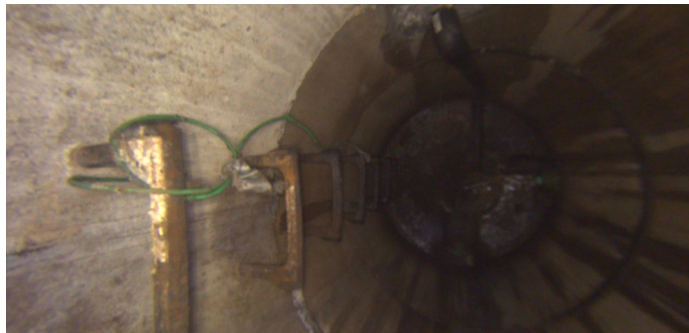
Code:	OBZ
Description:	Obstacle Other
Distance (ft):	2.6
Structural Grade:	0
O&M Grade:	2
Clock Start/From:	9
Clock To:	
1st Value:	
2nd Value:	
Value Percent:	0.000
Step:	YES
Remarks:	TWINE

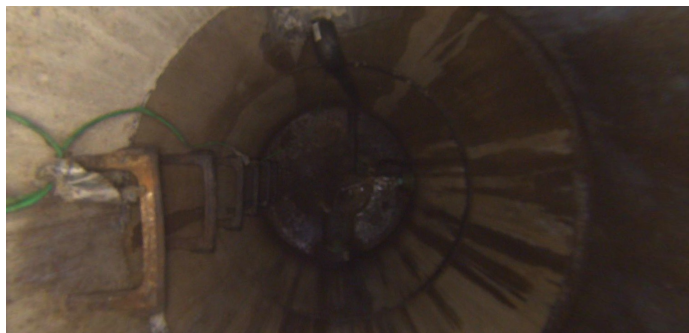
Code:	IW
Description:	Infil Weeper
Distance (ft):	2.6
Structural Grade:	0
O&M Grade:	2
Clock Start/From:	12
Clock To:	12
1st Value:	
2nd Value:	
Value Percent:	
Step:	NO
Remarks:

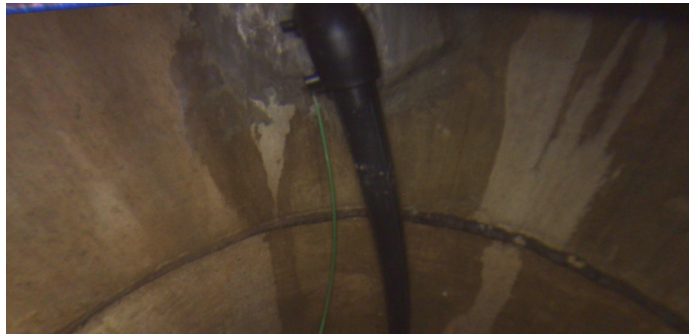
Code:	OBP
Description:	Obstacle External Pipe or Cable
Distance (ft):	5.3
Structural Grade:	0
O&M Grade:	2
Clock Start/From:	12
Clock To:	
1st Value:	
2nd Value:	
Value Percent:	5.000
Step:	NO
Remarks:

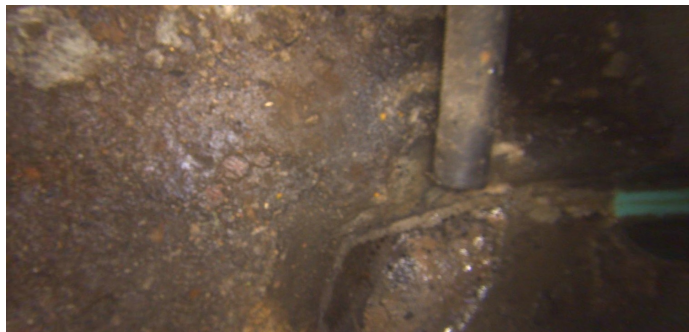
Code:	MGO
Description:	General Observation
Distance (ft):	8.7
Structural Grade:	0
O&M Grade:	0
Clock Start/From:	
Clock To:	
1st Value:	
2nd Value:	
Value Percent:	
Step:	NO
Remarks:	END SURVEY
