Manhole Inspection Report

Date:	05/11/2018	Weather:		Coding:	RZMACP
MH#:	M-1004-039	Owner:	NA	Len. Surveyed:	7.6
P.O.#:		Surveyor:	Jen Costello	Rim to Invert:	8.5
Customer:		Cert. #:	U-907-5518	Wall Material:	Concrete (reinforced)

Street:	Coral Dr. 786' East of Hillcrest Ave.	Project:	Hobart, IN
City:	Hobart, IN	GPS Northing:	2913516.572
Location:		GPS Easting:	2913516.572
Drain Area:	Northeast	GPS Accuracy:	Sub-Meter
Cover Shape:	Circular	Evidence of Surcharge:	No
Cover Size:	22.5	Potential for Runoff:	None
Comments:

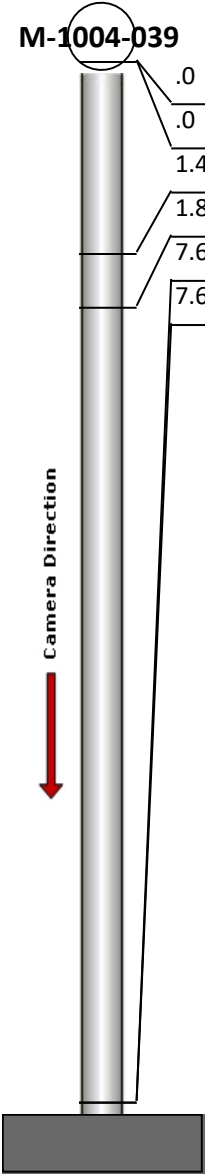
Position	Code	Observation	Video (sec)	Grade
M-1004-039

.0	MGO	General Observation	10	NA
	.0	IW	Infil Weeper	22	M 2
	1.4	SAV	Surface Aggregate Visible	36	S 3
	1.8	MGO	General Observation	50	NA
	7.6	SAV	Surface Aggregate Visible	74	S 3
	7.6	MGO	General Observation	85	NA

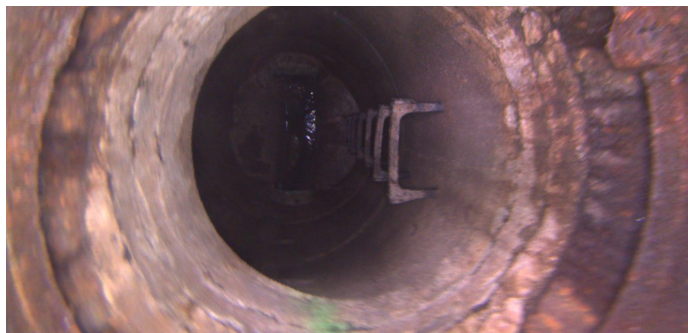
Code: **MGO**
Description: **General Observation**

Distance (ft): **.0**
Structural Grade: **0**
O&M Grade: **0**
Clock Start/From:
Clock To:
1st Value:
2nd Value:
Value Percent:
Step: **NO**
Remarks: **ACCESS MH**

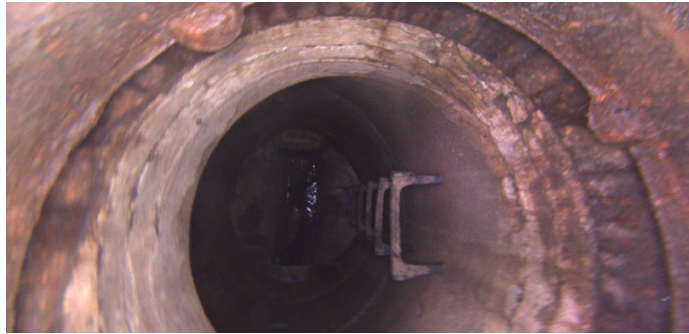
Code: **IW**
Description: **Infil Weeper**

Distance (ft): **.0**
Structural Grade: **0**
O&M Grade: **2**
Clock Start/From: **12**
Clock To: **12**
1st Value:
2nd Value:
Value Percent:
Step: **NO**
Remarks:

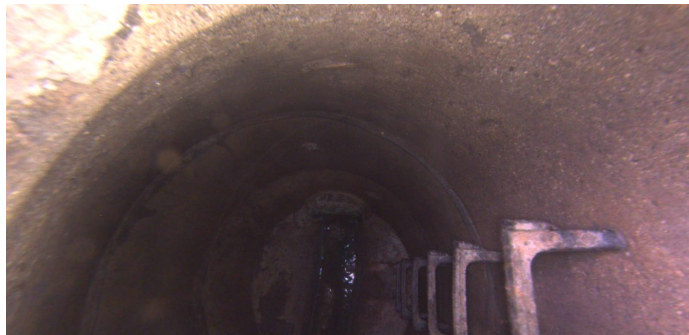
Code: **SAV**
Description: **Surface Aggregate Visible**

Distance (ft): **1.4**
Structural Grade: **3**
O&M Grade: **0**
Clock Start/From: **12**
Clock To: **12**
1st Value:
2nd Value:
Value Percent:
Step: **NO**
Remarks:

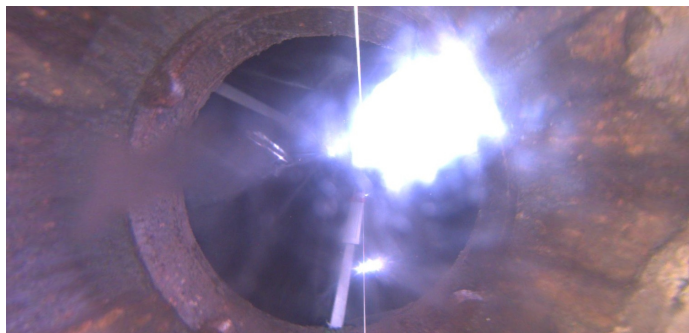
Code: **MGO**
Description: **General Observation**

Distance (ft): **1.8**
Structural Grade: **0**
O&M Grade: **0**
Clock Start/From:
Clock To:
1st Value:
2nd Value:
Value Percent:
Step: **NO**
Remarks: **UNDERSIDE OF FRAME**

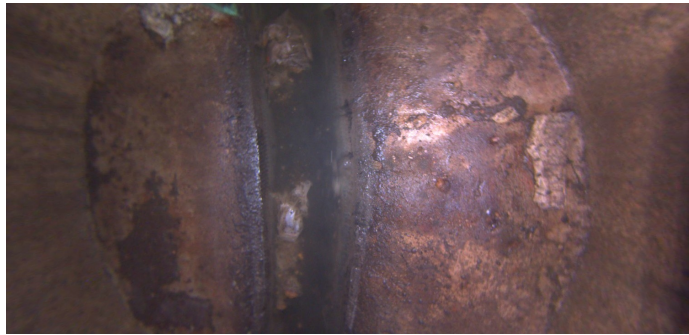
Code:	SAV
Description:	Surface Aggregate Visible
Distance (ft):	7.6
Structural Grade:	3
O&M Grade:	0
Clock Start/From:	12
Clock To:	12
1st Value:	
2nd Value:	
Value Percent:	
Step:	NO
Remarks:

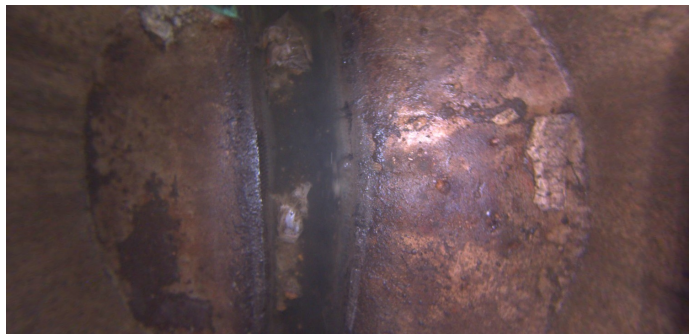
Code:	MGO
Description:	General Observation
Distance (ft):	7.6
Structural Grade:	0
O&M Grade:	0
Clock Start/From:	
Clock To:	
1st Value:	
2nd Value:	
Value Percent:	
Step:	NO
Remarks:	END SURVEY
