Manhole Inspection Report

Date:	05/11/2018	Weather:		Coding:	RZMACP
MH#:	M-1004-042	Owner:	NA	Len. Surveyed:	3.6
P.O.#:		Surveyor:	Jen Costello	Rim to Invert:	4.1
Customer:		Cert. #:	U-907-5518	Wall Material:	Concrete (reinforced)

Street:	Ryan Ct. 414' North of Coral Dr.	Project:	Hobart, IN
City:	Hobart, IN	GPS Northing:	2914845.941
Location:		GPS Easting:	2914845.941
Drain Area:	Northeast	GPS Accuracy:	Sub-Meter
Cover Shape:	Circular	Evidence of Surcharge:	No
Cover Size:	22.5	Potential for Runoff:	None
Comments:

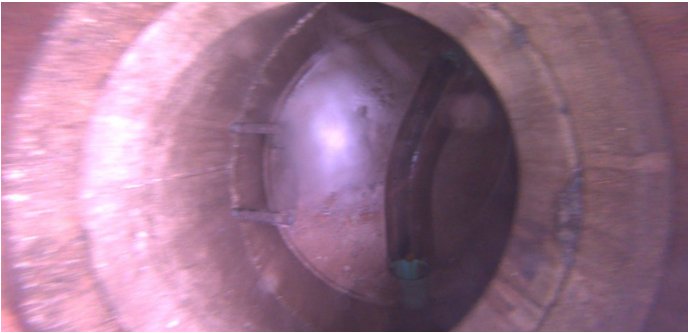
MGO

General Observation

.0

ACCESS MH

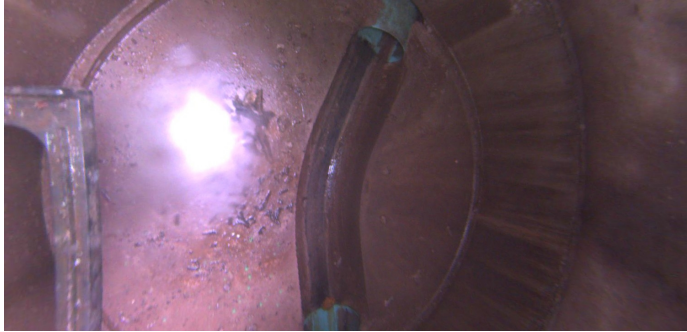
Code: **IW**
Description: **Infil Weeper**

Distance (ft): **1.5**
Structural Grade: **0**
O&M Grade: **2**
Clock Start/From: **12**
Clock To: **12**
1st Value:
2nd Value:
Value Percent:
Step: **NO**
Remarks:

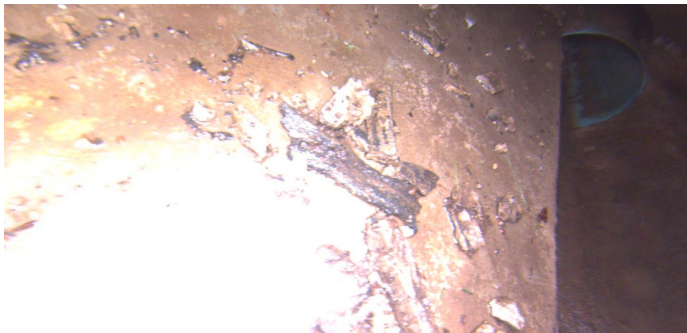
Code: **MGO**
Description: **General Observation**

Distance (ft): **3.6**
Structural Grade: **0**
O&M Grade: **0**
Clock Start/From:
Clock To:
1st Value:
2nd Value:
Value Percent:
Step: **NO**
Remarks: **END SURVEY**
