Manhole Inspection Report

Date:	05/11/2018	Weather:		Coding:	RZMACP
MH#:	M-1004-048	Owner:	NA	Len. Surveyed:	5.0
P.O.#:		Surveyor:	Jen Costello	Rim to Invert:	5.4
Customer:		Cert. #:	U-907-5518	Wall Material:	Concrete (reinforced)

Street:	Intersection of McAfee Dr. and Barb	Project:	Hobart, IN
City:	Hobart, IN	GPS Northing:	2914545.173
Location:		GPS Easting:	2914545.173
Drain Area:	Northeast	GPS Accuracy:	Sub-Meter
Cover Shape:	Circular	Evidence of Surcharge:	No
Cover Size:	22.5	Potential for Runoff:	None
Comments:

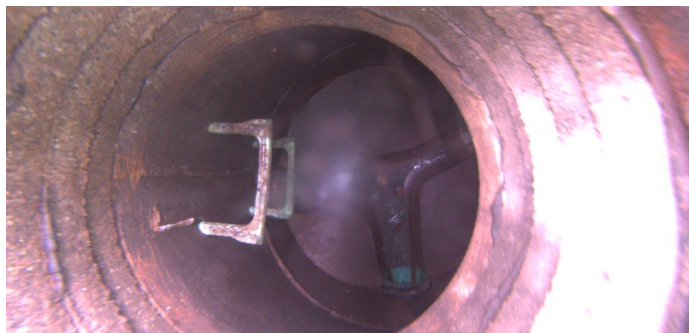
Code: **MGO**
Description: **General Observation**

Distance (ft): **.0**
Structural Grade: **0**
O&M Grade: **0**
Clock Start/From:
Clock To:
1st Value:
2nd Value:
Value Percent:
Step: **NO**
Remarks: **ACCESS MH**

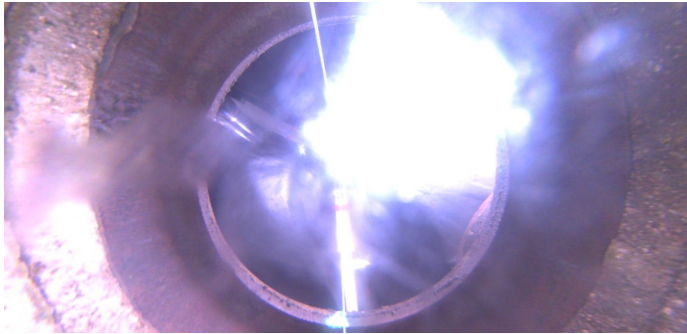
Code: **MGO**
Description: **General Observation**

Distance (ft): **1.6**
Structural Grade: **0**
O&M Grade: **0**
Clock Start/From:
Clock To:
1st Value:
2nd Value:
Value Percent:
Step: **NO**
Remarks: **UNDERSIDE OF FRAME**

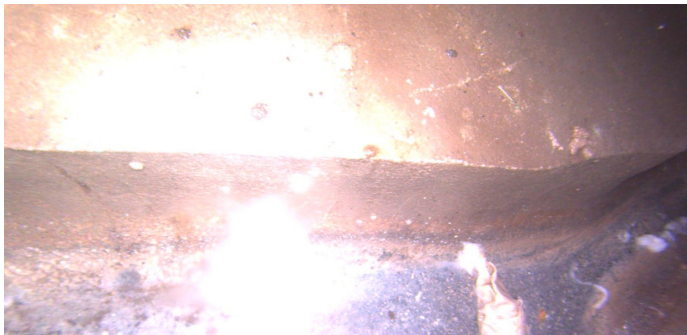
Code: **MGO**
Description: **General Observation**

Distance (ft): **5.0**
Structural Grade: **0**
O&M Grade: **0**
Clock Start/From:
Clock To:
1st Value:
2nd Value:
Value Percent:
Step: **NO**
Remarks: **END SURVEY**
