Manhole Inspection Report

| MH#: | M-1004-075 | Owner: | NA | Len. Surveyed: | 4.4 |

| Street: | Tulip Ln. 326' West of Hemlock Dr. | Project: | Hobart, IN |

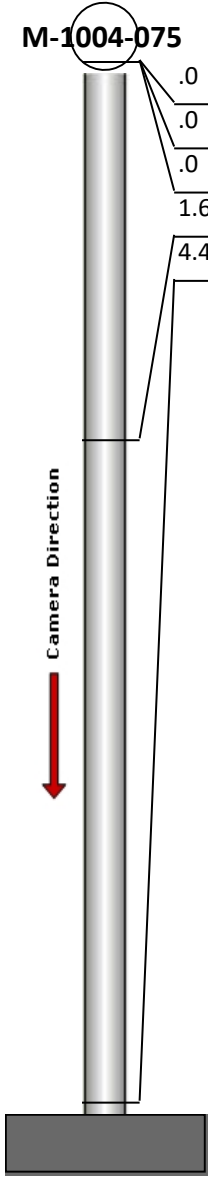
| | Position | Code | Observation | Video (sec) | Grade |
|--|---|---|---|---|---|
| | .0 | DAR | Deposits Attached Ragging | 10 | M 2 |
| | .0 | IW | Infil Weeper | 21 | M 2 |
| | .0 | MGO | General Observation | 33 | NA |
| | 1.6 | MGO | General Observation | 49 | NA |
| | 4.4 | MGO | General Observation | 68 | NA |

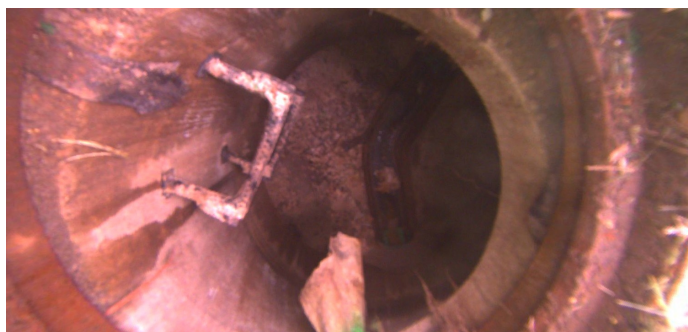
Code: **DAR**
Description: **Deposits Attached Ragging**

Distance (ft): **.0**
Structural Grade: **0**
O&M Grade: **2**
Clock Start/From: **6**
Clock To:
1st Value:
2nd Value:
Value Percent: **5.000**
Step: **NO**
Remarks:

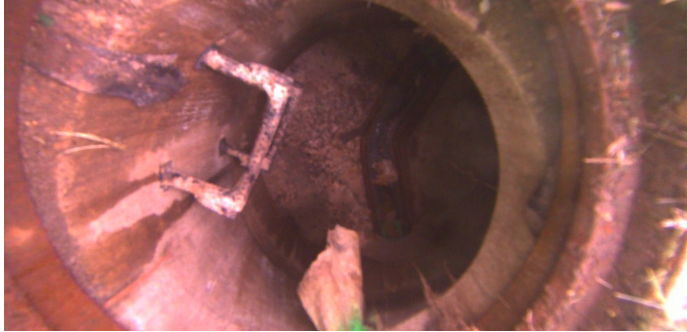
Code: **IW**
Description: **Infil Weeper**

Distance (ft): **.0**
Structural Grade: **0**
O&M Grade: **2**
Clock Start/From: **8**
Clock To:
1st Value:
2nd Value:
Value Percent:
Step: **NO**
Remarks:

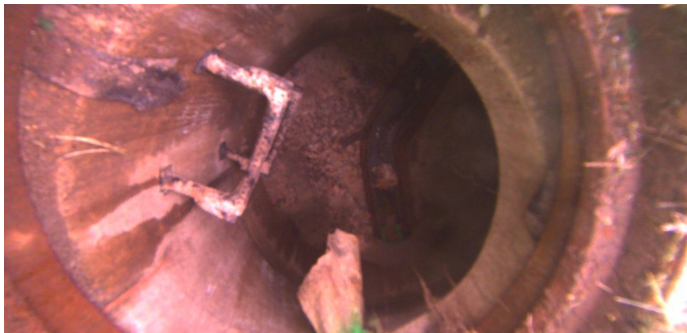
Code: **MGO**
Description: **General Observation**

Distance (ft): **.0**
Structural Grade: **0**
O&M Grade: **0**
Clock Start/From:
Clock To:
1st Value:
2nd Value:
Value Percent:
Step: **NO**
Remarks: **ACCESS MH**

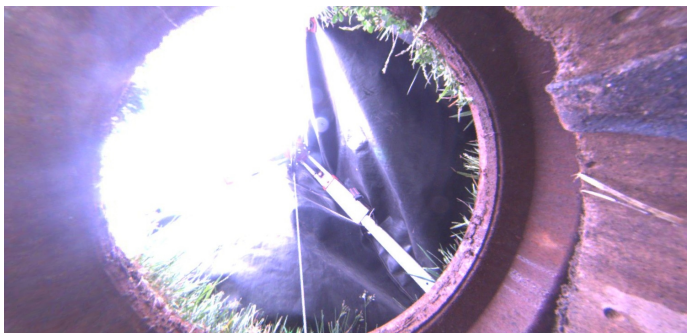
Code: **MGO**
Description: **General Observation**

Distance (ft): **1.6**
Structural Grade: **0**
O&M Grade: **0**
Clock Start/From:
Clock To:
1st Value:
2nd Value:
Value Percent:
Step: **NO**
Remarks: **UNDERSIDE OF FRAME**

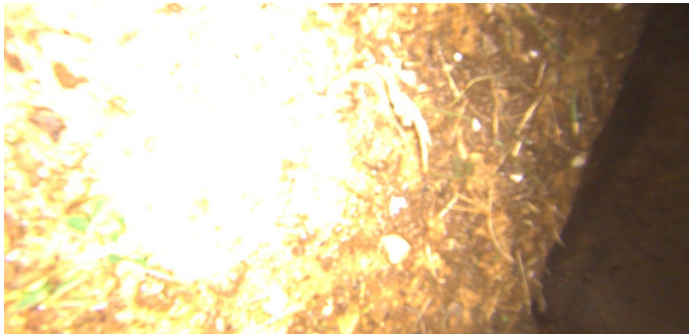
| Code: | MGO |
| Description: | General Observation |
| Distance (ft): | 4.4 |
| Remarks: | END SURVEY |
