Manhole Inspection Report

Date:	05/11/2018	Weather:		Coding:	RZMACP
MH#:	M-1004-081	Owner:	NA	Len. Surveyed:	4.2
P.O.#:		Surveyor:	Jen Costello	Rim to Invert:	5.8
Customer:		Cert. #:	U-907-5518	Wall Material:	Concrete (reinforced)

Street:	Tulip Ln. 265' North of Cypress Ln.	Project:	Hobart, IN
City:	Hobart, IN	GPS Northing:	2914460.166
Location:		GPS Easting:	2914460.166
Drain Area:	Northeast	GPS Accuracy:	Sub-Meter
Cover Shape:	Circular	Evidence of Surcharge:	No
Cover Size:	22.5	Potential for Runoff:	None
Comments:

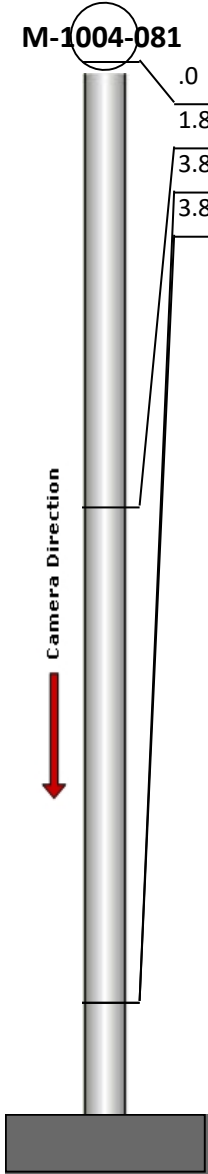
.0	MGO	General Observation	10	NA
	1.8	MGO	General Observation	28	NA
	3.8	DSGV	Deposits Settled Gravel	45	M 2
	3.8	MGO	General Observation	56	NA

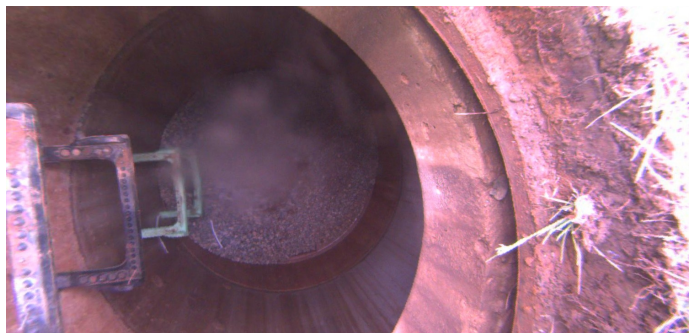
Code: **MGO**
Description: **General Observation**

Distance (ft): **.0**
Structural Grade: **0**
O&M Grade: **0**
Clock Start/From:
Clock To:
1st Value:
2nd Value:
Value Percent:
Step: **NO**
Remarks: **access MH**

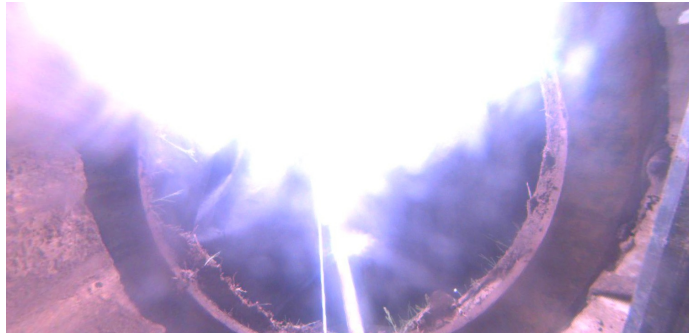
Code:	MGO
Description:	General Observation
Distance (ft):	1.8
Structural Grade:	0
O&M Grade:	0
Clock Start/From:	
Clock To:	
1st Value:	
2nd Value:	
Value Percent:	
Step:	NO
Remarks:	UNDERSIDE OF FRAME

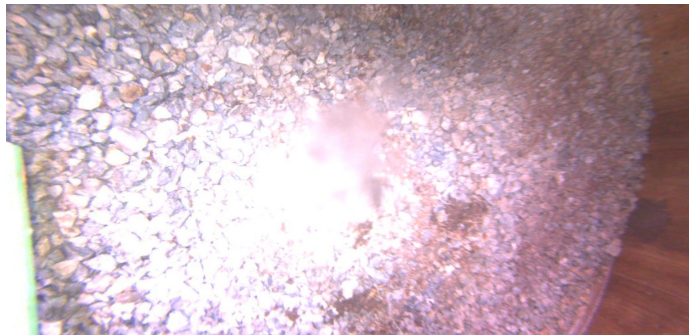
Code:	DSGV
Description:	Deposits Settled Gravel
Distance (ft):	3.8
Structural Grade:	0
O&M Grade:	2
Clock Start/From:	12
Clock To:	12
1st Value:	
2nd Value:	
Value Percent:	10.000
Step:	NO
Remarks:

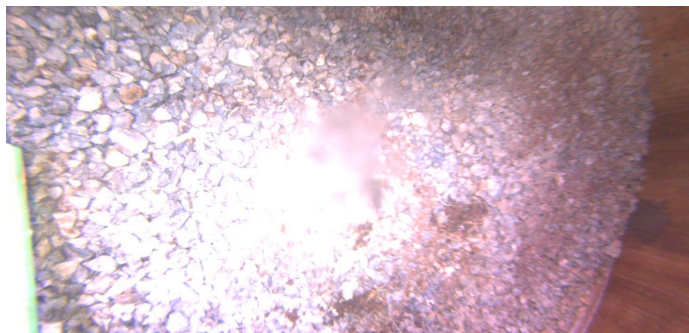
Code:	MGO
Description:	General Observation
Distance (ft):	3.8
Structural Grade:	0
O&M Grade:	0
Clock Start/From:	
Clock To:	
1st Value:	
2nd Value:	
Value Percent:	
Step:	NO
Remarks:	END SURVEY
