Manhole Inspection Report

Date:	05/11/2018	Weather:		Coding:	RZMACP
MH#:	M-1004-082	Owner:	NA	Len. Surveyed:	5.0
P.O.#:		Surveyor:	Jen Costello	Rim to Invert:	5.7
Customer:		Cert. #:	U-907-5518	Wall Material:	Concrete (reinforced)

Street:	McAfee Dr. 172' North of Cypress Ln.	Project:	Hobart, IN
City:	Hobart, IN	GPS Northing:	2914523.702
Location:		GPS Easting:	2914523.702
Drain Area:	Northeast	GPS Accuracy:	Sub-Meter
Cover Shape:	Circular	Evidence of Surcharge:	No
Cover Size:	22.5	Potential for Runoff:	None
Comments:

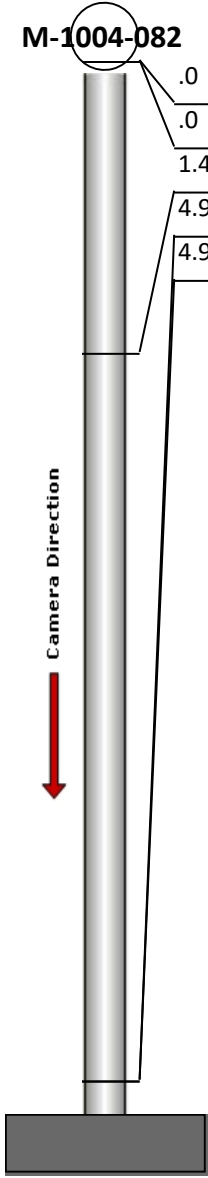
Position	Code	Observation	Video (sec)	Grade

0.0	MGO	General Observation	10	NA
	0.0	RFJ	Roots Fine Joint	21	M 1
	1.4	MGO	General Observation	37	NA
	4.9	DSF	Deposits Settled Fine	58	M 2
	4.9	MGO	General Observation	69	NA

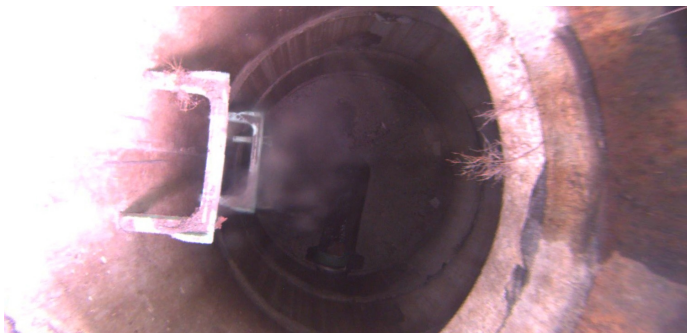
Code: **MGO**
Description: **General Observation**

Distance (ft): **.0**
Structural Grade: **0**
O&M Grade: **0**
Clock Start/From:
Clock To:
1st Value:
2nd Value:
Value Percent:
Step: **NO**
Remarks: **ACCESS MH**

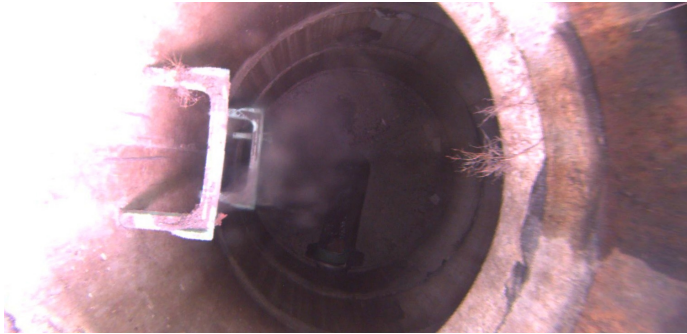
Code: **RFJ**
Description: **Roots Fine Joint**

Distance (ft): **.0**
Structural Grade: **0**
O&M Grade: **1**
Clock Start/From: **3**
Clock To:
1st Value:
2nd Value:
Value Percent:
Step: **NO**
Remarks:

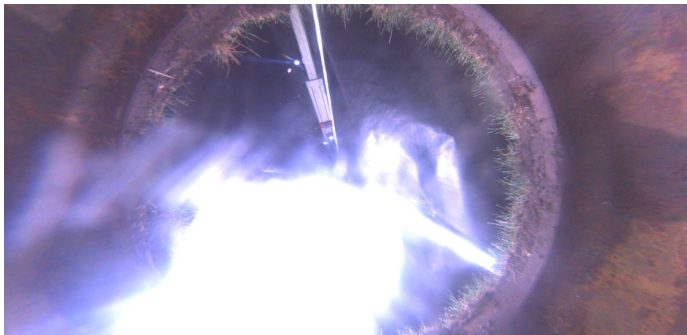
Code: **MGO**
Description: **General Observation**

Distance (ft): **1.4**
Structural Grade: **0**
O&M Grade: **0**
Clock Start/From:
Clock To:
1st Value:
2nd Value:
Value Percent:
Step: **NO**
Remarks: **UNDERSIDE OF FRAME**

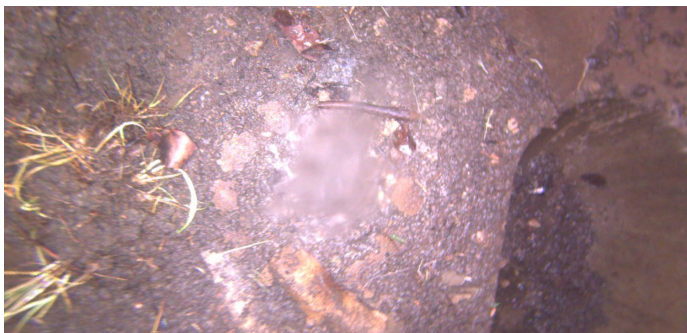
Code: **DSF**
Description: **Deposits Settled Fine**

Distance (ft): **4.9**
Structural Grade: **0**
O&M Grade: **2**
Clock Start/From: **12**
Clock To: **12**
1st Value:
2nd Value:
Value Percent: **5.000**
Step: **NO**
Remarks:

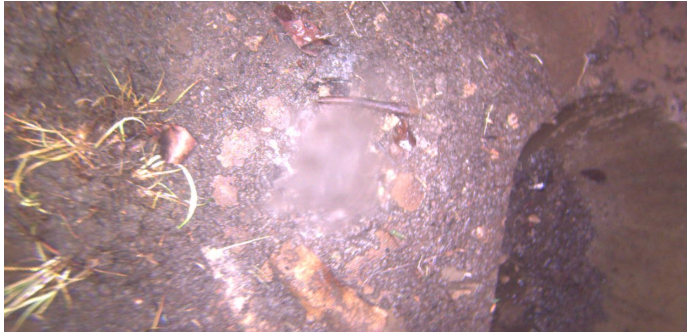
Code:	MGO
Description:	General Observation
Distance (ft):	4.9
Structural Grade:	0
O&M Grade:	0
Clock Start/From:	
Clock To:	
1st Value:	
2nd Value:	
Value Percent:	
Step:	NO
Remarks:	END SURVEY
