# Manhole Inspection Report

| MH#: | <b>M-1004-083</b> | Owner: | <b>NA</b> | Len. Surveyed: | <b>5.7</b> |

| Street: | <b>Cypress Ln. 221' West of McAfee.</b> | Project: | <b>Hobart, IN</b> |

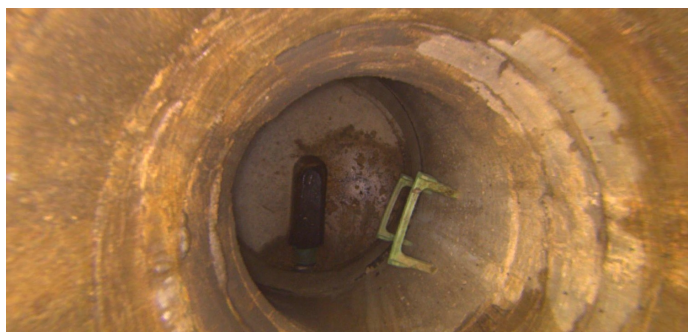
Code: **MGO**  
Description: **General Observation**

Distance (ft): **.0**  
Structural Grade: **0**  
O&M Grade: **0**  
Clock Start/From:  
Clock To:  
1st Value:  
2nd Value:  
Value Percent:  
Step: **NO**  
Remarks: **access mh**

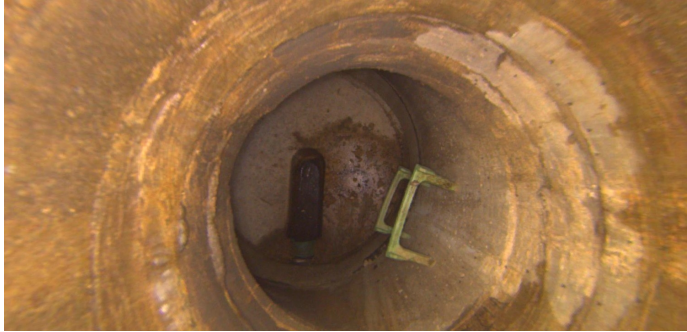
Code: **SRI**  
Description: **Surface Roughness Increased**

Distance (ft): **.0**  
Structural Grade: **1**  
O&M Grade: **0**  
Clock Start/From: **12**  
Clock To: **12**  
1st Value:  
2nd Value:  
Value Percent:  
Step: **NO**  
Remarks:
