Manhole Inspection Report

Date:	05/11/2018	Weather:		Coding:	RZMACP
MH#:	M-1004-090	Owner:	NA	Len. Surveyed:	6.5
P.O.#:		Surveyor:	Jen Costello	Rim to Invert:	6.5
Customer:		Cert. #:	U-907-5518	Wall Material:	Concrete (reinforced)

Street:	Cypress Ln. 672' West of Hemlock Dr	Project:	Hobart, IN
City:	Hobart, IN	GPS Northing:	2913211.645
Location:		GPS Easting:	2913211.645
Drain Area:	Northeast	GPS Accuracy:	Sub-Meter
Cover Shape:	Circular	Evidence of Surcharge:	No
Cover Size:	22.5	Potential for Runoff:	None
Comments:

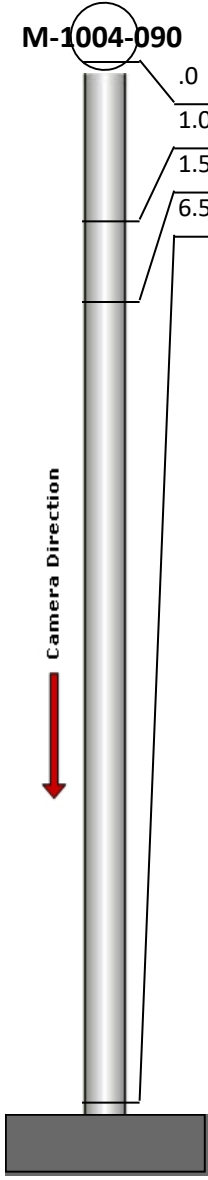
.0	MGP	General Photo	10	NA
	1.0	IW	Infil Weeper	24	M 2
	1.5	MGO	General Observation	38	NA
	6.5	MGO	General Observation	61	NA

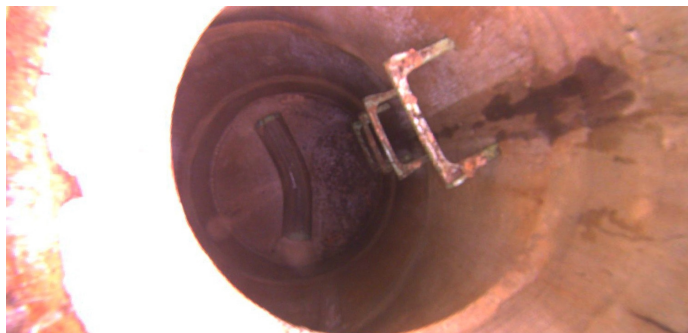
Code: **MGP**
Description: **General Photo**

Distance (ft): **.0**
Structural Grade: **0**
O&M Grade: **0**
Clock Start/From:
Clock To:
1st Value:
2nd Value:
Value Percent:
Step: **NO**
Remarks: **ACCESS MH**

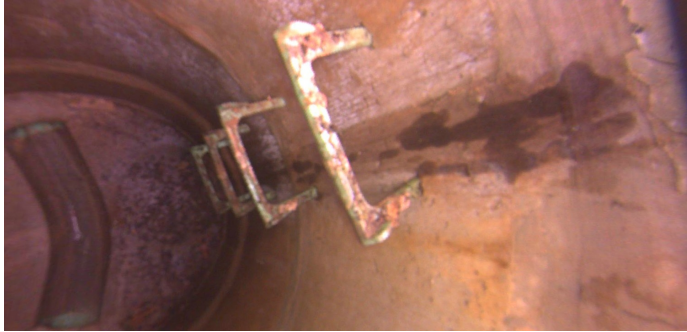
Code: **IW**
Description: **Infil Weeper**

Distance (ft): **1.0**
Structural Grade: **0**
O&M Grade: **2**
Clock Start/From: **3**
Clock To:
1st Value:
2nd Value:
Value Percent:
Step: **NO**
Remarks:

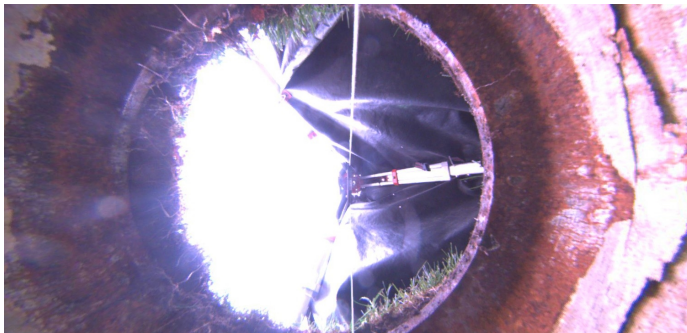
Code: **MGO**
Description: **General Observation**

Distance (ft): **1.5**
Structural Grade: **0**
O&M Grade: **0**
Clock Start/From:
Clock To:
1st Value:
2nd Value:
Value Percent:
Step: **NO**
Remarks: **UNDERSIDE OF FRAME**

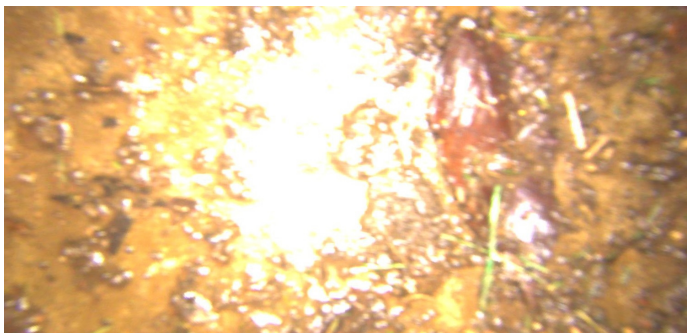
Code: **MGO**
Description: **General Observation**

Distance (ft): **6.5**
Structural Grade: **0**
O&M Grade: **0**
Clock Start/From:
Clock To:
1st Value:
2nd Value:
Value Percent:
Step: **NO**
Remarks: **END SURVEY**
