# Manhole Inspection Report

Date:	10/03/2022	Weather:		Coding:	RZMACP
MH#:	M-1005-006	Owner:	NA	Len. Surveyed:	4.0
P.O.#:		Surveyor:	Jen Costello	Rim to Invert:	7.8
Customer:		Cert. #:	U-907-5518	Wall Material:	Concrete (cast in place)

Street:	285' West of County Line Rd. 693' So	Project:	502259S9MACP26Jan2023
City:	Hobart, IN	GPS Northing:	2914770.345
Location:		GPS Easting:	2914770.345
Drain Area:	Northeast	GPS Accuracy:	Sub-Meter
Cover Shape:	Circular	Evidence of Surcharge:	No
Cover Size:	24.0	Potential for Runoff:	None
Comments:	PARTIAL DESCENT DUE TO SURCHARGE

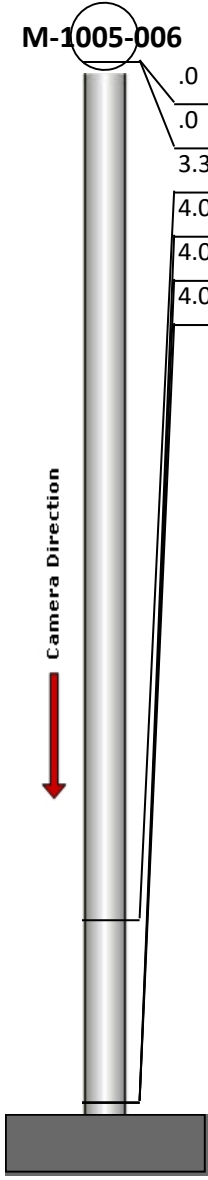
.0	MGO	General Observation	10	NA
	.0	SRI	Surface Roughness Increased	21	S 1
	3.3	MGO	General Observation	39	NA
	4.0	DSF	Deposits Settled Fine	53	M 2
	4.0	MGO	General Observation	64	NA
	4.0	SRI	Surface Roughness Increased	75	S 1

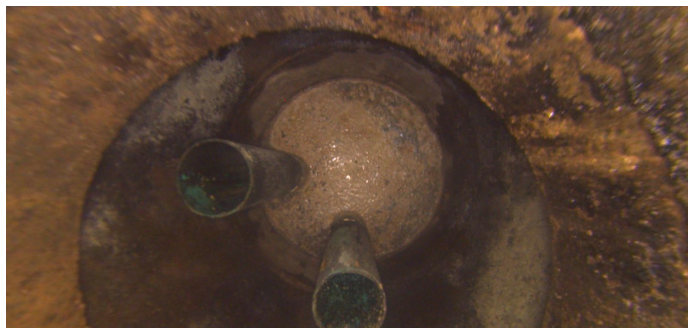
Code: **MGO**  
Description: **General Observation**

Distance (ft): **.0**  
Structural Grade: **0**  
O&M Grade: **0**  
Clock Start/From:  
Clock To:  
1st Value:  
2nd Value:  
Value Percent:  
Step: **NO**  
Remarks: **access mh**

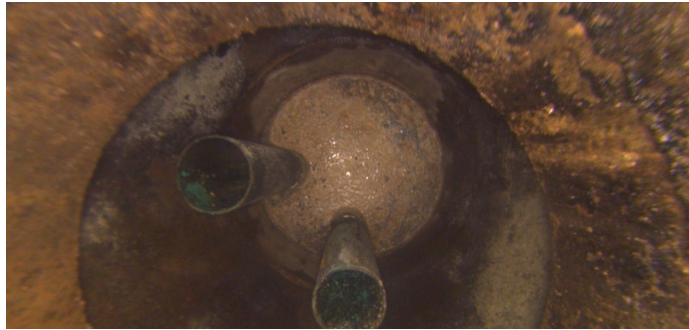
Code: **SRI**  
Description: **Surface Roughness Increased**

Distance (ft): **.0**  
Structural Grade: **1**  
O&M Grade: **0**  
Clock Start/From: **12**  
Clock To: **12**  
1st Value:  
2nd Value:  
Value Percent:  
Step: **NO**  
Remarks:

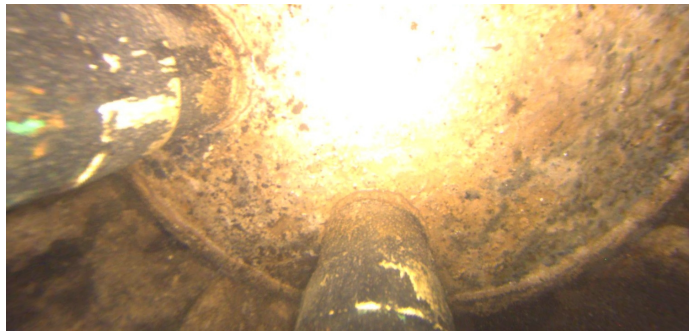
Code: **MGO**  
Description: **General Observation**

Distance (ft): **3.3**  
Structural Grade: **0**  
O&M Grade: **0**  
Clock Start/From:  
Clock To:  
1st Value:  
2nd Value:  
Value Percent:  
Step: **NO**  
Remarks: **lines are perpendicular to bench**

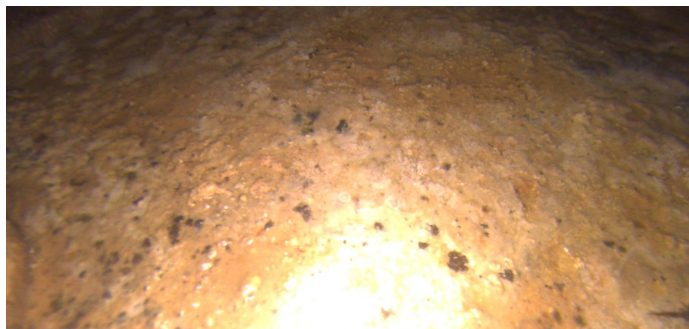
Code: **DSF**  
Description: **Deposits Settled Fine**

Distance (ft): **4.0**  
Structural Grade: **0**  
O&M Grade: **2**  
Clock Start/From: **12**  
Clock To: **12**  
1st Value:  
2nd Value:  
Value Percent: **5.000**  
Step: **NO**  
Remarks:

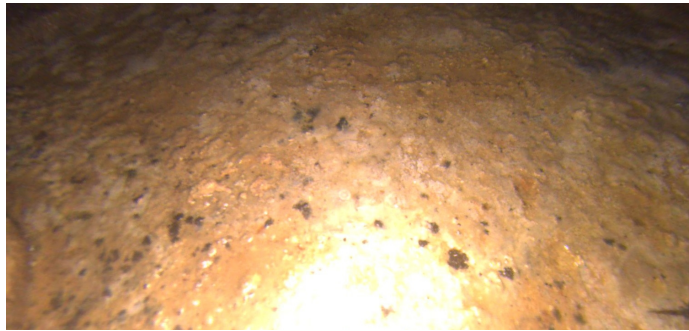
Code: **MGO**  
Description: **General Observation**

Distance (ft): **4.0**  
Structural Grade: **0**  
O&M Grade: **0**  
Clock Start/From:  
Clock To:  
1st Value:  
2nd Value:  
Value Percent:  
Step: **NO**  
Remarks: **end of survey**

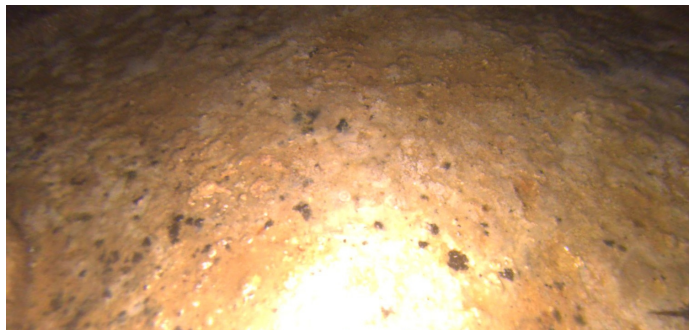
Code: **SRI**  
Description: **Surface Roughness Increased**

Distance (ft): **4.0**  
Structural Grade: **1**  
O&M Grade: **0**  
Clock Start/From: **12**  
Clock To: **12**  
1st Value:  
2nd Value:  
Value Percent:  
Step: **NO**  
Remarks:
