Manhole Inspection Report

Date:	04/22/2018	Weather:		Coding:	RZMACP
MH#:	M-1006-008	Owner:	NA	Len. Surveyed:	6.3
P.O.#:		Surveyor:	John Kuglmaier	Rim to Invert:	5.9
Customer:	8.7	Cert. #:	U-1215-07002349	Wall Material:	Concrete (reinforced)

Street:	224' North of Hwy 130. 1531' West	Project:	Hobart, IN
City:	Hobart, IN	GPS Northing:	0.0
Location:		GPS Easting:	0.0
Drain Area:	Southeast	GPS Accuracy:	Nearest Meter
Cover Shape:	Circular	Evidence of Surcharge:	No
Cover Size:	22.5	Potential for Runoff:	None
Comments:

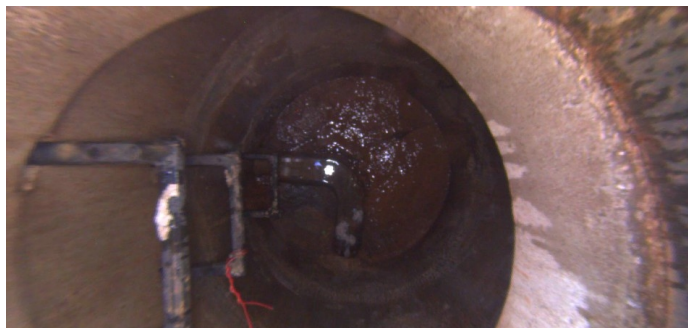
Code: **MGP**
Description: **General Photo**

Distance (ft): **.0**
Structural Grade: **0**
O&M Grade: **0**
Clock Start/From:
Clock To:
1st Value:
2nd Value:
Value Percent:
Step: **NO**
Remarks:

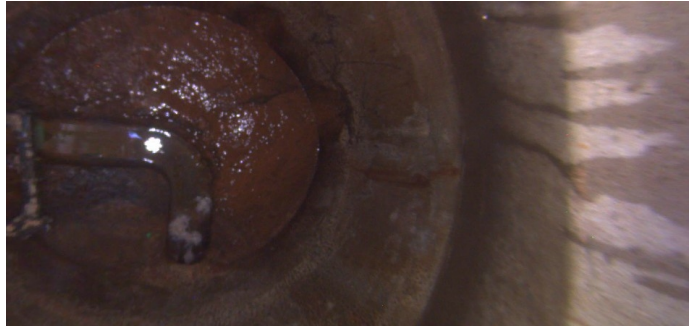
Code: **IS**
Description: **Infil Stain**

Distance (ft): **1.2**
Structural Grade: **0**
O&M Grade: **0**
Clock Start/From: **4**
Clock To:
1st Value:
2nd Value:
Value Percent:
Step: **NO**
Remarks:

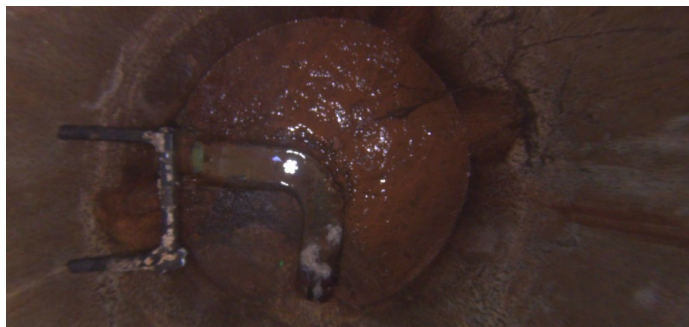
Code: **DAZ**
Description: **Deposits Attached Other**

Distance (ft): **2.5**
Structural Grade: **0**
O&M Grade: **2**
Clock Start/From: **12**
Clock To: **12**
1st Value:
2nd Value:
Value Percent: **5.000**
Step: **NO**
Remarks: **Mixed materials**

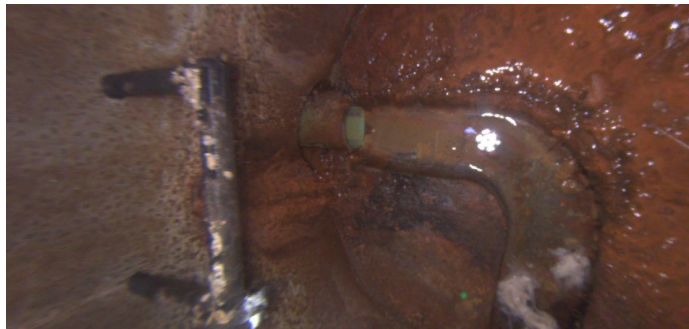
Code: **IS**
Description: **Infil Stain**

Distance (ft): **4.0**
Structural Grade: **0**
O&M Grade: **0**
Clock Start/From: **8**
Clock To:
1st Value:
2nd Value:
Value Percent:
Step: **NO**
Remarks:

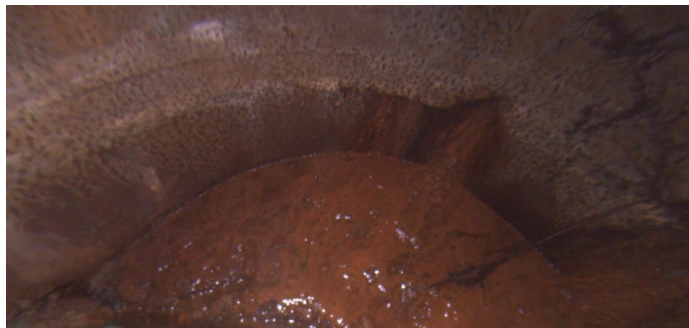
Code: **IS**
Description: **Infil Stain**

Distance (ft): **4.0**
Structural Grade: **0**
O&M Grade: **0**
Clock Start/From: **1**
Clock To:
1st Value:
2nd Value:
Value Percent:
Step: **NO**
Remarks:

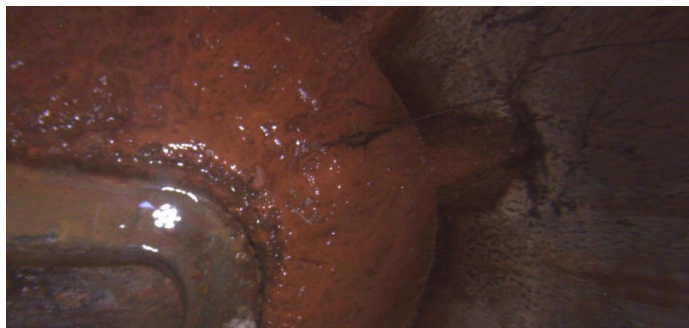
Code: **IS**
Description: **Infil Stain**

Distance (ft): **4.0**
Structural Grade: **0**
O&M Grade: **0**
Clock Start/From: **3**
Clock To:
1st Value:
2nd Value:
Value Percent:
Step: **NO**
Remarks:
