Manhole Inspection Report

Date:	04/22/2018	Weather:		Coding:	RZMACP
MH#:	M-1006-012	Owner:	NA	Len. Surveyed:	8.3
P.O.#:		Surveyor:	John Kuglmaier	Rim to Invert:	7.8
Customer:	8.7	Cert. #:	U-1215-07002349	Wall Material:	Concrete (reinforced)

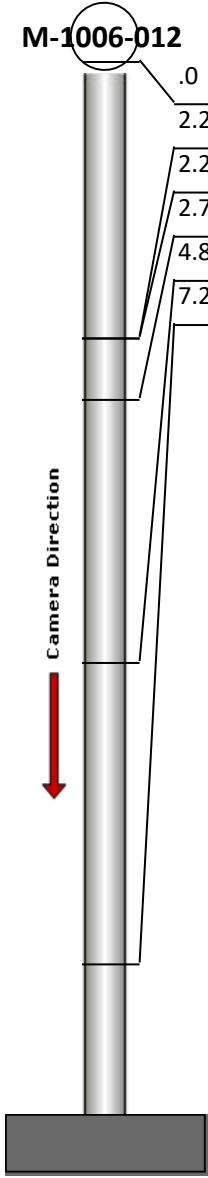
.0	MGP	General Photo	10	NA
	2.2	IS	Infil Stain	26	NA
	2.2	IS	Infil Stain	37	NA
	2.7	MGP	General Photo	52	NA
	4.8	DSF	Deposits Settled Fine	70	M 2
	7.2	MGO	General Observation	86	NA

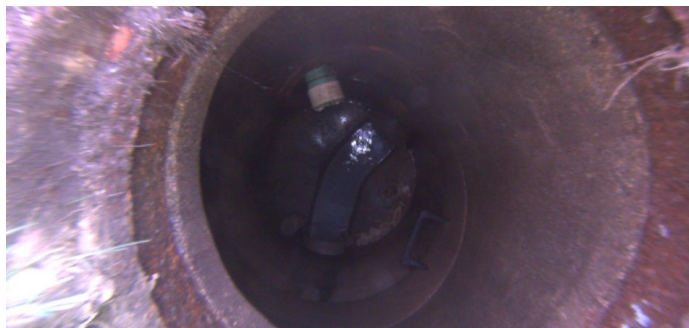
Code: **MGP**
 Description: **General Photo**

Distance (ft): **.0**
 Structural Grade: **0**
 O&M Grade: **0**
 Clock Start/From:
 Clock To:
 1st Value:
 2nd Value:
 Value Percent:
 Step: **NO**
 Remarks:

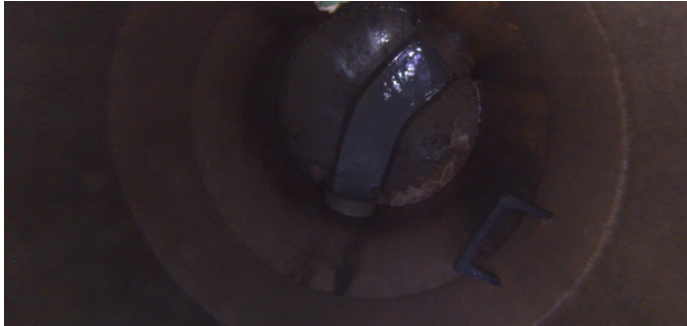
Code: **IS**
Description: **Infil Stain**

Distance (ft): **2.2**
Structural Grade: **0**
O&M Grade: **0**
Clock Start/From: **6**
Clock To: **7**
1st Value:
2nd Value:
Value Percent:
Step: **NO**
Remarks:

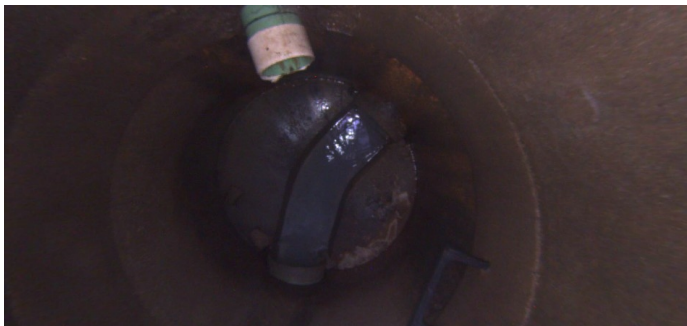
Code: **IS**
Description: **Infil Stain**

Distance (ft): **2.2**
Structural Grade: **0**
O&M Grade: **0**
Clock Start/From: **10**
Clock To: **4**
1st Value:
2nd Value:
Value Percent:
Step: **NO**
Remarks:

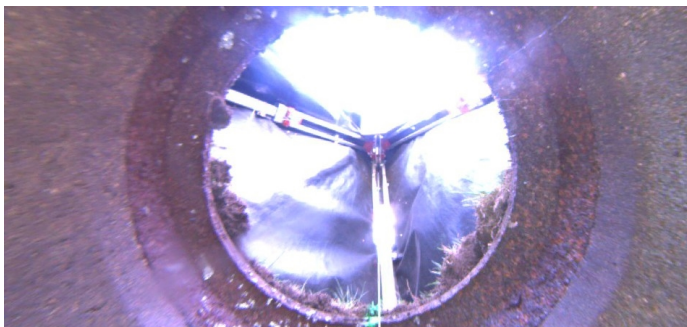
Code: **MGP**
Description: **General Photo**

Distance (ft): **2.7**
Structural Grade: **0**
O&M Grade: **0**
Clock Start/From:
Clock To:
1st Value:
2nd Value:
Value Percent:
Step: **NO**
Remarks:

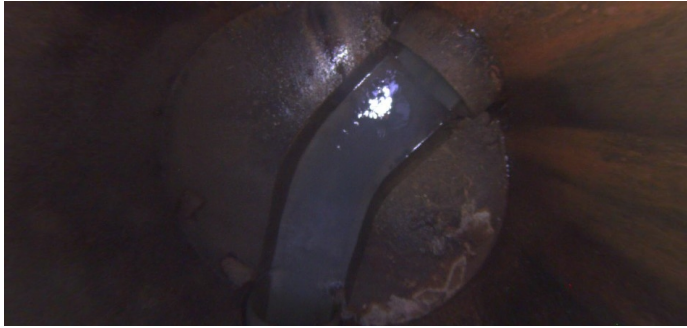
Code:	DSF
Description:	Deposits Settled Fine
Distance (ft):	4.8
Structural Grade:	0
O&M Grade:	2
Clock Start/From:	12
Clock To:	12
1st Value:	
2nd Value:	
Value Percent:	5.000
Step:	NO
Remarks:

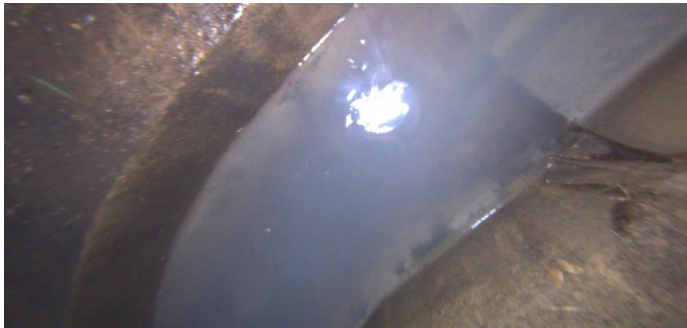
Code:	MGO
Description:	General Observation
Distance (ft):	7.2
Structural Grade:	0
O&M Grade:	0
Clock Start/From:	
Clock To:	
1st Value:	
2nd Value:	
Value Percent:	
Step:	NO
Remarks:	Ins. Comp.
