# Manhole Inspection Report

Date:	<b>04/19/2018</b>	Weather:		Coding:	<b>RZMACP</b>
MH#:	<b>M-103-003</b>	Owner:	<b>NA</b>	Len. Surveyed:	<b>9.5</b>
P.O.#:		Surveyor:	<b>John Kuglmaier</b>	Rim to Invert:	<b>11.2</b>
Customer:		Cert. #:	<b>U-1215-07002349</b>	Wall Material:	<b>Concrete (reinforced)</b>

Street:	<b>40th Ave. 168' East of Howard St.</b>	Project:	<b>Hobart, IN</b>
City:	<b>Hobart, IN</b>	GPS Northing:	<b>2891268.81</b>
Location:		GPS Easting:	<b>2891268.81</b>
Drain Area:	<b>Northwest</b>	GPS Accuracy:	<b>Sub-Meter</b>
Cover Shape:	<b>Circular</b>	Evidence of Surcharge:	<b>Yes</b>
Cover Size:	<b>23.0</b>	Potential for Runoff:	<b>None</b>
Comments:

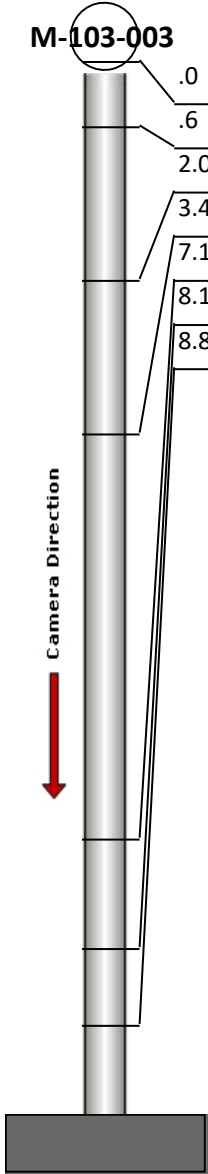
.0	MGP	General Photo	10	NA
	.6	DAZ	Deposits Attached Other	23	M 2
	2.0	MGP	General Photo	39	NA
	3.4	IS	Infil Stain	56	NA
	7.1	DSF	Deposits Settled Fine	75	M 3
	8.1	DAZ	Deposits Attached Other	89	M 2
	8.8	MGO	General Observation	102	NA

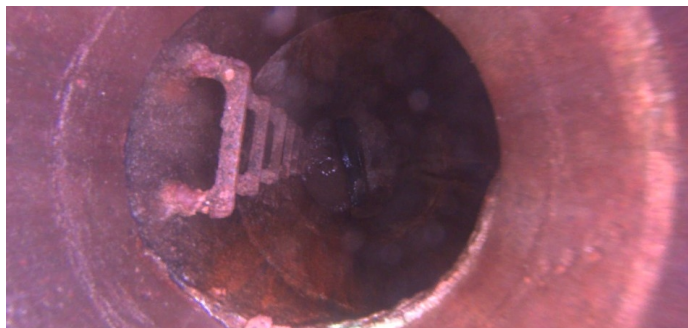
Code: **MGP**  
Description: **General Photo**

Distance (ft): **.0**  
Structural Grade: **0**  
O&M Grade: **0**  
Clock Start/From:  
Clock To:  
1st Value:  
2nd Value:  
Value Percent:  
Step: **NO**  
Remarks:

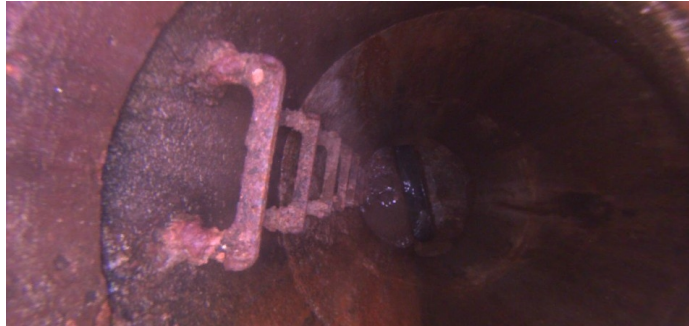
Code:	<b>DAZ</b>
Description:	<b>Deposits Attached Other</b>
Distance (ft):	<b>.6</b>
Structural Grade:	<b>0</b>
O&M Grade:	<b>2</b>
Clock Start/From:	<b>8</b>
Clock To:	<b>10</b>
1st Value:	
2nd Value:	
Value Percent:	<b>5.000</b>
Step:	<b>NO</b>
Remarks:

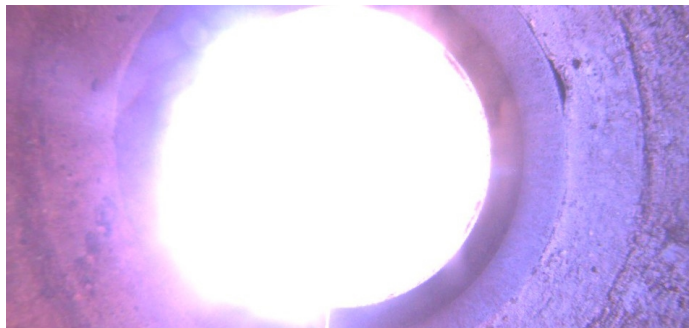
Code:	<b>MGP</b>
Description:	<b>General Photo</b>
Distance (ft):	<b>2.0</b>
Structural Grade:	<b>0</b>
O&M Grade:	<b>0</b>
Clock Start/From:	
Clock To:	
1st Value:	
2nd Value:	
Value Percent:	
Step:	<b>NO</b>
Remarks:

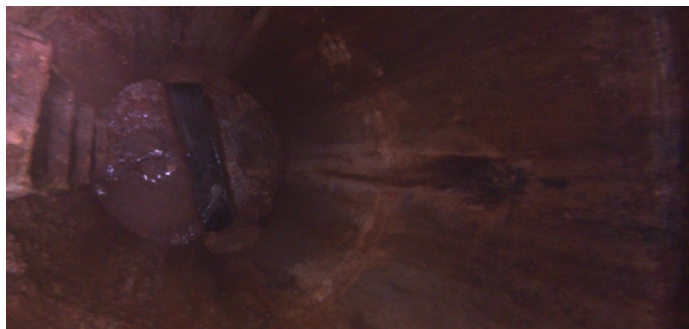
Code:	<b>IS</b>
Description:	<b>Infil Stain</b>
Distance (ft):	<b>3.4</b>
Structural Grade:	<b>0</b>
O&M Grade:	<b>0</b>
Clock Start/From:	<b>4</b>
Clock To:	
1st Value:	
2nd Value:	
Value Percent:	
Step:	<b>NO</b>
Remarks:

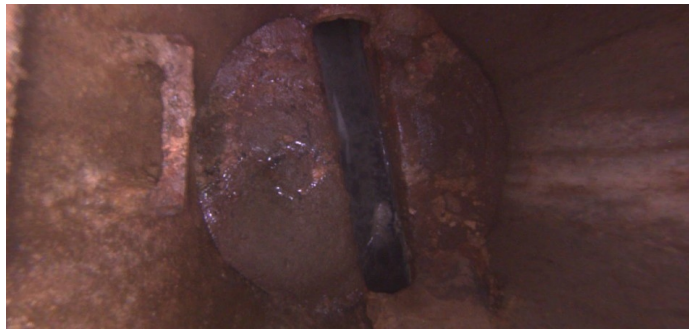
Code: **DSF**  
Description: **Deposits Settled Fine**

Distance (ft): **7.1**  
Structural Grade: **0**  
O&M Grade: **3**  
Clock Start/From: **12**  
Clock To: **12**  
1st Value:  
2nd Value:  
Value Percent: **15.000**  
Step: **NO**  
Remarks:

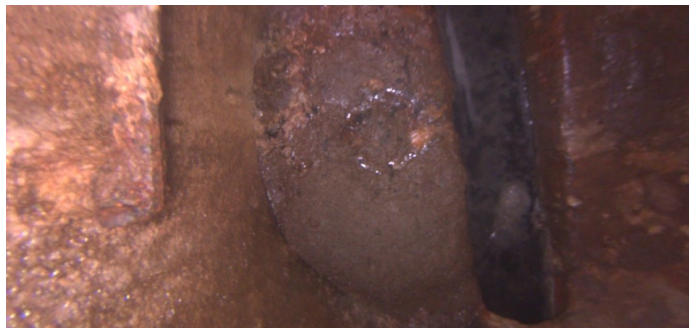
Code: **DAZ**  
Description: **Deposits Attached Other**

Distance (ft): **8.1**  
Structural Grade: **0**  
O&M Grade: **2**  
Clock Start/From: **8**  
Clock To: **10**  
1st Value:  
2nd Value:  
Value Percent: **5.000**  
Step: **NO**  
Remarks:

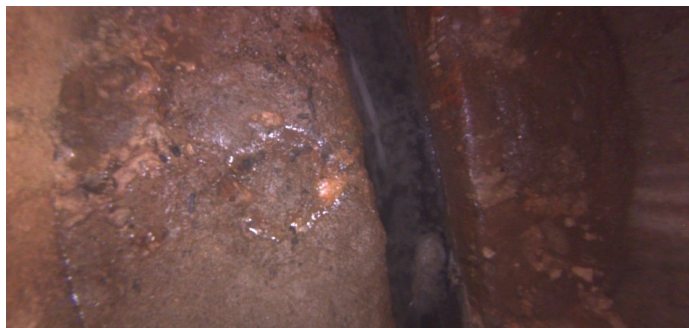
Code: **MGO**  
Description: **General Observation**

Distance (ft): **8.8**  
Structural Grade: **0**  
O&M Grade: **0**  
Clock Start/From:  
Clock To:  
1st Value:  
2nd Value:  
Value Percent:  
Step: **NO**  
Remarks: **Ins. Comp.**
