Manhole Inspection Report

Date:	10/04/2022	Weather:		Coding:	RZMACP
MH#:	M-103-007	Owner:	NA	Len. Surveyed:	8.3
P.O.#:		Surveyor:	Jen Costello	Rim to Invert:	10.2
Customer:		Cert. #:	U-907-5518	Wall Material:	Concrete (cast in place)

Street:	Howard St. 166' South of 39th Ave.	Project:	Hobart, IN
City:	Hobart, IN	GPS Northing:	2294387.905
Location:	Local Rural Streets	GPS Easting:	2891101.64
Drain Area:	Northwest	GPS Accuracy:	Sub-Meter
Cover Shape:	Circular	Evidence of Surcharge:	No
Cover Size:	24.0	Potential for Runoff:	None
Comments:

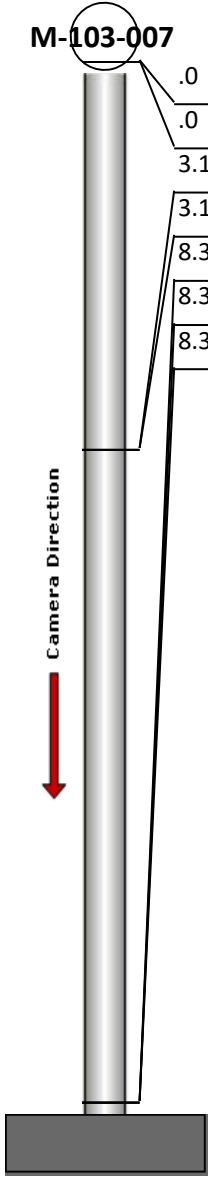
M-103-007				
	.0	MGO	General Observation	10	NA
	.0	SRI	Surface Roughness Increased	21	S 1
	3.1	IW	Infil Weeper	39	M 2
	3.1	MGO	General Observation	53	NA
	8.3	DSF	Deposits Settled Fine	77	M 2
	8.3	SRI	Surface Roughness Increased	88	S 1
	8.3	MGO	General Observation	100	NA

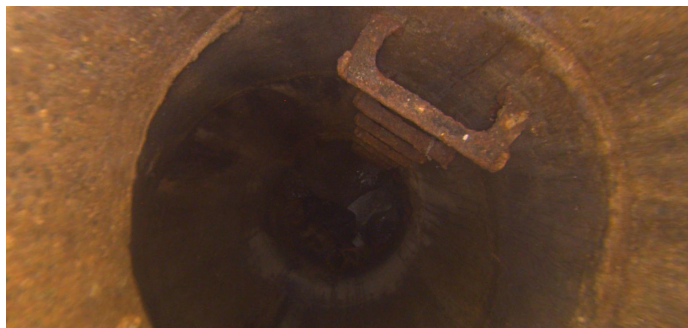
Code: **MGO**
Description: **General Observation**

Distance (ft): **.0**
Structural Grade: **0**
O&M Grade: **0**
Clock Start/From:
Clock To:
1st Value:
2nd Value:
Value Percent:
Step: **NO**
Remarks: **access mh**

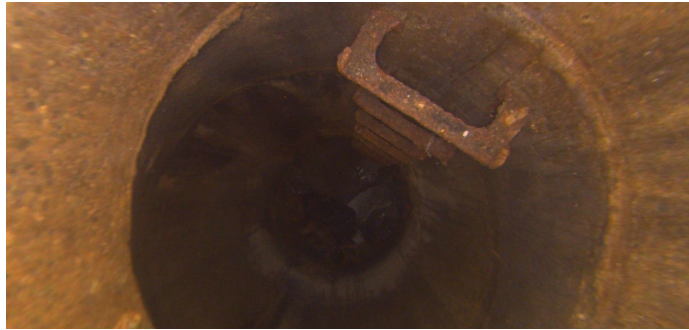
Code: **SRI**
Description: **Surface Roughness Increased**

Distance (ft): **.0**
Structural Grade: **1**
O&M Grade: **0**
Clock Start/From: **12**
Clock To: **12**
1st Value:
2nd Value:
Value Percent:
Step: **NO**
Remarks:

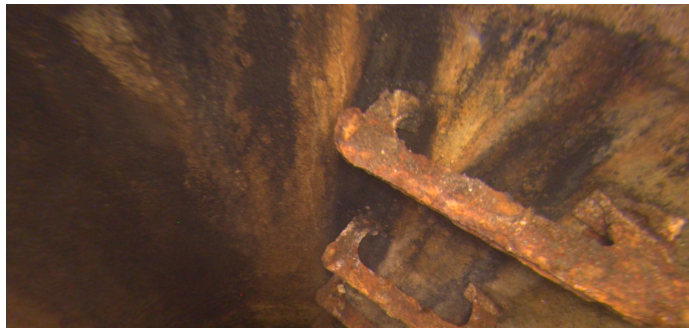
Code: **IW**
Description: **Infil Weeper**

Distance (ft): **3.1**
Structural Grade: **0**
O&M Grade: **2**
Clock Start/From: **12**
Clock To: **12**
1st Value:
2nd Value:
Value Percent:
Step: **NO**
Remarks:

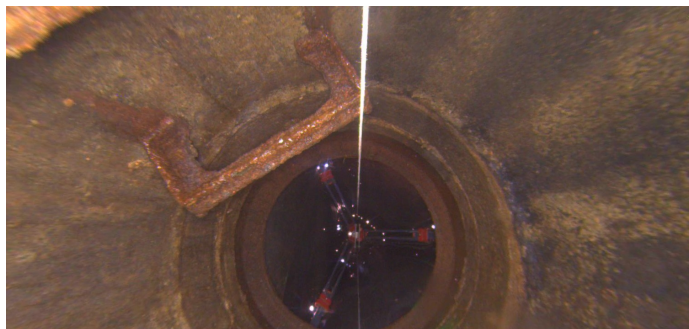
Code: **MGO**
Description: **General Observation**

Distance (ft): **3.1**
Structural Grade: **0**
O&M Grade: **0**
Clock Start/From:
Clock To:
1st Value:
2nd Value:
Value Percent:
Step: **NO**
Remarks: **underside of frame**

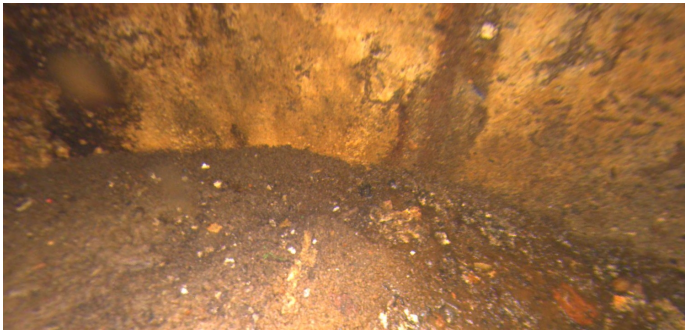
Code:	DSF
Description:	Deposits Settled Fine

Distance (ft):	8.3
Structural Grade:	0
O&M Grade:	2
Clock Start/From:	12
Clock To:	12
1st Value:	
2nd Value:	
Value Percent:	5.000
Step:	NO
Remarks:

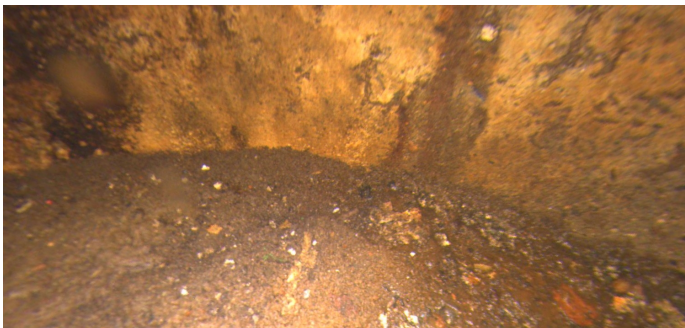
Code:	SRI
Description:	Surface Roughness Increased

Distance (ft):	8.3
Structural Grade:	1
O&M Grade:	0
Clock Start/From:	12
Clock To:	12
1st Value:	
2nd Value:	
Value Percent:	
Step:	NO
Remarks:

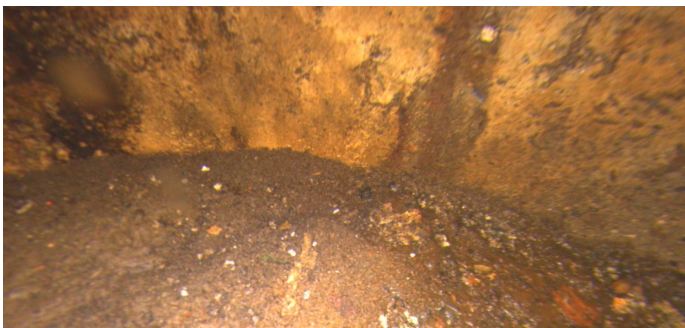
Code:	MGO
Description:	General Observation

Distance (ft):	8.3
Structural Grade:	0
O&M Grade:	0
Clock Start/From:	
Clock To:	
1st Value:	
2nd Value:	
Value Percent:	
Step:	NO
Remarks:	end of survey
