Manhole Inspection Report

Date:	04/18/2018	Weather:		Coding:	RZMACP
MH#:	M-103-018	Owner:	NA	Len. Surveyed:	5.6
P.O.#:		Surveyor:	John Kuglmaier	Rim to Invert:	6.6
Customer:		Cert. #:	U-1215-07002349	Wall Material:	Concrete (reinforced)

Street:	Willow St. 160' South of 39th Ave.	Project:	Hobart, IN
City:	Hobart, IN	GPS Northing:	2890747.682
Location:		GPS Easting:	2890747.682
Drain Area:	Northwest	GPS Accuracy:	Sub-Meter
Cover Shape:	Circular	Evidence of Surcharge:	No
Cover Size:	23.0	Potential for Runoff:	None
Comments:

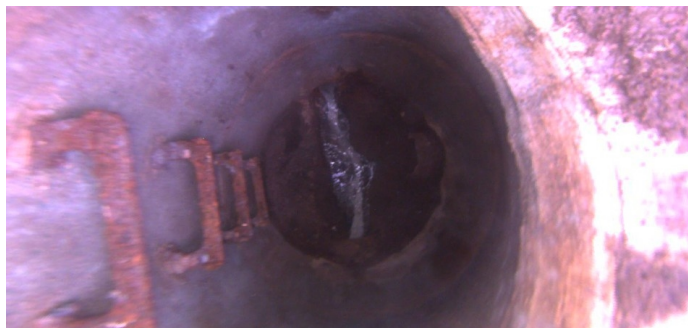
Code: **MGP**
 Description: **General Photo**

Distance (ft): **.0**
 Structural Grade: **0**
 O&M Grade: **0**
 Clock Start/From:
 Clock To:
 1st Value:
 2nd Value:
 Value Percent:
 Step: **NO**
 Remarks:

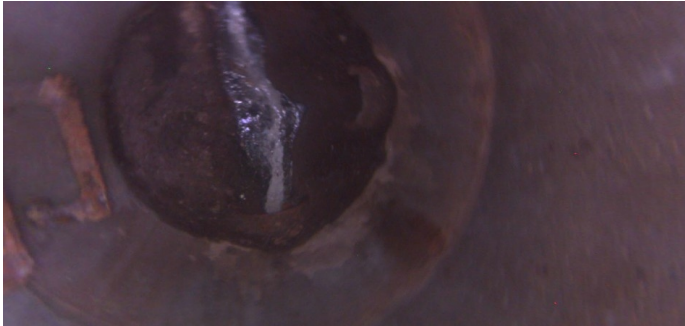
Code: **IS**
Description: **Infil Stain**

Distance (ft): **1.9**
Structural Grade: **0**
O&M Grade: **0**
Clock Start/From: **4**
Clock To:
1st Value:
2nd Value:
Value Percent:
Step: **NO**
Remarks:

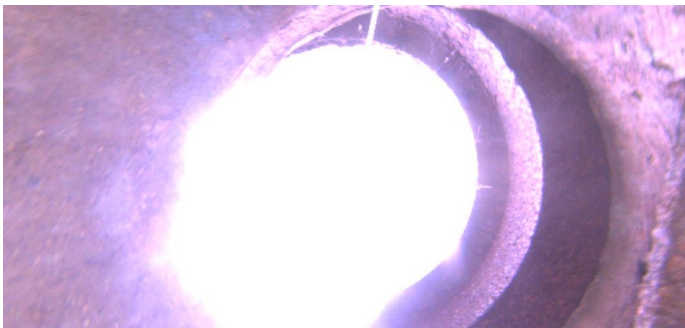
Code: **MGP**
Description: **General Photo**

Distance (ft): **2.2**
Structural Grade: **0**
O&M Grade: **0**
Clock Start/From:
Clock To:
1st Value:
2nd Value:
Value Percent:
Step: **NO**
Remarks:

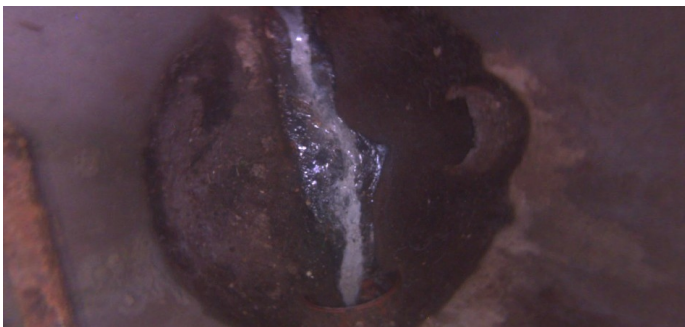
Code: **DAZ**
Description: **Deposits Attached Other**

Distance (ft): **3.0**
Structural Grade: **0**
O&M Grade: **2**
Clock Start/From: **12**
Clock To: **12**
1st Value:
2nd Value:
Value Percent: **5.000**
Step: **NO**
Remarks: **Mixed materials**

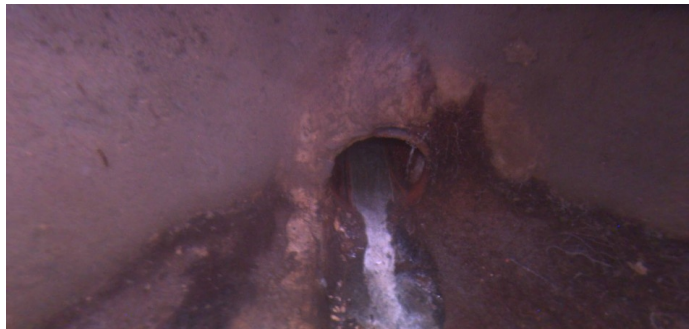
Code: **IS**
Description: **Infil Stain**

Distance (ft): **4.7**
Structural Grade: **0**
O&M Grade: **0**
Clock Start/From: **1**
Clock To:
1st Value:
2nd Value:
Value Percent:
Step: **NO**
Remarks:

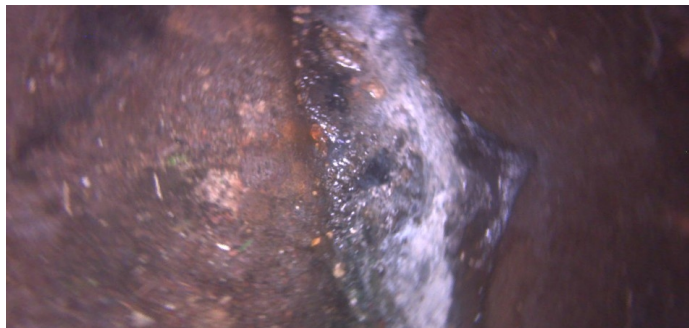
Code: **MGO**
Description: **General Observation**

Distance (ft): **5.1**
Structural Grade: **0**
O&M Grade: **0**
Clock Start/From:
Clock To:
1st Value:
2nd Value:
Value Percent:
Step: **NO**
Remarks: **Ins. Comp.**
