Manhole Inspection Report

Date:	04/18/2018	Weather:		Coding:	RZMACP
MH#:	M-103-113	Owner:	NA	Len. Surveyed:	6.5
P.O.#:		Surveyor:	John Kuglmaier	Rim to Invert:	7.6
Customer:		Cert. #:	U-1215-07002349	Wall Material:	Concrete (reinforced)

Street:	Intersection of 39th Ave. and Swift S	Project:	Hobart, IN
City:	Hobart, IN	GPS Northing:	2889127.227
Location:		GPS Easting:	2889127.227
Drain Area:	Northwest	GPS Accuracy:	Sub-Meter
Cover Shape:	Circular	Evidence of Surcharge:	Yes
Cover Size:	23.0	Potential for Runoff:	None
Comments:

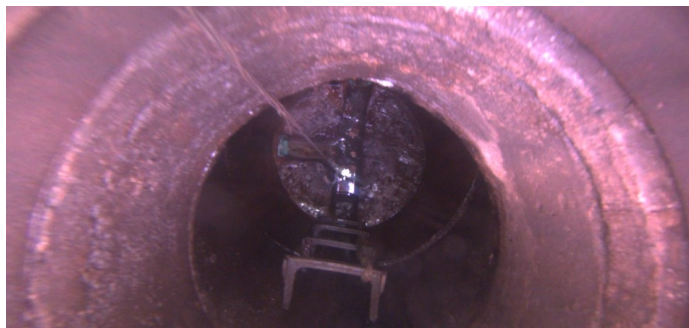
Code: **MGP**
Description: **General Photo**

Distance (ft): **.0**
Structural Grade: **0**
O&M Grade: **0**
Clock Start/From:
Clock To:
1st Value:
2nd Value:
Value Percent:
Step: **NO**
Remarks:

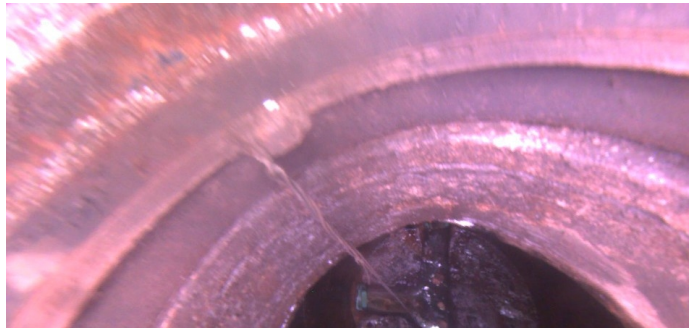
Code: **OBZ**
Description: **Obstacle Other**

Distance (ft): **.0**
Structural Grade: **0**
O&M Grade: **2**
Clock Start/From: **11**
Clock To:
1st Value:
2nd Value:
Value Percent: **5.000**
Step: **NO**
Remarks: **Rope**

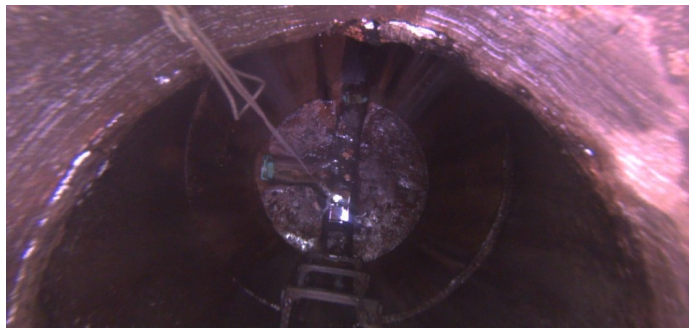
Code: **IS**
Description: **Infil Stain**

Distance (ft): **.9**
Structural Grade: **0**
O&M Grade: **0**
Clock Start/From: **9**
Clock To: **3**
1st Value:
2nd Value:
Value Percent:
Step: **NO**
Remarks:

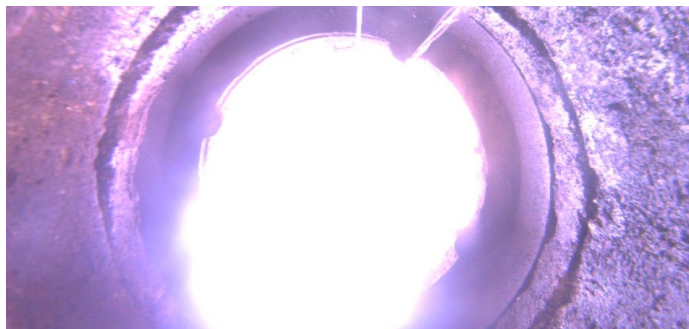
Code: **MGP**
Description: **General Photo**

Distance (ft): **2.2**
Structural Grade: **0**
O&M Grade: **0**
Clock Start/From:
Clock To:
1st Value:
2nd Value:
Value Percent:
Step: **NO**
Remarks:

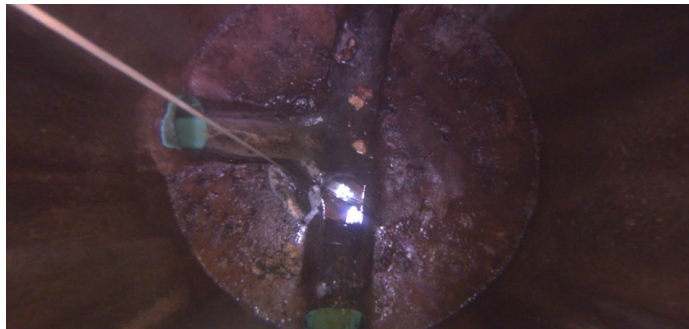
Code: **DSF**
Description: **Deposits Settled Fine**

Distance (ft): **4.4**
Structural Grade: **0**
O&M Grade: **2**
Clock Start/From: **12**
Clock To: **12**
1st Value:
2nd Value:
Value Percent: **5.000**
Step: **NO**
Remarks:

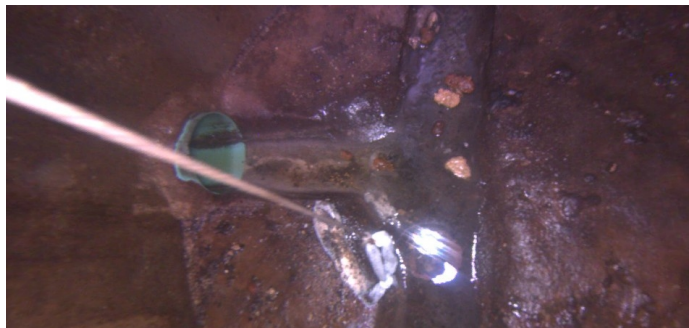
Code: **OBZ**
Description: **Obstacle Other**

Distance (ft): **5.6**
Structural Grade: **0**
O&M Grade: **2**
Clock Start/From: **11**
Clock To:
1st Value:
2nd Value:
Value Percent: **5.000**
Step: **NO**
Remarks: **Rope**

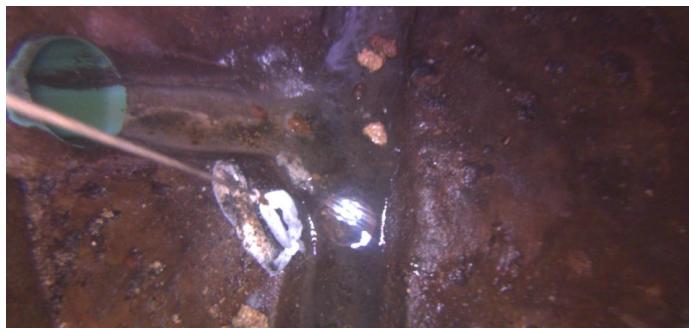
Code: **MGO**
Description: **General Observation**

Distance (ft): **5.8**
Structural Grade: **0**
O&M Grade: **0**
Clock Start/From:
Clock To:
1st Value:
2nd Value:
Value Percent:
Step: **NO**
Remarks: **Ins. Comp.**
