Manhole Inspection Report

Date:	10/04/2022	Weather:		Coding:	RZMACP
MH#:	M-103-115	Owner:	NA	Len. Surveyed:	14.7
P.O.#:		Surveyor:	Jen Costello	Rim to Invert:	15.8
Customer:		Cert. #:	U-907-5518	Wall Material:	Concrete (cast in place)

Street:	Maple St. 366' South of 38th Ave.	Project:	Hobart, IN
City:	Hobart, IN	GPS Northing:	2294881.41
Location:	Local Rural Streets	GPS Easting:	2889723.309
Drain Area:	Northwest	GPS Accuracy:	Sub-Meter
Cover Shape:	Circular	Evidence of Surcharge:	No
Cover Size:	24.0	Potential for Runoff:	None
Comments:

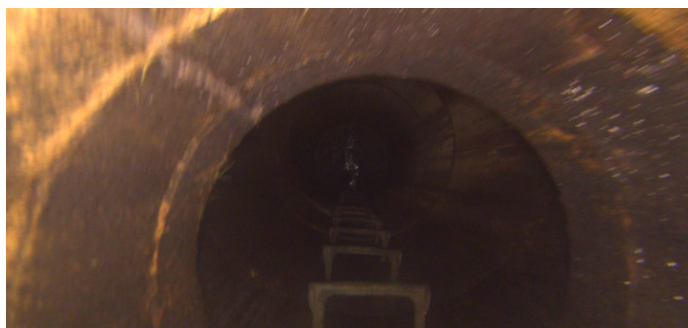
Code: **MGO**
Description: **General Observation**

Distance (ft): **.0**
Structural Grade: **0**
O&M Grade: **0**
Clock Start/From:
Clock To:
1st Value:
2nd Value:
Value Percent:
Step: **NO**
Remarks: **access mh**

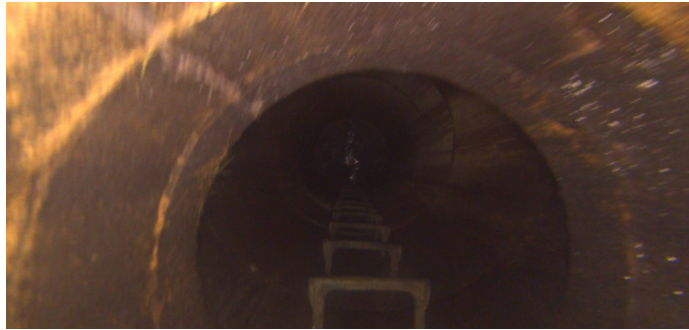
Code: **SRI**
Description: **Surface Roughness Increased**

Distance (ft): **.0**
Structural Grade: **1**
O&M Grade: **0**
Clock Start/From: **12**
Clock To: **12**
1st Value:
2nd Value:
Value Percent:
Step: **NO**
Remarks:

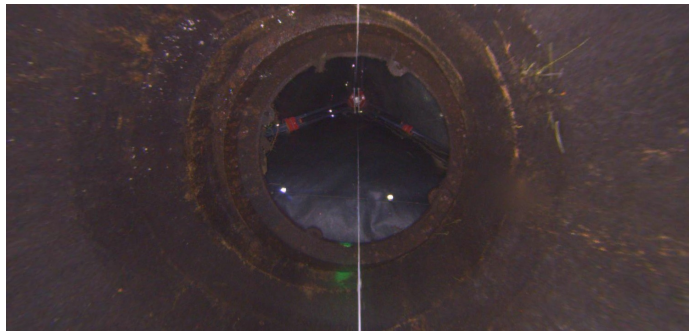
Code: **MGO**
Description: **General Observation**

Distance (ft): **2.8**
Structural Grade: **0**
O&M Grade: **0**
Clock Start/From:
Clock To:
1st Value:
2nd Value:
Value Percent:
Step: **NO**
Remarks: **underside of frame**

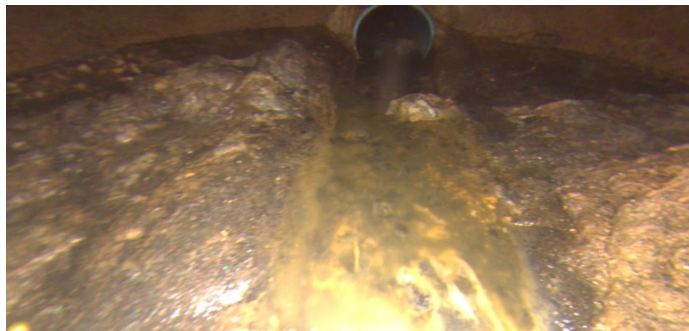
Code: **DSF**
Description: **Deposits Settled Fine**

Distance (ft): **14.7**
Structural Grade: **0**
O&M Grade: **2**
Clock Start/From: **12**
Clock To: **12**
1st Value:
2nd Value:
Value Percent: **5.000**
Step: **NO**
Remarks:

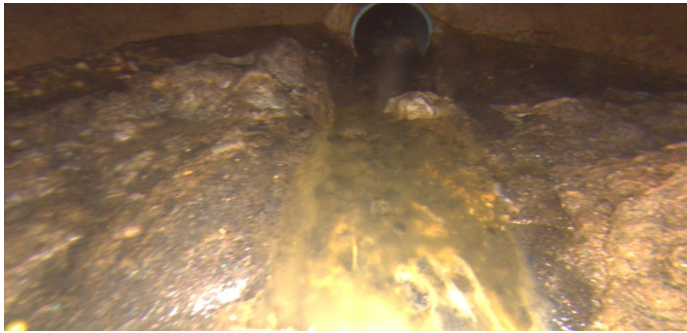
Code: **SRI**
Description: **Surface Roughness Increased**

Distance (ft): **14.7**
Structural Grade: **1**
O&M Grade: **0**
Clock Start/From: **12**
Clock To: **12**
1st Value:
2nd Value:
Value Percent:
Step: **NO**
Remarks:

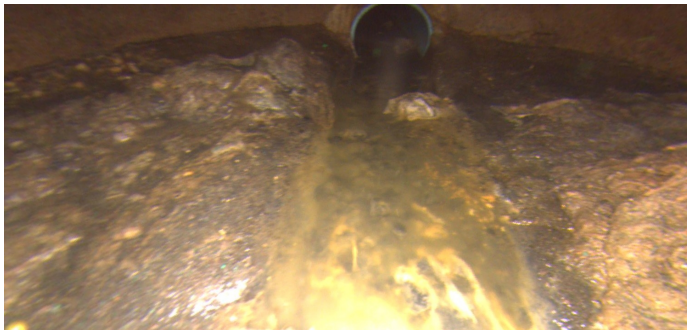
Code: **MGO**
Description: **General Observation**

Distance (ft): **14.7**
Structural Grade: **0**
O&M Grade: **0**
Clock Start/From:
Clock To:
1st Value:
2nd Value:
Value Percent:
Step: **NO**
Remarks: **end of survey**
