Manhole Inspection Report

Date:	04/16/2018	Weather:		Coding:	RZMACP
MH#:	M-103-116	Owner:	NA	Len. Surveyed:	15.7
P.O.#:		Surveyor:	John Kuglmaier	Rim to Invert:	17.0
Customer:		Cert. #:	U-1215-07002349	Wall Material:	Concrete (reinforced)

Street:	Intersection of 38th Ave and Maple	Project:	Hobart, IN
City:	Hobart, IN	GPS Northing:	2889746.341
Location:		GPS Easting:	2889746.341
Drain Area:	Northwest	GPS Accuracy:	Sub-Meter
Cover Shape:	Circular	Evidence of Surcharge:	Yes
Cover Size:	23.0	Potential for Runoff:	None
Comments:

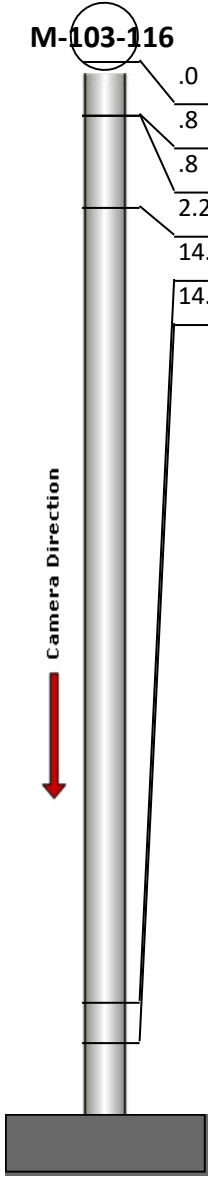
.0	MGP	General Photo	10	NA
	.8	OBZ	Obstacle Other	23	M 2
	.8	OBZ	Obstacle Other	34	M 2
	2.2	MGP	General Photo	51	NA
	14.2	OBZ	Obstacle Other	89	M 2
	14.8	MGO	General Observation	101	NA

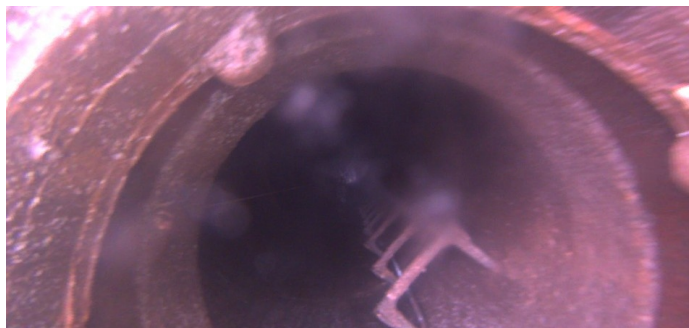
Code: **MGP**
Description: **General Photo**

Distance (ft): **.0**
Structural Grade: **0**
O&M Grade: **0**
Clock Start/From:
Clock To:
1st Value:
2nd Value:
Value Percent:
Step: **NO**
Remarks:

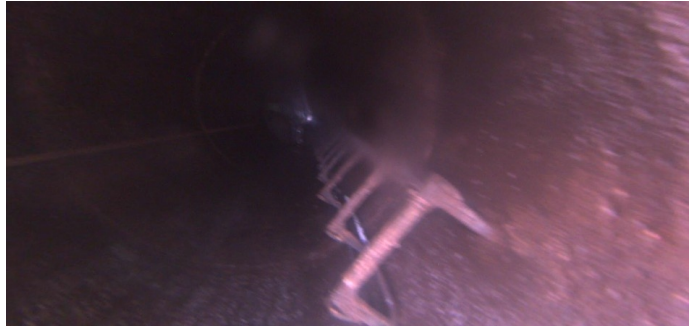
Code: **OBZ**
Description: **Obstacle Other**

Distance (ft): **.8**
Structural Grade: **0**
O&M Grade: **2**
Clock Start/From: **4**
Clock To:
1st Value:
2nd Value:
Value Percent: **5.000**
Step: **YES**
Remarks: **Unknown**

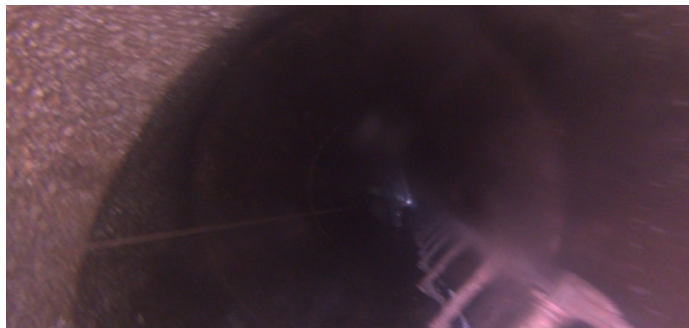
Code: **OBZ**
Description: **Obstacle Other**

Distance (ft): **.8**
Structural Grade: **0**
O&M Grade: **2**
Clock Start/From: **8**
Clock To:
1st Value:
2nd Value:
Value Percent: **5.000**
Step: **NO**
Remarks: **Rope**

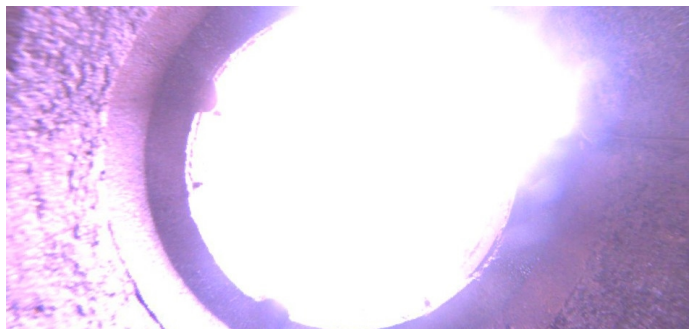
Code: **MGP**
Description: **General Photo**

Distance (ft): **2.2**
Structural Grade: **0**
O&M Grade: **0**
Clock Start/From:
Clock To:
1st Value:
2nd Value:
Value Percent:
Step: **NO**
Remarks:

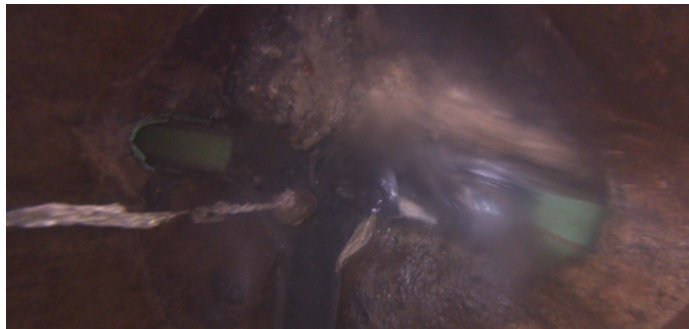
Code: **OBZ**
Description: **Obstacle Other**

Distance (ft): **14.2**
Structural Grade: **0**
O&M Grade: **2**
Clock Start/From: **8**
Clock To:
1st Value:
2nd Value:
Value Percent: **5.000**
Step: **NO**
Remarks: **Rope**

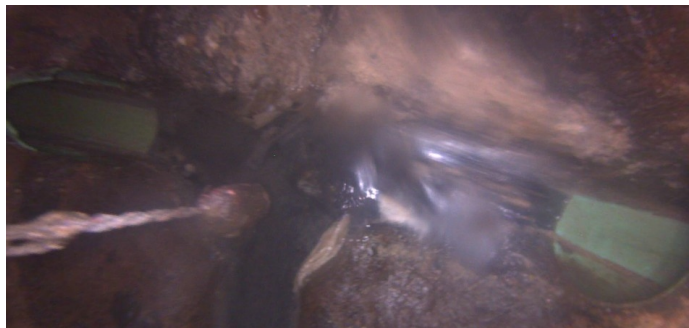
Code: **MGO**
Description: **General Observation**

Distance (ft): **14.8**
Structural Grade: **0**
O&M Grade: **0**
Clock Start/From:
Clock To:
1st Value:
2nd Value:
Value Percent:
Step: **NO**
Remarks: **Ins. Comp.**
