Manhole Inspection Report

Date:	04/16/2018	Weather:		Coding:	RZMACP
MH#:	M-103-117	Owner:	NA	Len. Surveyed:	6.5
P.O.#:		Surveyor:	Jen Costello	Rim to Invert:	8.0
Customer:		Cert. #:	U-907-5518	Wall Material:	Concrete (reinforced)

Street:	Maple St. 198' North of 38th Ave.	Project:	Hobart, IN
City:	Hobart, IN	GPS Northing:	2889751.49
Location:		GPS Easting:	2889751.49
Drain Area:	Northwest	GPS Accuracy:	Sub-Meter
Cover Shape:	Circular	Evidence of Surcharge:	No
Cover Size:	23.0	Potential for Runoff:	None
Comments:

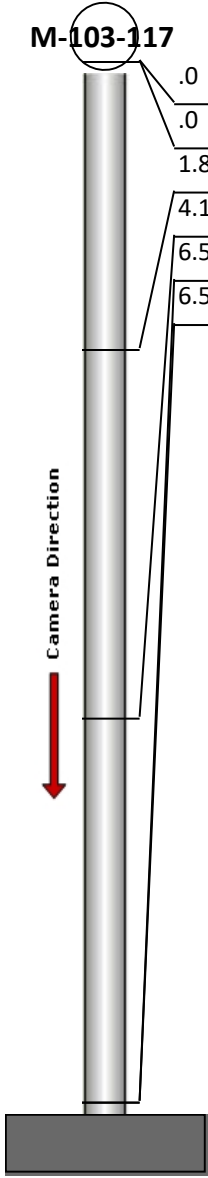
.0	MGO	General Observation	10	NA
	.0	SAV	Surface Aggregate Visible	21	S 3
	1.8	MGP	General Photo	39	NA
	4.1	IS	Infil Stain	57	NA
	6.5	SAP	Surface Aggregate Projecting	73	S 3
	6.5	MGO	General Observation	84	NA

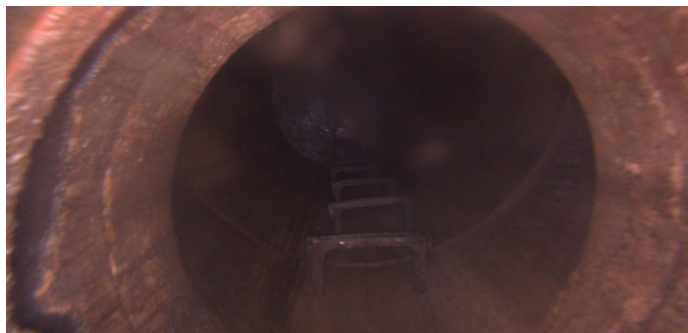
Code: **MGO**
Description: **General Observation**

Distance (ft): **.0**
Structural Grade: **0**
O&M Grade: **0**
Clock Start/From:
Clock To:
1st Value:
2nd Value:
Value Percent:
Step: **NO**
Remarks: **ACCESS MH**

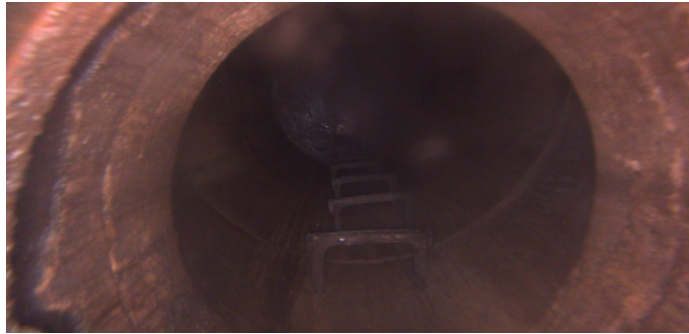
Code: **SAV**
Description: **Surface Aggregate Visible**

Distance (ft): **.0**
Structural Grade: **3**
O&M Grade: **0**
Clock Start/From: **12**
Clock To: **12**
1st Value:
2nd Value:
Value Percent:
Step: **NO**
Remarks:

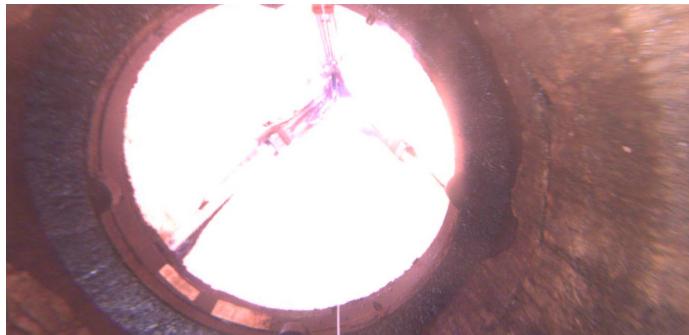
Code: **MGP**
Description: **General Photo**

Distance (ft): **1.8**
Structural Grade: **0**
O&M Grade: **0**
Clock Start/From:
Clock To:
1st Value:
2nd Value:
Value Percent:
Step: **NO**
Remarks: **UNDERSIDE OF FRAME**

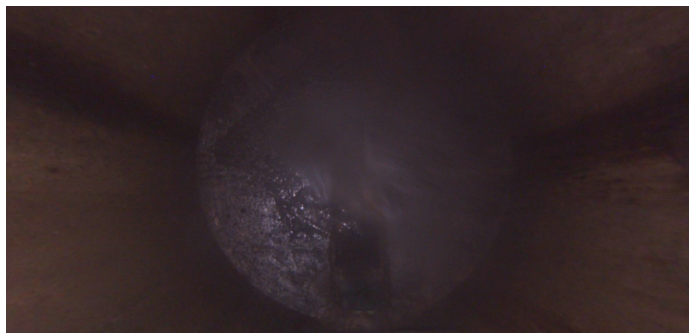
Code: **IS**
Description: **Infil Stain**

Distance (ft): **4.1**
Structural Grade: **0**
O&M Grade: **0**
Clock Start/From: **12**
Clock To: **12**
1st Value:
2nd Value:
Value Percent:
Step: **NO**
Remarks:

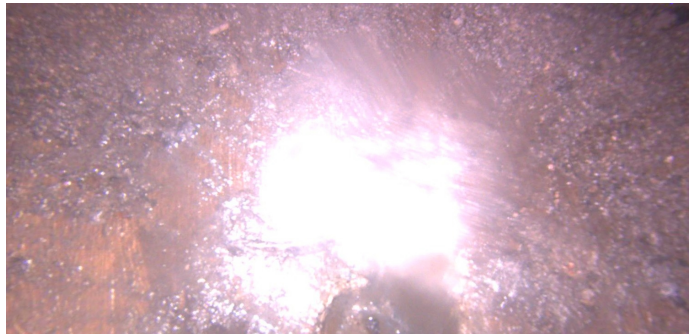
Code:	SAP
Description:	Surface Aggregate Projecting
Distance (ft):	6.5
Structural Grade:	3
O&M Grade:	0
Clock Start/From:	12
Clock To:	12
1st Value:	
2nd Value:	
Value Percent:	
Step:	NO
Remarks:

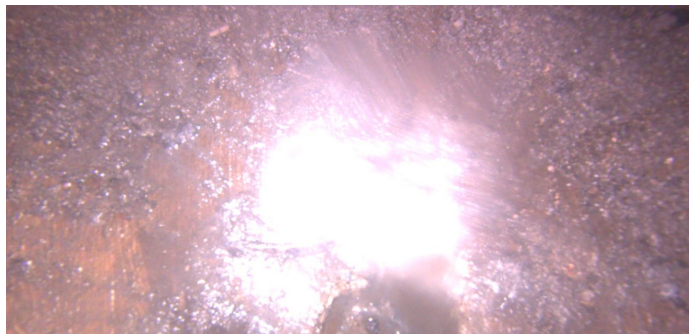
Code:	MGO
Description:	General Observation
Distance (ft):	6.5
Structural Grade:	0
O&M Grade:	0
Clock Start/From:	
Clock To:	
1st Value:	
2nd Value:	
Value Percent:	
Step:	NO
Remarks:	END SURVEY
