Manhole Inspection Report

Date:	04/16/2018	Weather:		Coding:	RZMACP
MH#:	M-103-120	Owner:	NA	Len. Surveyed:	8.7
P.O.#:		Surveyor:	Jen Costello	Rim to Invert:	10.2
Customer:		Cert. #:	U-907-5518	Wall Material:	Concrete (reinforced)

Street:	Missouri St. 229' South of 38th Ave.	Project:	Hobart, IN
City:	Hobart, IN	GPS Northing:	2890087.606
Location:		GPS Easting:	2890087.606
Drain Area:	Northwest	GPS Accuracy:	Sub-Meter
Cover Shape:	Circular	Evidence of Surcharge:	No
Cover Size:	23.0	Potential for Runoff:	None
Comments:

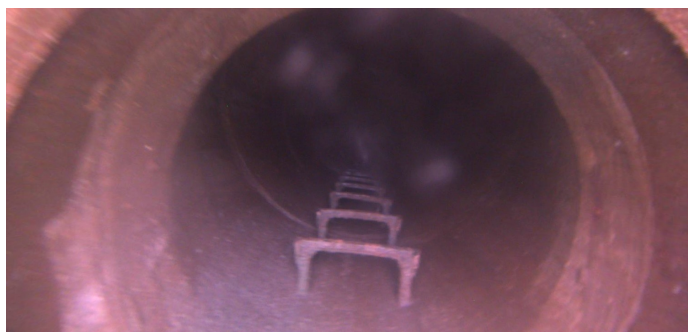
Code: **MGO**
 Description: **General Observation**

Distance (ft): **.0**
 Structural Grade: **0**
 O&M Grade: **0**
 Clock Start/From:
 Clock To:
 1st Value:
 2nd Value:
 Value Percent:
 Step: **NO**
 Remarks: **ACCESS MH**

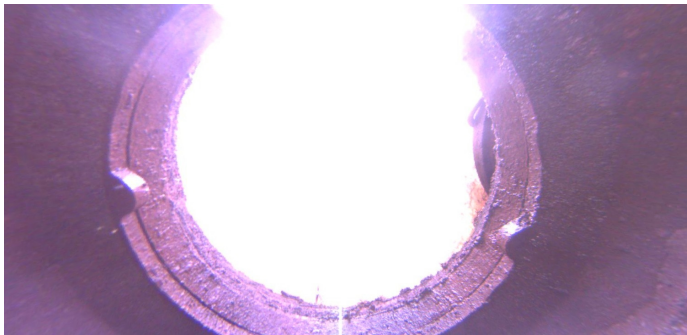
Code:	MGO
Description:	General Observation
Distance (ft):	1.3
Structural Grade:	0
O&M Grade:	0
Clock Start/From:	
Clock To:	
1st Value:	
2nd Value:	
Value Percent:	
Step:	NO
Remarks:	UNDERSIDE OF FRAME

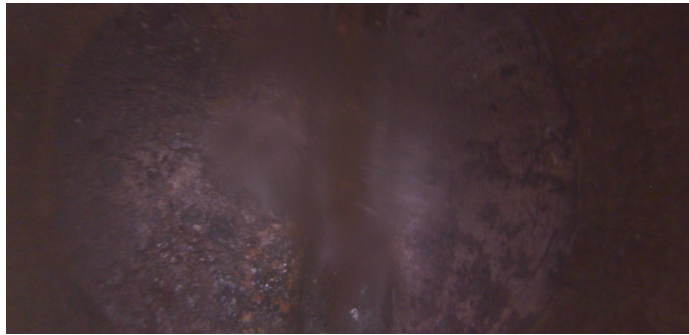
Code:	DSF
Description:	Deposits Settled Fine
Distance (ft):	7.6
Structural Grade:	0
O&M Grade:	2
Clock Start/From:	12
Clock To:	12
1st Value:	
2nd Value:	
Value Percent:	5.000
Step:	NO
Remarks:
