Date:	04/16/2018	Weather:		Coding:	RZMACP
MH#:	M-103-125	Owner:	NA	Len. Surveyed:	6.9
P.O.#:		Surveyor:	John Kuglmaier	Rim to Invert:	8.3
Customer:		Cert. #:	U-1215-07002349	Wall Material:	Concrete (reinforced)
Street:	Alley between Alabama St. and Map Project:			Hobart, IN	
City:	Hobart, IN	(GPS Northing:	2889585.096	
Location:		(GPS Easting:	2889585.096	
Drain Area:	Northwest	(GPS Accuracy:	Sub-Meter	
Cover Shape:	Circular	E	Evidence of Surcharge:	No	
Cover Size: Comments:	23.0	F	Potential for Runoff:	None	
O&M Index:	2.00	O&M Quick:	2100	O&M Rating:	2.00
Structural Index:	0.00	Structural Quic	ck: 0000	Structural Rating:	0.00
Overall Index:	2.00	Overall Quick:	2100	Overall Rating:	2.00

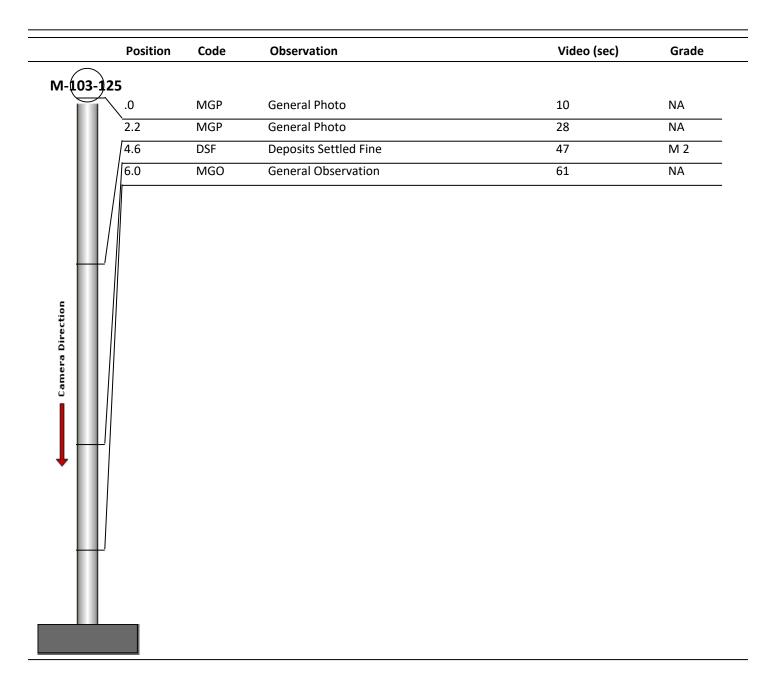
Code: Description:	MGP General Photo
Distance (ft):	.0
Structural Grade:	0
O&M Grade:	0
Clock Start/From:	
Clock To:	
1st Value:	
2nd Value:	
Value Percent:	
Step:	NO
Remarks:
