Manhole Inspection Report

Date:	04/16/2018	Weather:		Coding:	RZMACP
MH#:	M-103-126	Owner:	NA	Len. Surveyed:	6.2
P.O.#:		Surveyor:	John Kuglmaier	Rim to Invert:	7.5
Customer:		Cert. #:	U-1215-07002349	Wall Material:	Concrete (reinforced)

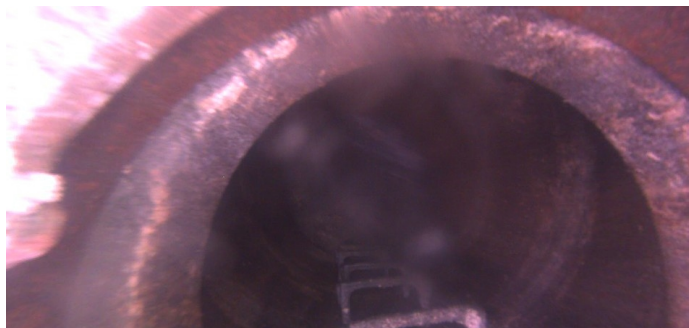
Code: **MGP**
Description: **General Photo**

Distance (ft): **.0**
Structural Grade: **0**
O&M Grade: **0**
Clock Start/From:
Clock To:
1st Value:
2nd Value:
Value Percent:
Step: **NO**
Remarks:

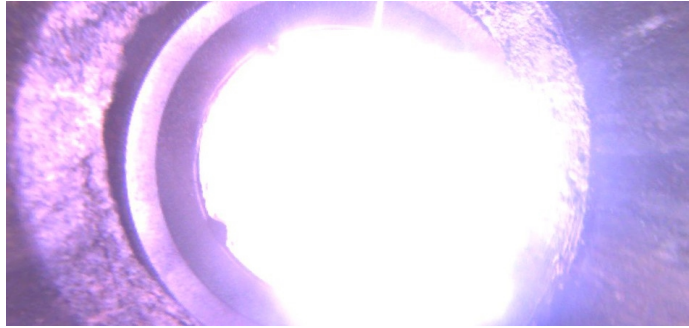
Code: **MGP**
Description: **General Photo**

Distance (ft): **2.1**
Structural Grade: **0**
O&M Grade: **0**
Clock Start/From:
Clock To:
1st Value:
2nd Value:
Value Percent:
Step: **NO**
Remarks:

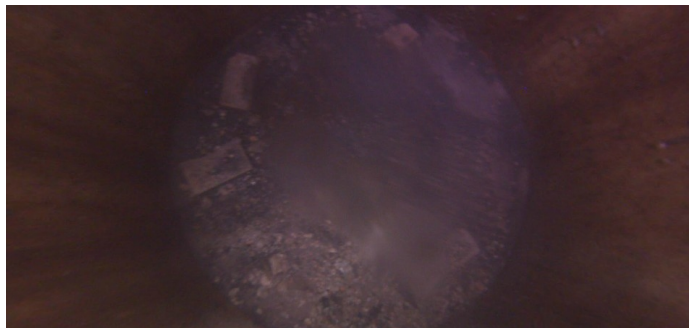
Code: **DAZ**
Description: **Deposits Attached Other**

Distance (ft): **4.4**
Structural Grade: **0**
O&M Grade: **2**
Clock Start/From: **12**
Clock To: **12**
1st Value:
2nd Value:
Value Percent: **10.000**
Step: **NO**
Remarks: **Mixed materials**

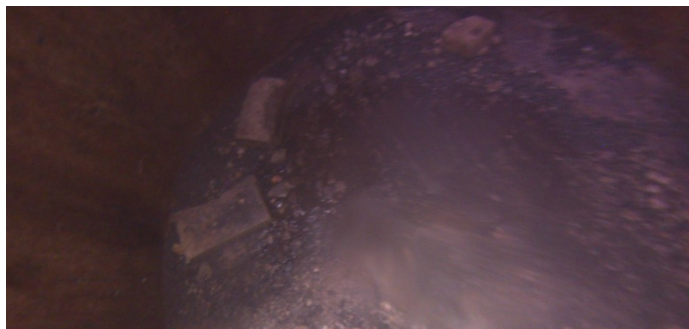
Code: **OBB**
Description: **Obstacle Brick**

Distance (ft): **5.5**
Structural Grade: **0**
O&M Grade: **2**
Clock Start/From: **9**
Clock To: **10**
1st Value:
2nd Value:
Value Percent: **10.000**
Step: **NO**
Remarks:

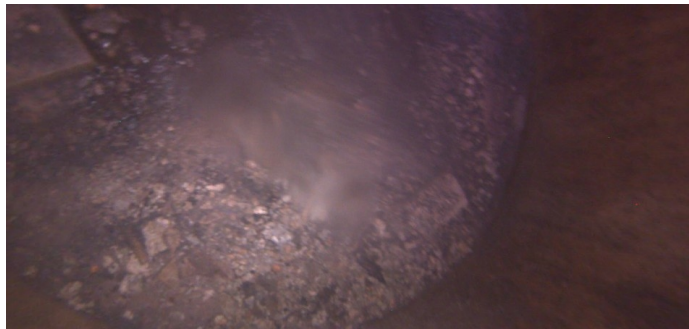
Code: **OBB**
Description: **Obstacle Brick**

Distance (ft): **5.5**
Structural Grade: **0**
O&M Grade: **2**
Clock Start/From: **4**
Clock To:
1st Value:
2nd Value:
Value Percent: **5.000**
Step: **NO**
Remarks:

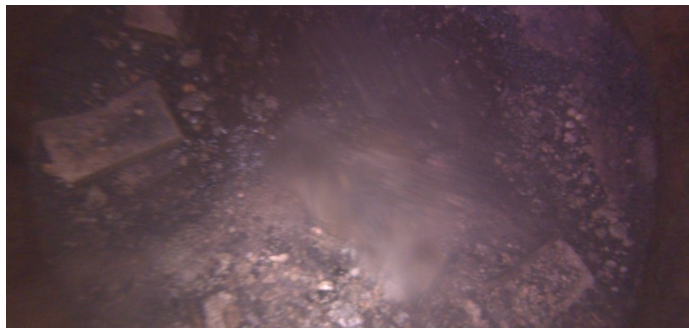
Code: **MGO**
Description: **General Observation**

Distance (ft): **5.7**
Structural Grade: **0**
O&M Grade: **0**
Clock Start/From:
Clock To:
1st Value:
2nd Value:
Value Percent:
Step: **NO**
Remarks: **Ins. Comp.**
