# Manhole Inspection Report

Date:	<b>04/16/2018</b>	Weather:		Coding:	<b>RZMACP</b>
MH#:	<b>M-103-127</b>	Owner:	<b>NA</b>	Len. Surveyed:	<b>11.6</b>
P.O.#:		Surveyor:	<b>John Kuglmaier</b>	Rim to Invert:	<b>13.0</b>
Customer:		Cert. #:	<b>U-1215-07002349</b>	Wall Material:	<b>Concrete (reinforced)</b>

Street:	<b>38th Ave and alley between Swift S</b>	Project:	<b>Hobart, IN</b>
City:	<b>Hobart, IN</b>	GPS Northing:	<b>2889261.215</b>
Location:		GPS Easting:	<b>2889261.215</b>
Drain Area:	<b>Northwest</b>	GPS Accuracy:	<b>Sub-Meter</b>
Cover Shape:	<b>Circular</b>	Evidence of Surcharge:	<b>Yes</b>
Cover Size:	<b>23.0</b>	Potential for Runoff:	<b>None</b>
Comments:

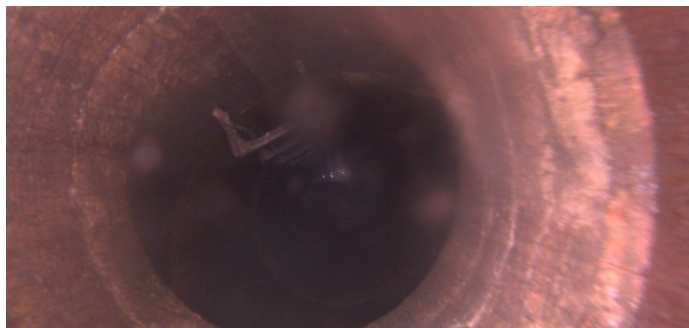
Code: **MGP**  
Description: **General Photo**

Distance (ft): **.0**  
Structural Grade: **0**  
O&M Grade: **0**  
Clock Start/From:  
Clock To:  
1st Value:  
2nd Value:  
Value Percent:  
Step: **NO**  
Remarks:

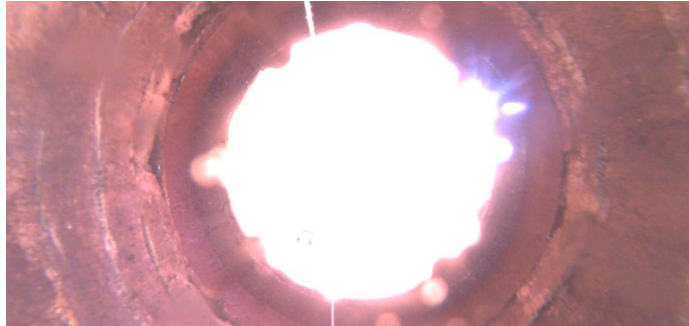
Code: **MGP**  
Description: **General Photo**

Distance (ft): **2.1**  
Structural Grade: **0**  
O&M Grade: **0**  
Clock Start/From:  
Clock To:  
1st Value:  
2nd Value:  
Value Percent:  
Step: **NO**  
Remarks:

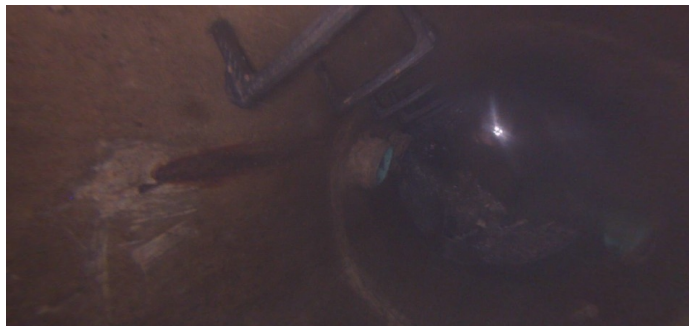
Code: **IS**  
Description: **Infil Stain**

Distance (ft): **6.6**  
Structural Grade: **0**  
O&M Grade: **0**  
Clock Start/From: **9**  
Clock To:  
1st Value:  
2nd Value:  
Value Percent:  
Step: **NO**  
Remarks:

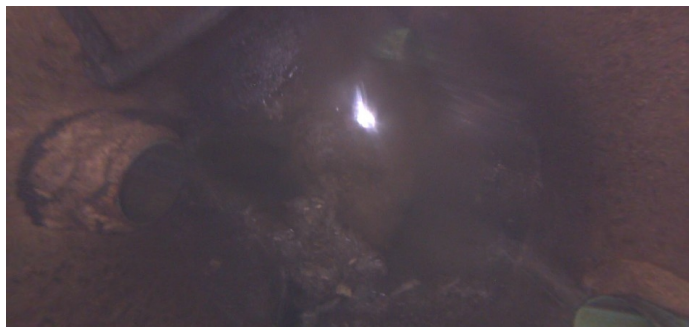
Code: **DAZ**  
Description: **Deposits Attached Other**

Distance (ft): **10.0**  
Structural Grade: **0**  
O&M Grade: **2**  
Clock Start/From: **12**  
Clock To: **12**  
1st Value:  
2nd Value:  
Value Percent: **5.000**  
Step: **NO**  
Remarks: **Mixed materials**

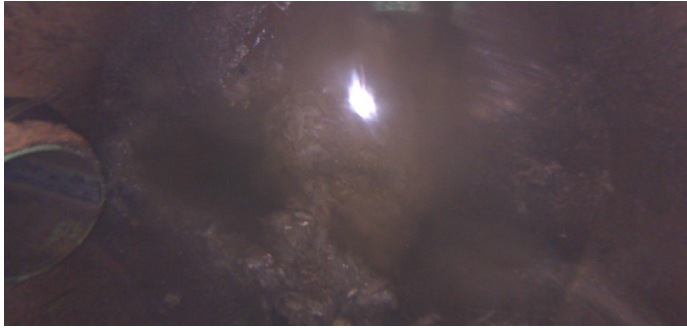
Code:	<b>MGO</b>
Description:	<b>General Observation</b>
Distance (ft):	<b>10.8</b>
Structural Grade:	<b>0</b>
O&M Grade:	<b>0</b>
Clock Start/From:	
Clock To:	
1st Value:	
2nd Value:	
Value Percent:	
Step:	<b>NO</b>
Remarks:	<b>Ins. Comp.</b>
