# Manhole Inspection Report

Date:	<b>04/16/2018</b>	Weather:		Coding:	<b>RZMACP</b>
MH#:	<b>M-103-133</b>	Owner:	<b>NA</b>	Len. Surveyed:	<b>7.0</b>
P.O.#:		Surveyor:	<b>John Kuglmaier</b>	Rim to Invert:	<b>8.6</b>
Customer:		Cert. #:	<b>U-1215-07002349</b>	Wall Material:	<b>Concrete (reinforced)</b>

Street:	<b>Alley / Mississippi St. and Swift St. 4</b>	Project:	<b>Hobart, IN</b>
City:	<b>Hobart, IN</b>	GPS Northing:	<b>0.0</b>
Location:		GPS Easting:	<b>0.0</b>
Drain Area:	<b>Northwest</b>	GPS Accuracy:	<b>Nearest Meter</b>
Cover Shape:	<b>Circular</b>	Evidence of Surcharge:	<b>No</b>
Cover Size:	<b>23.0</b>	Potential for Runoff:	<b>None</b>
Comments:

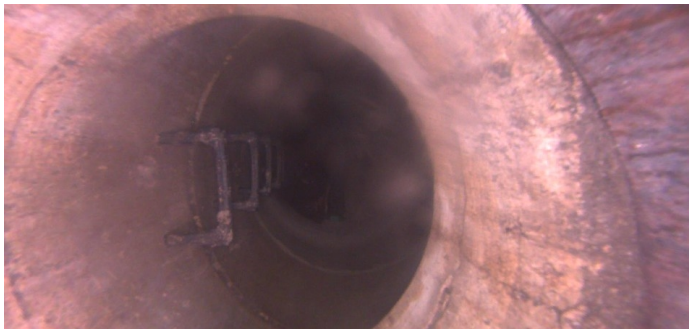
Code: **MGP**  
Description: **General Photo**

Distance (ft): **.0**  
Structural Grade: **0**  
O&M Grade: **0**  
Clock Start/From:  
Clock To:  
1st Value:  
2nd Value:  
Value Percent:  
Step: **NO**  
Remarks:

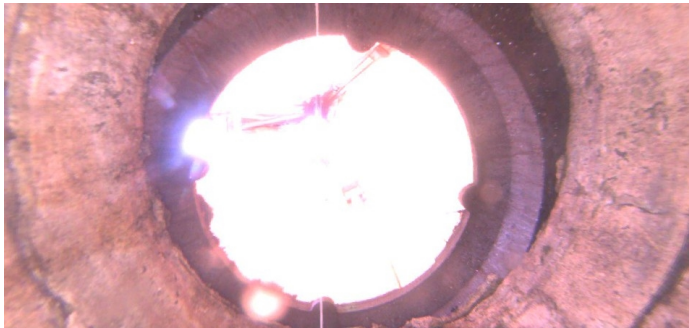
Code: **MGP**  
Description: **General Photo**

Distance (ft): **2.1**  
Structural Grade: **0**  
O&M Grade: **0**  
Clock Start/From:  
Clock To:  
1st Value:  
2nd Value:  
Value Percent:  
Step: **NO**  
Remarks:

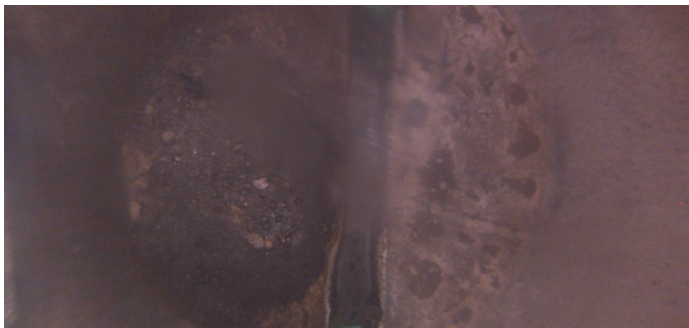
Code: **DSF**  
Description: **Deposits Settled Fine**

Distance (ft): **5.6**  
Structural Grade: **0**  
O&M Grade: **2**  
Clock Start/From: **6**  
Clock To: **12**  
1st Value:  
2nd Value:  
Value Percent: **5.000**  
Step: **NO**  
Remarks:

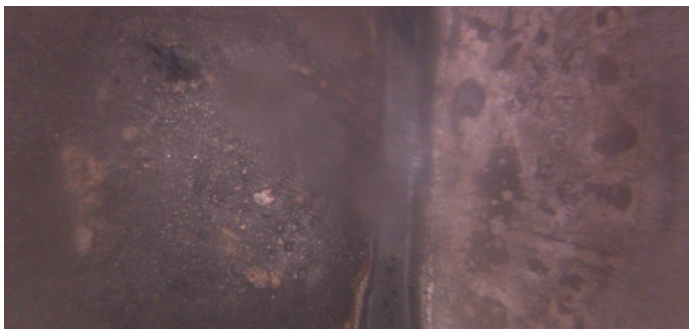
Code: **MGO**  
Description: **General Observation**

Distance (ft): **6.4**  
Structural Grade: **0**  
O&M Grade: **0**  
Clock Start/From:  
Clock To:  
1st Value:  
2nd Value:  
Value Percent:  
Step: **NO**  
Remarks: **Ins. Comp.**
