Manhole Inspection Report

Date:	03/20/2018	Weather:		Coding:	RZMACP
MH#:	M-108-025	Owner:	NA	Len. Surveyed:	6.3
P.O.#:		Surveyor:	John Kuglmaier	Rim to Invert:	7.1
Customer:		Cert. #:	U-1215-07002349	Wall Material:	Concrete (reinforced)

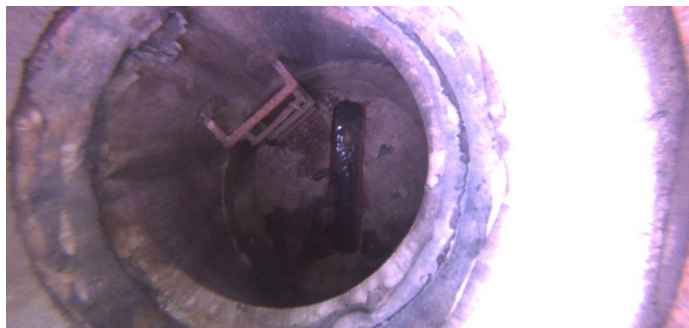
Code: **MGP**
Description: **General Photo**

Distance (ft): **.0**
Structural Grade: **0**
O&M Grade: **0**
Clock Start/From:
Clock To:
1st Value:
2nd Value:
Value Percent:
Step: **NO**
Remarks:

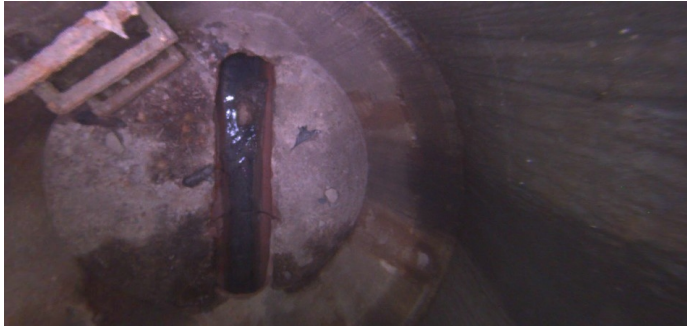
Code: **IS**
Description: **Infil Stain**

Distance (ft): **2.3**
Structural Grade: **0**
O&M Grade: **0**
Clock Start/From: **2**
Clock To:
1st Value:
2nd Value:
Value Percent:
Step: **NO**
Remarks:

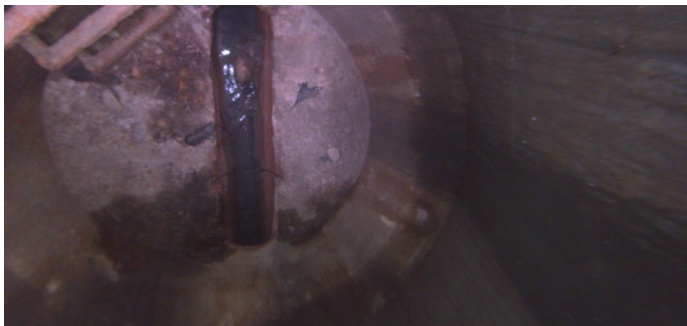
Code: **IS**
Description: **Infil Stain**

Distance (ft): **2.3**
Structural Grade: **0**
O&M Grade: **0**
Clock Start/From: **4**
Clock To:
1st Value:
2nd Value:
Value Percent:
Step: **NO**
Remarks:

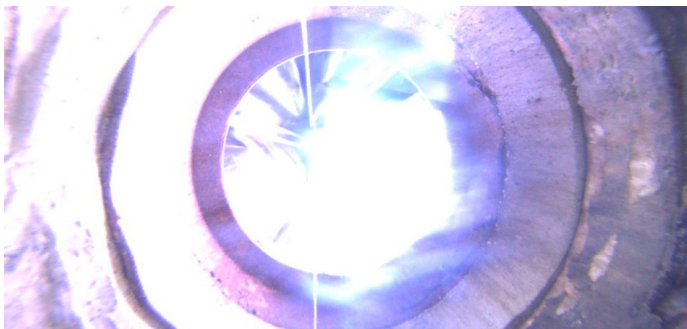
Code: **MGP**
Description: **General Photo**

Distance (ft): **2.6**
Structural Grade: **0**
O&M Grade: **0**
Clock Start/From:
Clock To:
1st Value:
2nd Value:
Value Percent:
Step: **NO**
Remarks:

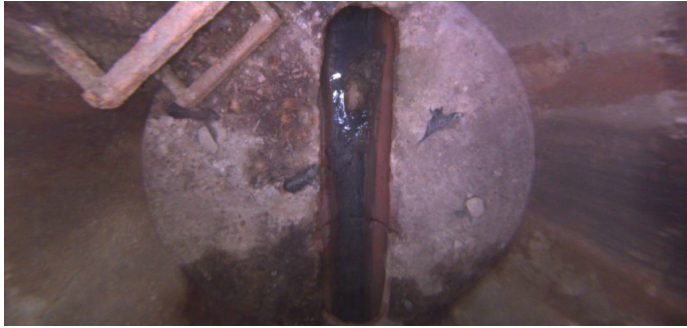
Code:	DAZ
Description:	Deposits Attached Other
Distance (ft):	3.7
Structural Grade:	0
O&M Grade:	2
Clock Start/From:	12
Clock To:	12
1st Value:	
2nd Value:	
Value Percent:	5.000
Step:	NO
Remarks:	Mixed materials

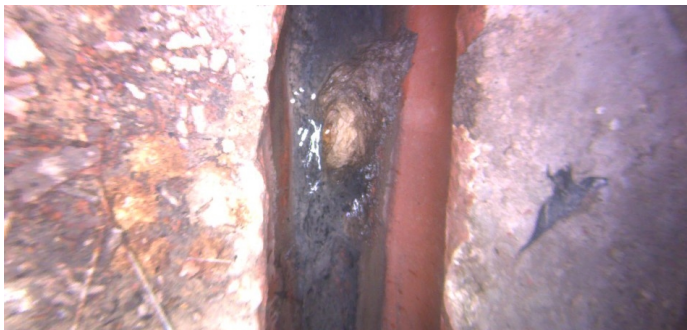
Code:	MGO
Description:	General Observation
Distance (ft):	5.7
Structural Grade:	0
O&M Grade:	0
Clock Start/From:	
Clock To:	
1st Value:	
2nd Value:	
Value Percent:	
Step:	NO
Remarks:	Ins. Comp.
