Manhole Inspection Report

Date:	03/21/2018	Weather:		Coding:	RZMACP
MH#:	M-108-039	Owner:	NA	Len. Surveyed:	5.8
P.O.#:		Surveyor:	John Kuglmaier	Rim to Invert:	6.1
Customer:		Cert. #:	U-1215-07002349	Wall Material:	Concrete (reinforced)

Street:	Alabama St. West 15th Pl. to the So	Project:	Hobart, IN
City:	Hobart, IN	GPS Northing:	0.0
Location:		GPS Easting:	0.0
Drain Area:	Southwest	GPS Accuracy:	Nearest Meter
Cover Shape:	Circular	Evidence of Surcharge:	No
Cover Size:	22.5	Potential for Runoff:	None
Comments:

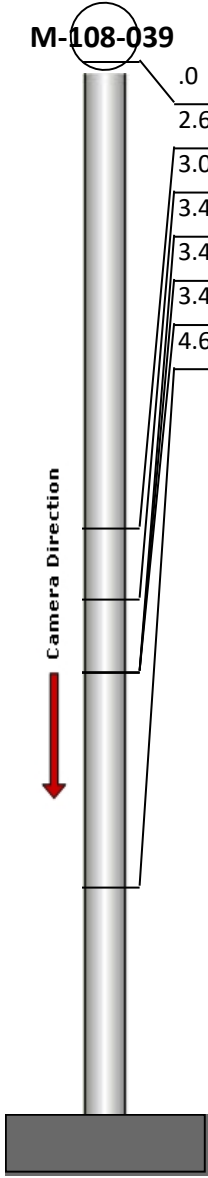
.0	MGP	General Photo	10	NA
	2.6	MGP	General Photo	29	NA
	3.0	DSF	Deposits Settled Fine	44	M 2
	3.4	IS	Infil Stain	56	NA
	3.4	IS	Infil Stain	68	NA
	3.4	IS	Infil Stain	79	NA
	4.6	MGO	General Observation	93	NA

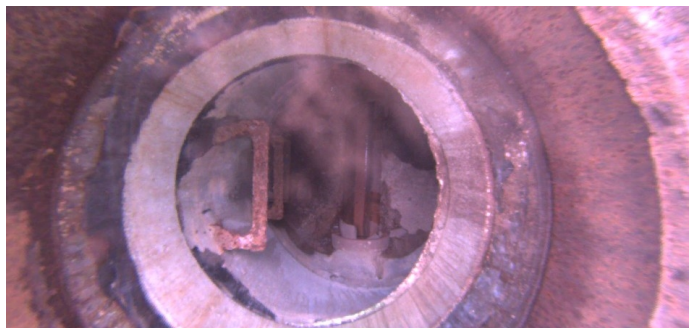
Code: **MGP**
Description: **General Photo**

Distance (ft): **.0**
Structural Grade: **0**
O&M Grade: **0**
Clock Start/From:
Clock To:
1st Value:
2nd Value:
Value Percent:
Step: **NO**
Remarks:

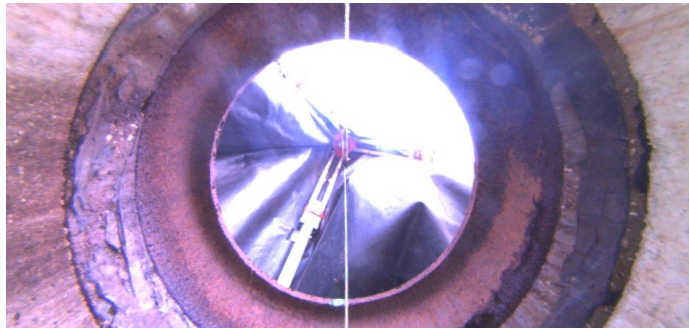
Code: **MGP**
Description: **General Photo**

Distance (ft): **2.6**
Structural Grade: **0**
O&M Grade: **0**
Clock Start/From:
Clock To:
1st Value:
2nd Value:
Value Percent:
Step: **NO**
Remarks:

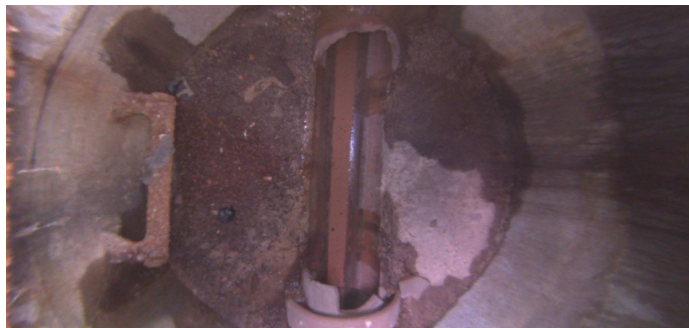
Code: **DSF**
Description: **Deposits Settled Fine**

Distance (ft): **3.0**
Structural Grade: **0**
O&M Grade: **2**
Clock Start/From: **6**
Clock To: **12**
1st Value:
2nd Value:
Value Percent: **5.000**
Step: **NO**
Remarks:

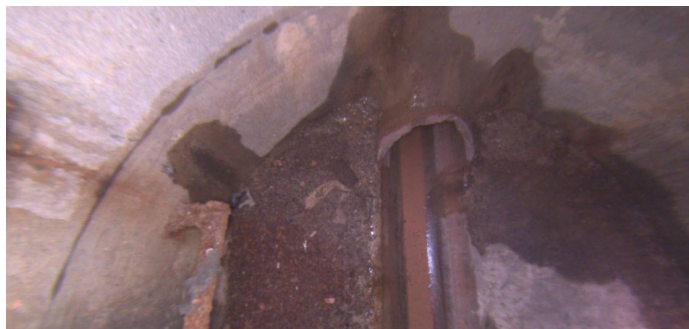
Code: **IS**
Description: **Infil Stain**

Distance (ft): **3.4**
Structural Grade: **0**
O&M Grade: **0**
Clock Start/From: **10**
Clock To:
1st Value:
2nd Value:
Value Percent:
Step: **NO**
Remarks:

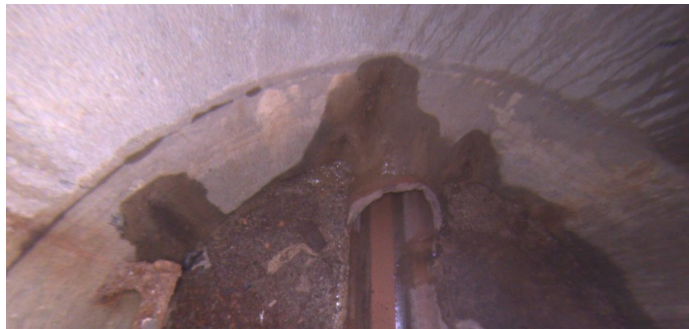
Code: **IS**
Description: **Infil Stain**

Distance (ft): **3.4**
Structural Grade: **0**
O&M Grade: **0**
Clock Start/From: **12**
Clock To:
1st Value:
2nd Value:
Value Percent:
Step: **NO**
Remarks:

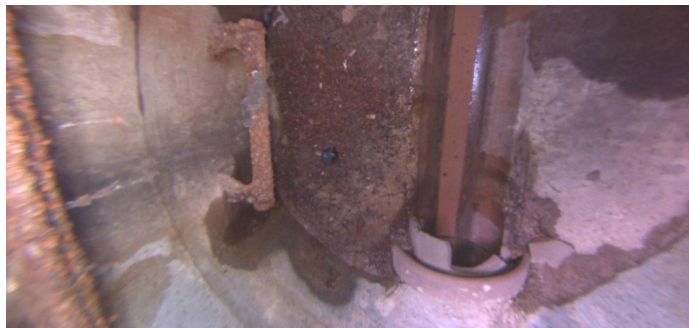
Code: **IS**
Description: **Infil Stain**

Distance (ft): **3.4**
Structural Grade: **0**
O&M Grade: **0**
Clock Start/From: **8**
Clock To:
1st Value:
2nd Value:
Value Percent:
Step: **NO**
Remarks:

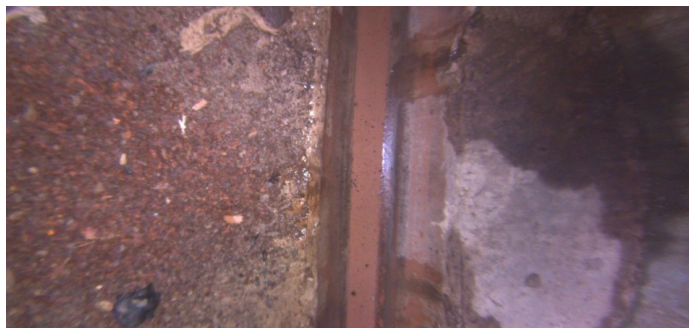
Code: **MGO**
Description: **General Observation**

Distance (ft): **4.6**
Structural Grade: **0**
O&M Grade: **0**
Clock Start/From:
Clock To:
1st Value:
2nd Value:
Value Percent:
Step: **NO**
Remarks: **Ins. Comp.**
