Manhole Inspection Report

Date:	09/20/2022	Weather:		Coding:	RZMACP
MH#:	M-108-041	Owner:	NA	Len. Surveyed:	4.4
P.O.#:		Surveyor:	Jen Costello	Rim to Invert:	5.6
Customer:		Cert. #:	U-907-5518	Wall Material:	Concrete (cast in place)

Street:	West 15th Pl. Mississippi St. to the S	Project:	Hobart, IN
City:	Hobart, IN	GPS Northing:	2281260.609
Location:	Local Rural Streets	GPS Easting:	2889138.181
Drain Area:	Southwest	GPS Accuracy:	Sub-Meter
Cover Shape:	Circular	Evidence of Surcharge:	No
Cover Size:	24.0	Potential for Runoff:	None
Comments:

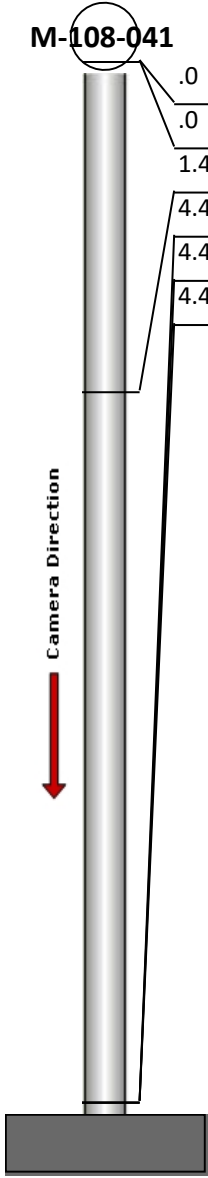
M-108-041				
	.0	MGO	General Observation	10	NA
	.0	SRI	Surface Roughness Increased	21	S 1
	1.4	ISGT	Intruding Sealing Grout	37	M 2
	4.4	DSF	Deposits Settled Fine	56	M 2
	4.4	SRI	Surface Roughness Increased	66	S 1
	4.4	MGO	General Observation	76	NA

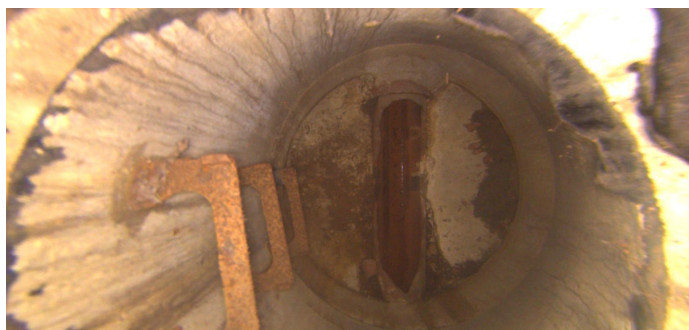
Code: **MGO**
Description: **General Observation**

Distance (ft): **.0**
Structural Grade: **0**
O&M Grade: **0**
Clock Start/From:
Clock To:
1st Value:
2nd Value:
Value Percent:
Step: **NO**
Remarks: **access mh**

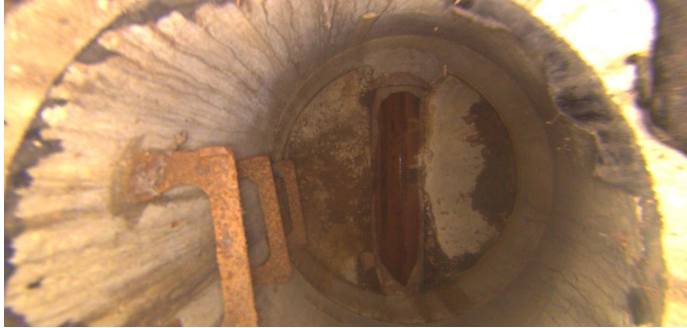
Code: **SRI**
Description: **Surface Roughness Increased**

Distance (ft): **.0**
Structural Grade: **1**
O&M Grade: **0**
Clock Start/From: **12**
Clock To: **12**
1st Value:
2nd Value:
Value Percent:
Step: **NO**
Remarks:

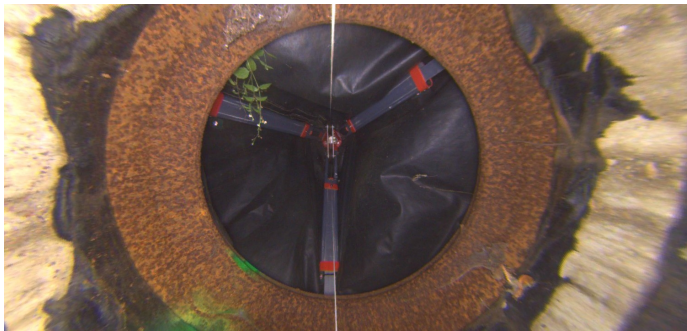
Code: **ISGT**
Description: **Intruding Sealing Grout**

Distance (ft): **1.4**
Structural Grade: **0**
O&M Grade: **2**
Clock Start/From: **12**
Clock To: **12**
1st Value:
2nd Value:
Value Percent: **5.000**
Step: **NO**
Remarks:

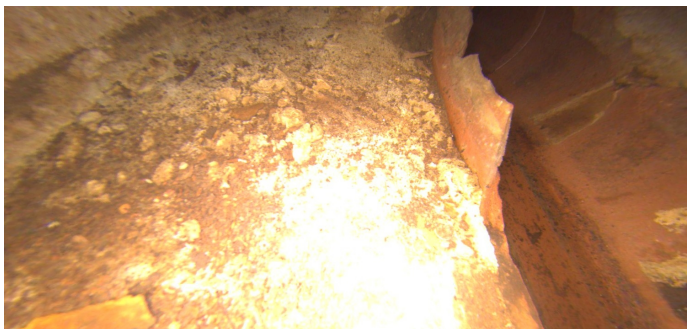
Code: **DSF**
Description: **Deposits Settled Fine**

Distance (ft): **4.4**
Structural Grade: **0**
O&M Grade: **2**
Clock Start/From: **12**
Clock To: **12**
1st Value:
2nd Value:
Value Percent: **5.000**
Step: **NO**
Remarks:

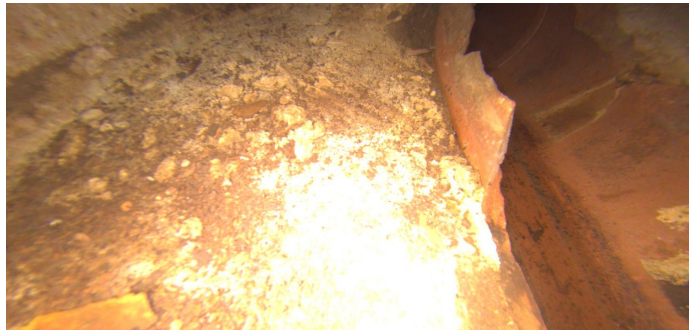
Code: **SRI**
Description: **Surface Roughness Increased**

Distance (ft): **4.4**
Structural Grade: **1**
O&M Grade: **0**
Clock Start/From: **12**
Clock To: **12**
1st Value:
2nd Value:
Value Percent:
Step: **NO**
Remarks:

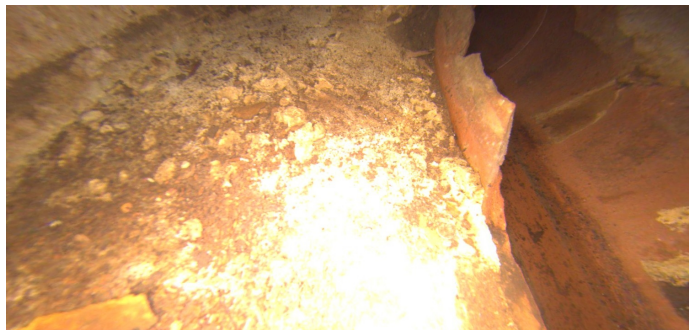
Code: **MGO**
Description: **General Observation**

Distance (ft): **4.4**
Structural Grade: **0**
O&M Grade: **0**
Clock Start/From:
Clock To:
1st Value:
2nd Value:
Value Percent:
Step: **NO**
Remarks: **end of survey**
