# Manhole Inspection Report

Date:	<b>03/25/2018</b>	Weather:		Coding:	<b>RZMACP</b>
MH#:	<b>M-108-052</b>	Owner:	<b>NA</b>	Len. Surveyed:	<b>7.0</b>
P.O.#:		Surveyor:	<b>John Kuglmaier</b>	Rim to Invert:	<b>7.9</b>
Customer:		Cert. #:	<b>U-1215-07002349</b>	Wall Material:	<b>Concrete (reinforced)</b>

Street:	<b>61st Ave. 999' East of Marcella Blvd.</b>	Project:	<b>Hobart, IN</b>
City:	<b>Hobart, IN</b>	GPS Northing:	<b>0.0</b>
Location:		GPS Easting:	<b>0.0</b>
Drain Area:	<b>Southwest</b>	GPS Accuracy:	<b>Nearest Meter</b>
Cover Shape:	<b>Circular</b>	Evidence of Surcharge:	<b>No</b>
Cover Size:	<b>22.5</b>	Potential for Runoff:	<b>None</b>
Comments:

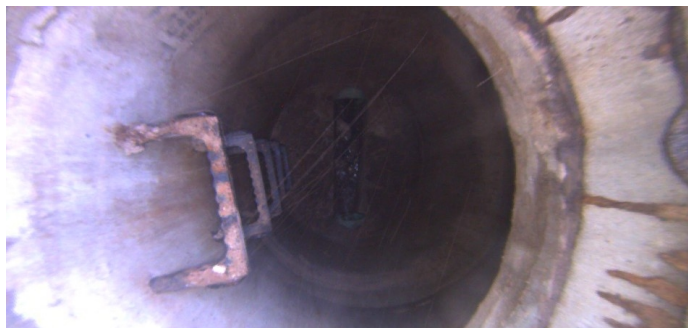
Code: **MGP**  
Description: **General Photo**

Distance (ft): **.0**  
Structural Grade: **0**  
O&M Grade: **0**  
Clock Start/From:  
Clock To:  
1st Value:  
2nd Value:  
Value Percent:  
Step: **NO**  
Remarks:

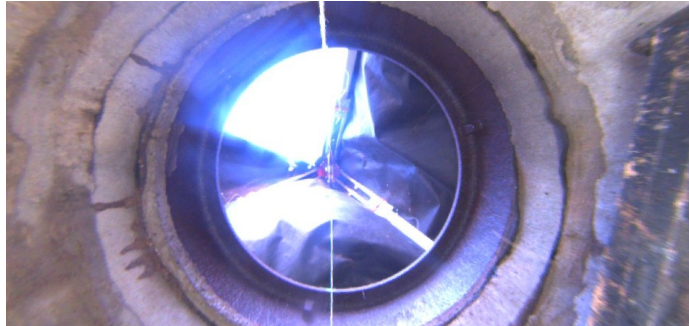
Code: **MGP**  
Description: **General Photo**

Distance (ft): **2.3**  
Structural Grade: **0**  
O&M Grade: **0**  
Clock Start/From:  
Clock To:  
1st Value:  
2nd Value:  
Value Percent:  
Step: **NO**  
Remarks:

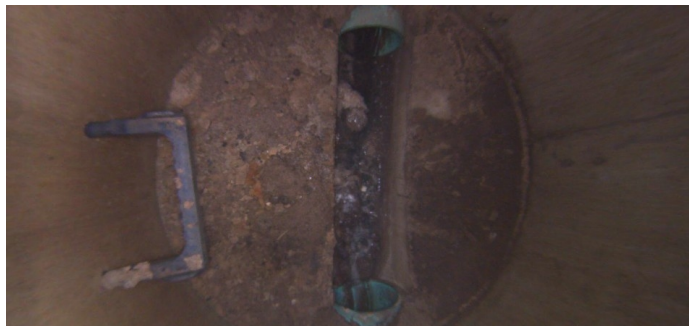
Code: **DAZ**  
Description: **Deposits Attached Other**

Distance (ft): **4.4**  
Structural Grade: **0**  
O&M Grade: **2**  
Clock Start/From: **12**  
Clock To: **12**  
1st Value:  
2nd Value:  
Value Percent: **10.000**  
Step: **NO**  
Remarks: **Mixed materials**

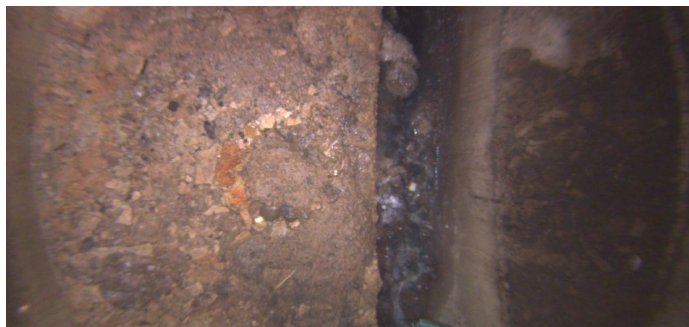
Code: **MGO**  
Description: **General Observation**

Distance (ft): **5.8**  
Structural Grade: **0**  
O&M Grade: **0**  
Clock Start/From:  
Clock To:  
1st Value:  
2nd Value:  
Value Percent:  
Step: **NO**  
Remarks: **Ins. Comp.**
