Manhole Inspection Report

Date:	04/19/2018	Weather:		Coding:	RZMACP
MH#:	M-203-003	Owner:	NA	Len. Surveyed:	8.7
P.O.#:		Surveyor:	Jen Costello	Rim to Invert:	9.5
Customer:		Cert. #:	U-907-5518	Wall Material:	Concrete (reinforced)

Street:	Intersection of Ridge Rd. and Parker	Project:	Hobart, IN
City:	Hobart, IN	GPS Northing:	2893758.746
Location:		GPS Easting:	2893758.746
Drain Area:	Northwest	GPS Accuracy:	Sub-Meter
Cover Shape:	Circular	Evidence of Surcharge:	No
Cover Size:	23.0	Potential for Runoff:	None
Comments:

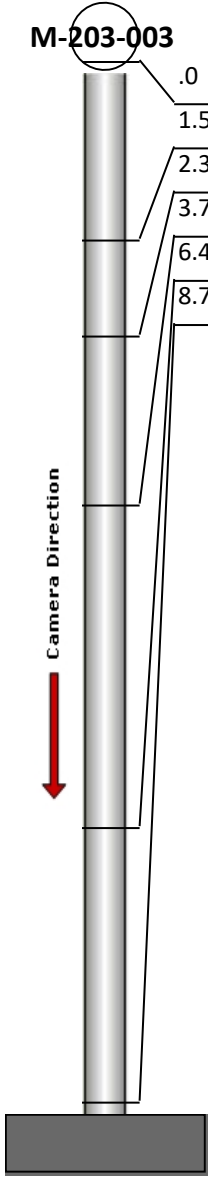
.0	MGO	General Observation	10	NA
	1.5	MGO	General Observation	27	NA
	2.3	IW	Infil Weeper	42	M 2
	3.7	IW	Infil Weeper	56	M 2
	6.4	SAP	Surface Aggregate Projecting	73	S 3
	8.7	MGO	General Observation	89	NA

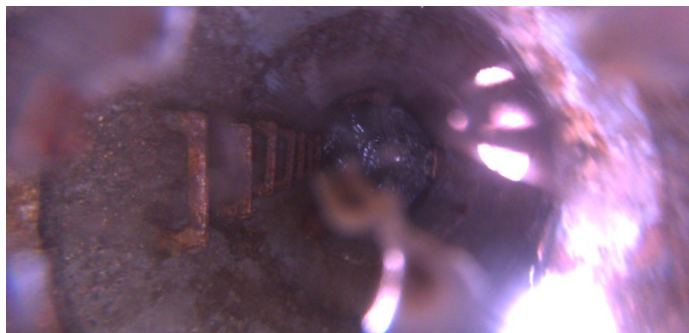
Code: **MGO**
Description: **General Observation**

Distance (ft): **.0**
Structural Grade: **0**
O&M Grade: **0**
Clock Start/From:
Clock To:
1st Value:
2nd Value:
Value Percent:
Step: **NO**
Remarks: **access MH**

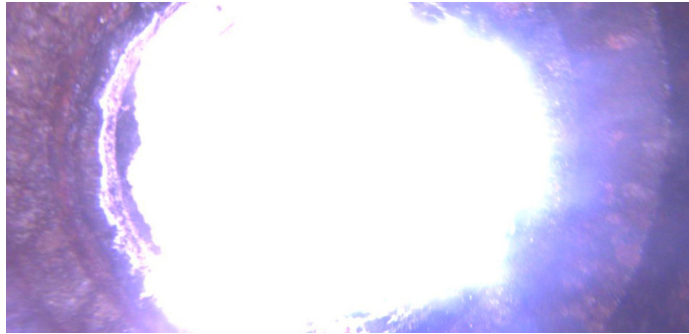
Code:	MGO
Description:	General Observation
Distance (ft):	1.5
Structural Grade:	0
O&M Grade:	0
Clock Start/From:	
Clock To:	
1st Value:	
2nd Value:	
Value Percent:	
Step:	NO
Remarks:	UNDERSIDE OF FRAME

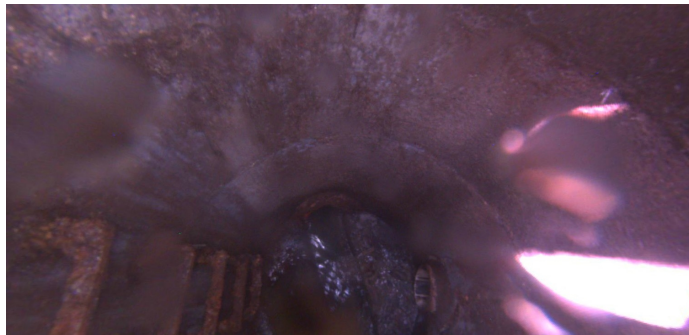
Code:	IW
Description:	Infil Weeper
Distance (ft):	2.3
Structural Grade:	0
O&M Grade:	2
Clock Start/From:	10
Clock To:	12
1st Value:	
2nd Value:	
Value Percent:	
Step:	NO
Remarks:

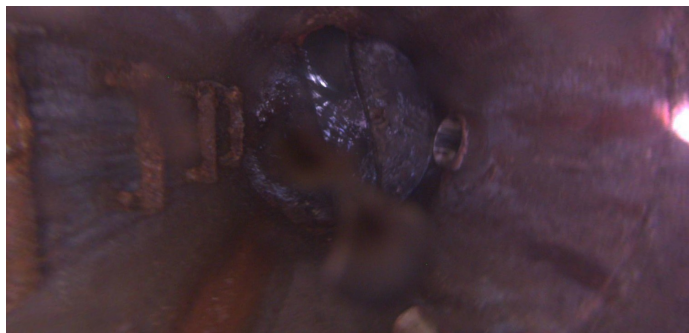
Code:	IW
Description:	Infil Weeper
Distance (ft):	3.7
Structural Grade:	0
O&M Grade:	2
Clock Start/From:	12
Clock To:	12
1st Value:	
2nd Value:	
Value Percent:	
Step:	NO
Remarks:

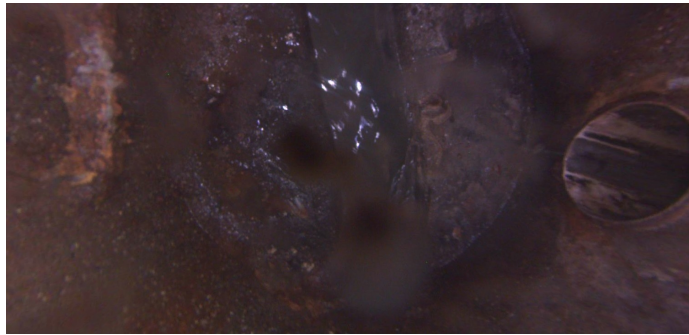
Code:	SAP
Description:	Surface Aggregate Projecting
Distance (ft):	6.4
Structural Grade:	3
O&M Grade:	0
Clock Start/From:	6
Clock To:	9
1st Value:	
2nd Value:	
Value Percent:	
Step:	NO
Remarks:

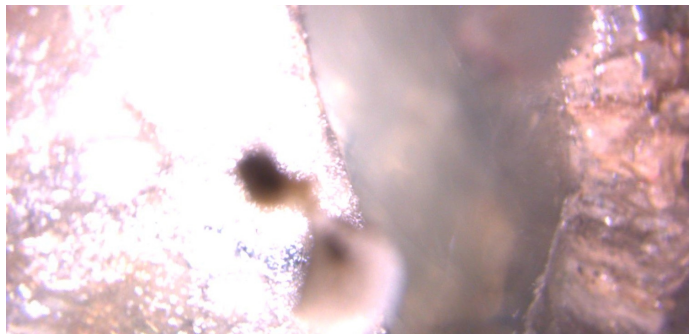
Code:	MGO
Description:	General Observation
Distance (ft):	8.7
Structural Grade:	0
O&M Grade:	0
Clock Start/From:	
Clock To:	
1st Value:	
2nd Value:	
Value Percent:	
Step:	NO
Remarks:	END SURVEY
