Manhole Inspection Report

| MH#: | M-203-013 | Owner: | NA | Len. Surveyed: | 6.2 |

| Street: | Intersection of 38th Ave. and Maxw | Project: | Hobart, IN |

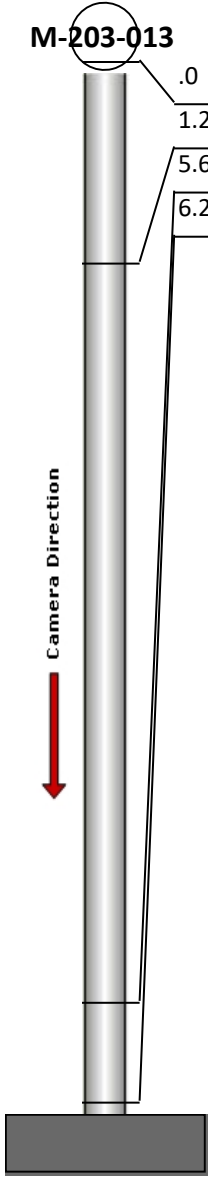
| | Position | Code | Observation | Video (sec) | Grade |
|--|---|---|---|---|---|
| | M-203-013 | | | | |

| | Position | Code | Observation | Video (sec) | Grade |
|--|---|---|---|---|---|
| | .0 | MGO | General Observation | 10 | NA |
| | 1.2 | MGP | General Photo | 26 | NA |
| | 5.6 | OBR | Obstacle Rocks | 48 | M 2 |
| | 6.2 | MGO | General Observation | 61 | NA |

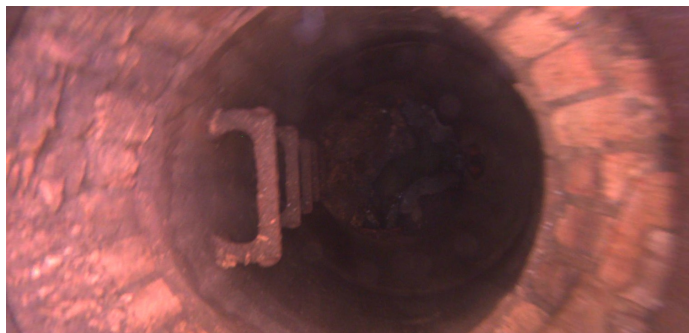
Code: **MGO**
Description: **General Observation**

Distance (ft): **.0**
Structural Grade: **0**
O&M Grade: **0**
Clock Start/From:
Clock To:
1st Value:
2nd Value:
Value Percent:
Step: **NO**
Remarks: **access MH**

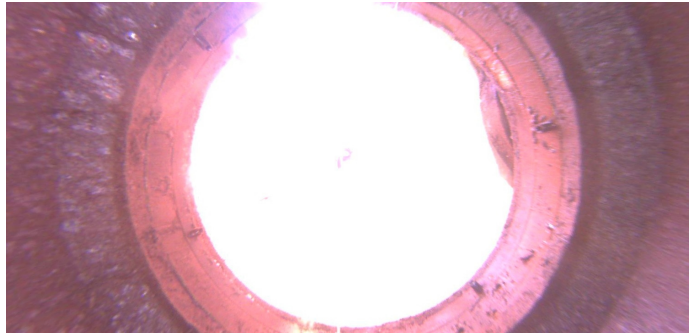
| Code: | MGP |

| Description: | General Photo |
| Distance (ft): | 1.2 |
| Remarks: | UNDERSIDE OF FRAME |

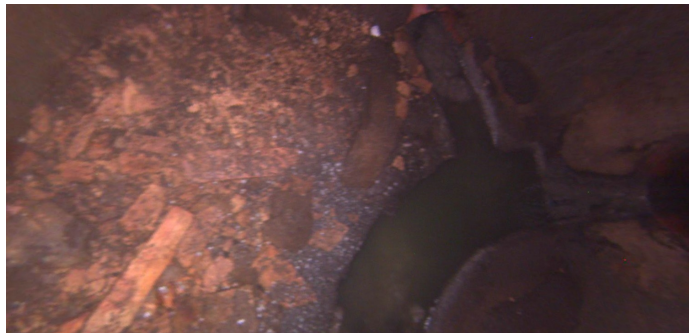
| Code: | OBR |

| Description: | Obstacle Rocks |
| Distance (ft): | 5.6 |
| O&M Grade: | 2 |
| Clock Start/From: | 12 |
| Value Percent: | 10.000 |

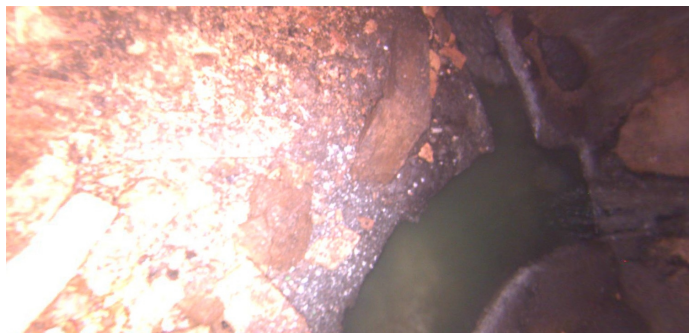
| Code: | MGO |

| Description: | General Observation |
| Distance (ft): | 6.2 |
| Remarks: | END SURVEY |
