Manhole Inspection Report

Date:	04/18/2018	Weather:		Coding:	RZMACP
MH#:	M-203-014	Owner:	NA	Len. Surveyed:	7.4
P.O.#:		Surveyor:	Jen Costello	Rim to Invert:	8.9
Customer:		Cert. #:	U-907-5518	Wall Material:	Concrete (reinforced)

Street:	38th Ave. Between Parker St. and M	Project:	Hobart, IN
City:	Hobart, IN	GPS Northing:	2893910.681
Location:		GPS Easting:	2893910.681
Drain Area:	Northwest	GPS Accuracy:	Sub-Meter
Cover Shape:	Circular	Evidence of Surcharge:	No
Cover Size:	23.0	Potential for Runoff:	None
Comments:

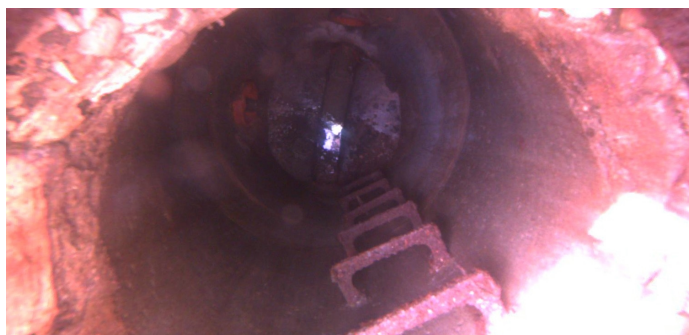
Code: **MGO**
Description: **General Observation**

Distance (ft): **.0**
Structural Grade: **0**
O&M Grade: **0**
Clock Start/From:
Clock To:
1st Value:
2nd Value:
Value Percent:
Step: **NO**
Remarks: **ACCESS MH**

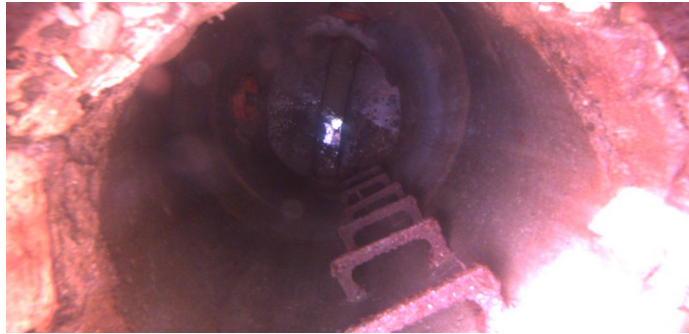
Code: **FM**
Description: **Fracture Multiple**

Distance (ft): **.0**
Structural Grade: **4**
O&M Grade: **0**
Clock Start/From: **12**
Clock To: **12**
1st Value:
2nd Value:
Value Percent:
Step: **NO**
Remarks:

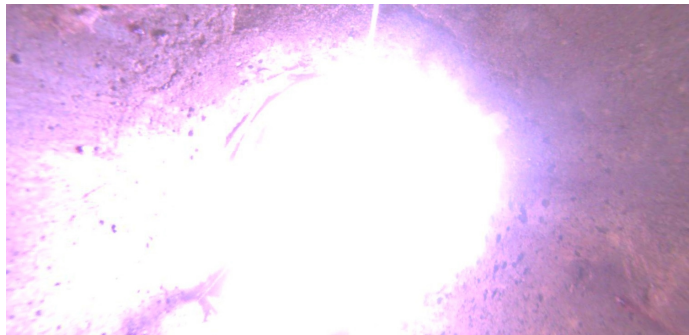
Code: **MGO**
Description: **General Observation**

Distance (ft): **3.4**
Structural Grade: **0**
O&M Grade: **0**
Clock Start/From:
Clock To:
1st Value:
2nd Value:
Value Percent:
Step: **NO**
Remarks: **UNDERSIDE OF FRAME**

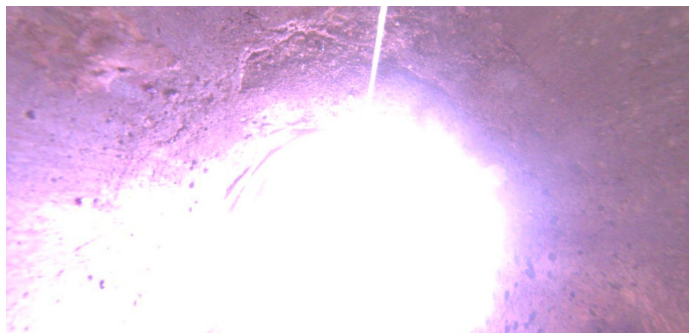
Code: **SSS**
Description: **Surface Spalling**

Distance (ft): **3.4**
Structural Grade: **2**
O&M Grade: **0**
Clock Start/From: **12**
Clock To: **12**
1st Value:
2nd Value:
Value Percent:
Step: **NO**
Remarks:

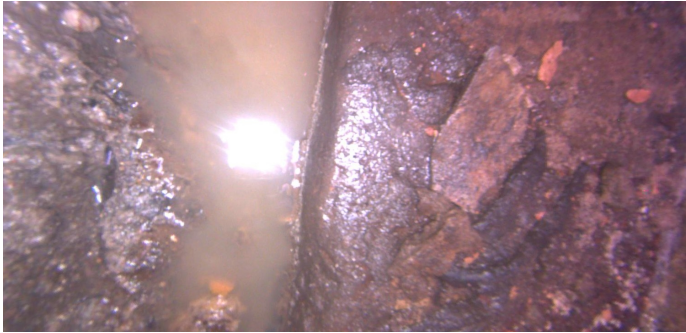
Code: **OBR**
Description: **Obstacle Rocks**

Distance (ft): **7.4**
Structural Grade: **0**
O&M Grade: **2**
Clock Start/From: **12**
Clock To: **12**
1st Value:
2nd Value:
Value Percent: **5.000**
Step: **NO**
Remarks:
