Manhole Inspection Report

Date:	04/17/2018	Weather:		Coding:	RZMACP
MH#:	M-203-020	Owner:	NA	Len. Surveyed:	4.2
P.O.#:		Surveyor:	Jen Costello	Rim to Invert:	6.0
Customer:		Cert. #:	U-907-5518	Wall Material:	Concrete (reinforced)

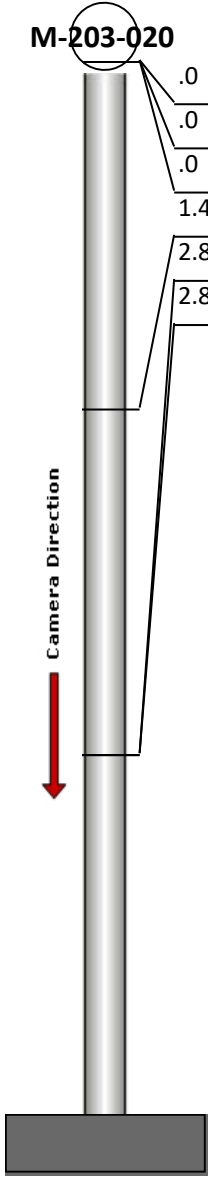
.0	MGO	General Observation	10	NA
	.0	DAR	Deposits Attached Ragging	21	M 2
	.0	RFB	Roots Fine Barrel	31	M 2
	1.4	MGO	General Observation	47	NA
	2.8	IW	Infil Weeper	63	M 2
	2.8	DSF	Deposits Settled Fine	74	M 2

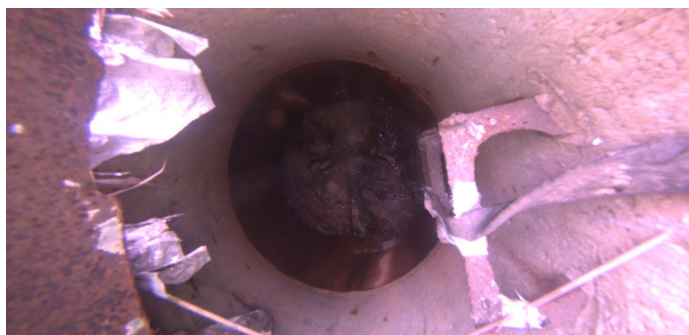
Code: **MGO**
Description: **General Observation**

Distance (ft): **.0**
Structural Grade: **0**
O&M Grade: **0**
Clock Start/From:
Clock To:
1st Value:
2nd Value:
Value Percent:
Step: **NO**
Remarks: **access MH**

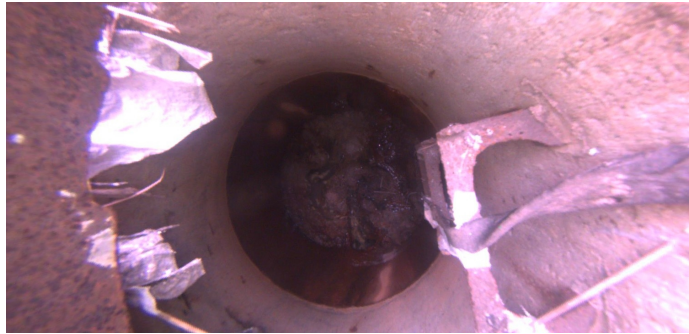
Code: **DAR**
Description: **Deposits Attached Ragging**

Distance (ft): **.0**
Structural Grade: **0**
O&M Grade: **2**
Clock Start/From: **8**
Clock To: **10**
1st Value:
2nd Value:
Value Percent: **5.000**
Step: **NO**
Remarks:

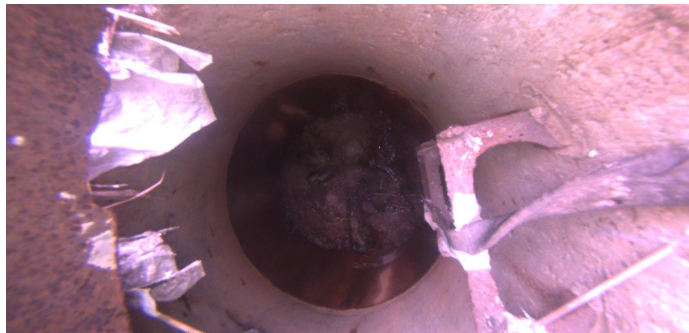
Code: **RFB**
Description: **Roots Fine Barrel**

Distance (ft): **.0**
Structural Grade: **0**
O&M Grade: **2**
Clock Start/From: **3**
Clock To:
1st Value:
2nd Value:
Value Percent:
Step: **NO**
Remarks:

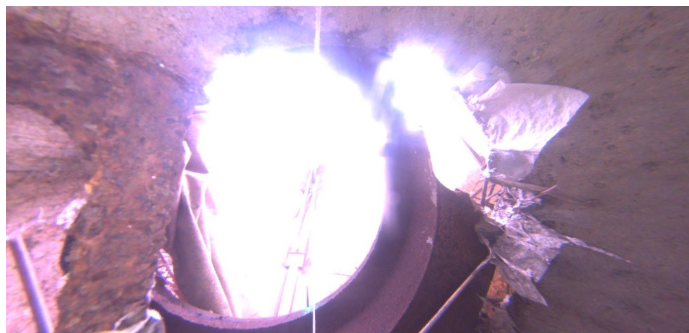
Code: **MGO**
Description: **General Observation**

Distance (ft): **1.4**
Structural Grade: **0**
O&M Grade: **0**
Clock Start/From:
Clock To:
1st Value:
2nd Value:
Value Percent:
Step: **NO**
Remarks: **UNDERSIDE OF FRAME**

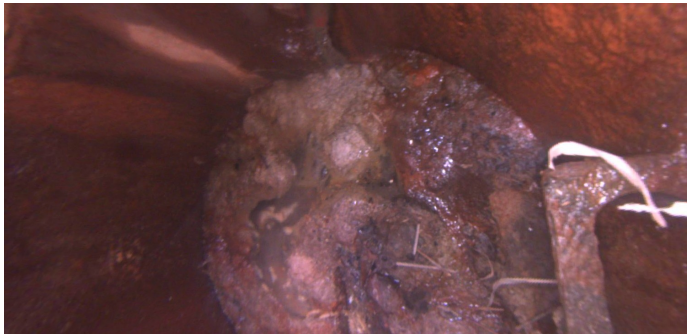
Code: **IW**
Description: **Infil Weeper**

Distance (ft): **2.8**
Structural Grade: **0**
O&M Grade: **2**
Clock Start/From: **12**
Clock To: **12**
1st Value:
2nd Value:
Value Percent:
Step: **NO**
Remarks:

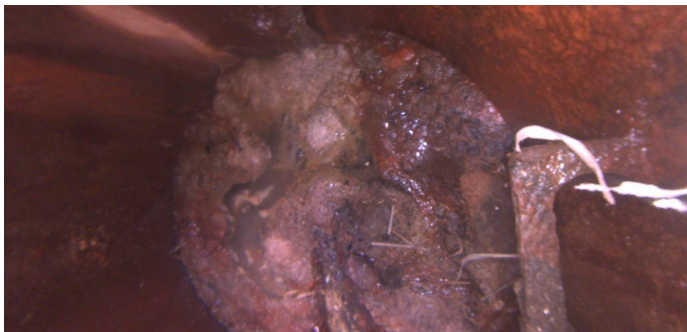
Code: **DSF**
Description: **Deposits Settled Fine**

Distance (ft): **2.8**
Structural Grade: **0**
O&M Grade: **2**
Clock Start/From: **12**
Clock To: **12**
1st Value:
2nd Value:
Value Percent: **5.000**
Step: **NO**
Remarks:
