Manhole Inspection Report

Date:	04/17/2018	Weather:		Coding:	RZMACP
MH#:	M-203-021	Owner:	NA	Len. Surveyed:	3.5
P.O.#:		Surveyor:	Jen Costello	Rim to Invert:	4.4
Customer:		Cert. #:	U-907-5518	Wall Material:	Concrete (reinforced)

Street:	Alley between 37th Ave. and 38th A	Project:	Hobart, IN
City:	Hobart, IN	GPS Northing:	0.0
Location:		GPS Easting:	0.0
Drain Area:	Northwest	GPS Accuracy:	Nearest Meter
Cover Shape:	Circular	Evidence of Surcharge:	No
Cover Size:	23.0	Potential for Runoff:	None
Comments:

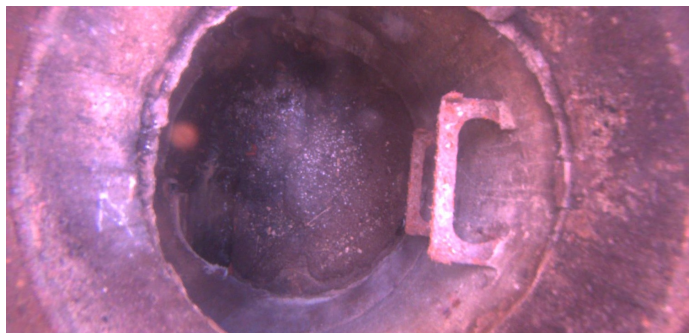
Code: **MGO**
Description: **General Observation**

Distance (ft): **.0**
Structural Grade: **0**
O&M Grade: **0**
Clock Start/From:
Clock To:
1st Value:
2nd Value:
Value Percent:
Step: **NO**
Remarks: **access MH**

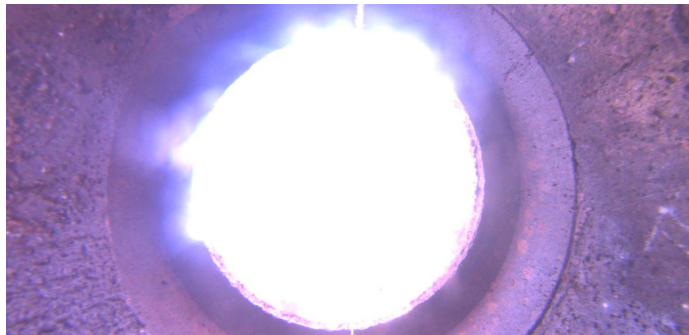
Code:	SRI
Description:	Surface Roughness Increased
Distance (ft):	1.8
Structural Grade:	1
O&M Grade:	0
Clock Start/From:	12
Clock To:	12
1st Value:	
2nd Value:	
Value Percent:	
Step:	NO
Remarks:

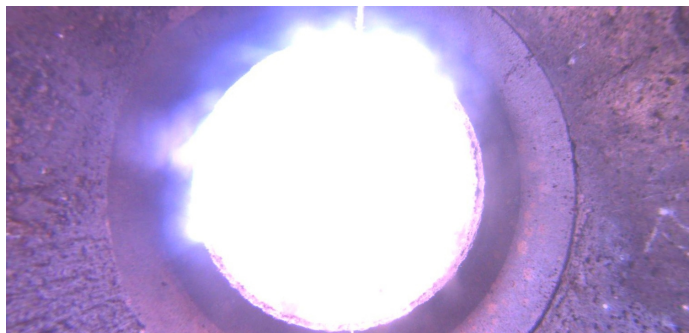
Code:	MGP
Description:	General Photo
Distance (ft):	1.8
Structural Grade:	0
O&M Grade:	0
Clock Start/From:	
Clock To:	
1st Value:	
2nd Value:	
Value Percent:	
Step:	NO
Remarks:	UNDERSIDE OF FRAME
