Manhole Inspection Report

Date:	10/05/2022	Weather:		Coding:	RZMACP
MH#:	M-203-024	Owner:	NA	Len. Surveyed:	5.4
P.O.#:		Surveyor:	Jen Costello	Rim to Invert:	6.4
Customer:		Cert. #:	U-907-5518	Wall Material:	Concrete (cast in place)

Street:	Alley between Parker St. and Barnes	Project:	Hobart, IN
City:	Hobart, IN	GPS Northing:	2295051.278
Location:	Other	GPS Easting:	2893569.242
Drain Area:	Northwest	GPS Accuracy:	Sub-Meter
Cover Shape:	Circular	Evidence of Surcharge:	No
Cover Size:	24.0	Potential for Runoff:	None
Comments:

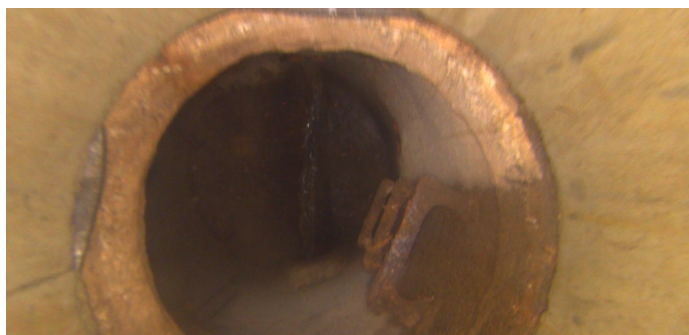
Code: **MGO**
Description: **General Observation**

Distance (ft): **.0**
Structural Grade: **0**
O&M Grade: **0**
Clock Start/From:
Clock To:
1st Value:
2nd Value:
Value Percent:
Step: **NO**
Remarks: **access mh**

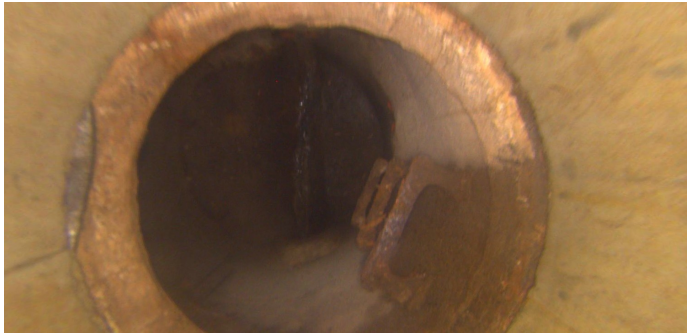
Code: **ISGT**
Description: **Intruding Sealing Grout**

Distance (ft): **.0**
Structural Grade: **0**
O&M Grade: **2**
Clock Start/From: **8**
Clock To: **9**
1st Value:
2nd Value:
Value Percent: **5.000**
Step: **NO**
Remarks:

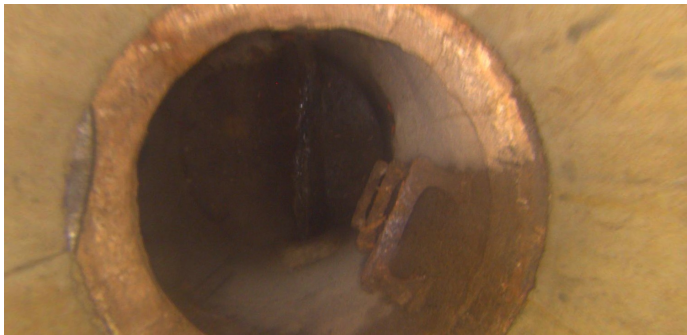
Code: **SRI**
Description: **Surface Roughness Increased**

Distance (ft): **.0**
Structural Grade: **1**
O&M Grade: **0**
Clock Start/From: **12**
Clock To: **12**
1st Value:
2nd Value:
Value Percent:
Step: **NO**
Remarks:

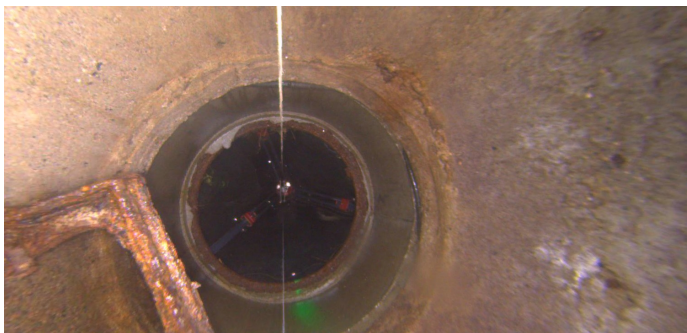
Code: **MGO**
Description: **General Observation**

Distance (ft): **3.4**
Structural Grade: **0**
O&M Grade: **0**
Clock Start/From:
Clock To:
1st Value:
2nd Value:
Value Percent:
Step: **NO**
Remarks: **underside of frame**

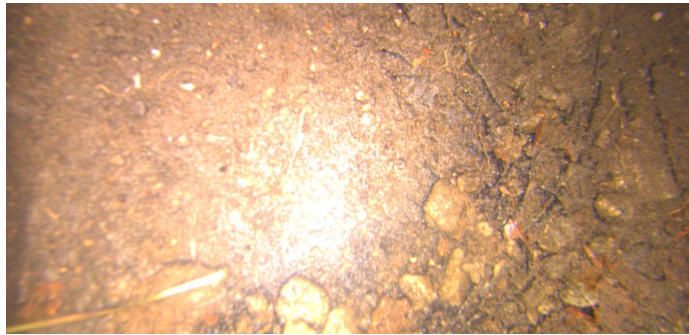
Code: **DSF**
Description: **Deposits Settled Fine**

Distance (ft): **5.4**
Structural Grade: **0**
O&M Grade: **2**
Clock Start/From: **12**
Clock To: **12**
1st Value:
2nd Value:
Value Percent: **5.000**
Step: **NO**
Remarks:

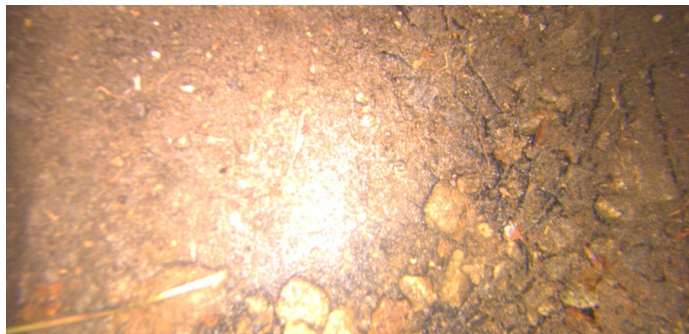
Code: **MGO**
Description: **General Observation**

Distance (ft): **5.4**
Structural Grade: **0**
O&M Grade: **0**
Clock Start/From:
Clock To:
1st Value:
2nd Value:
Value Percent:
Step: **NO**
Remarks: **end of survey**

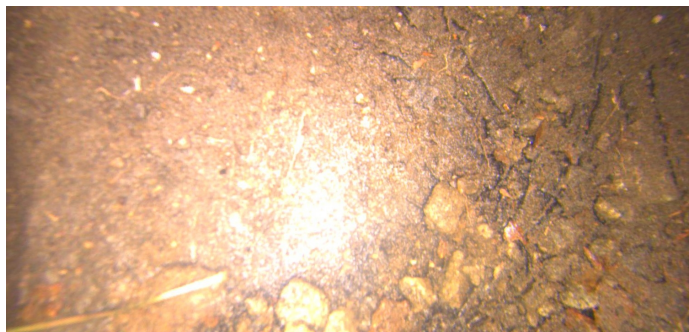
Code: **SRI**
Description: **Surface Roughness Increased**

Distance (ft): **5.4**
Structural Grade: **1**
O&M Grade: **0**
Clock Start/From: **12**
Clock To: **12**
1st Value:
2nd Value:
Value Percent:
Step: **NO**
Remarks:
