# Manhole Inspection Report

Date:	<b>04/17/2018</b>	Weather:		Coding:	<b>RZMACP</b>
MH#:	<b>M-203-032</b>	Owner:	<b>NA</b>	Len. Surveyed:	<b>7.2</b>
P.O.#:		Surveyor:	<b>Jen Costello</b>	Rim to Invert:	<b>9.4</b>
Customer:		Cert. #:	<b>U-907-5518</b>	Wall Material:	<b>Concrete (reinforced)</b>

Street:	<b>between Montgomery St. and Sher</b>	Project:	<b>Hobart, IN</b>
City:	<b>Hobart, IN</b>	GPS Northing:	<b>0.0</b>
Location:		GPS Easting:	<b>0.0</b>
Drain Area:	<b>Northwest</b>	GPS Accuracy:	<b>Nearest Meter</b>
Cover Shape:	<b>Circular</b>	Evidence of Surcharge:	<b>No</b>
Cover Size:	<b>23.0</b>	Potential for Runoff:	<b>None</b>
Comments:

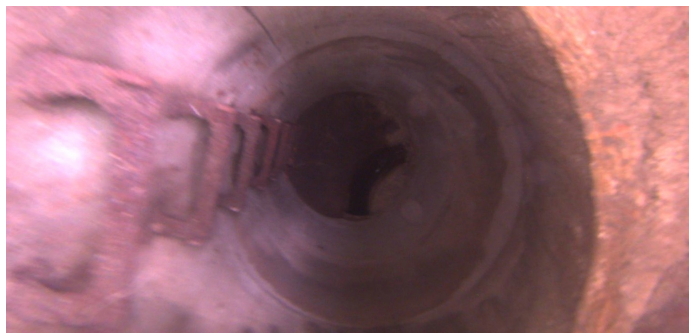
Code: **MGO**  
Description: **General Observation**

Distance (ft): **.0**  
Structural Grade: **0**  
O&M Grade: **0**  
Clock Start/From:  
Clock To:  
1st Value:  
2nd Value:  
Value Percent:  
Step: **NO**  
Remarks: **ACCESS MH**

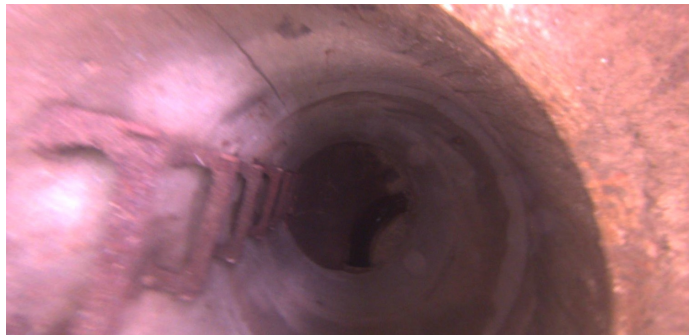
Code: **SAV**  
Description: **Surface Aggregate Visible**

Distance (ft): **.0**  
Structural Grade: **3**  
O&M Grade: **0**  
Clock Start/From: **12**  
Clock To: **12**  
1st Value:  
2nd Value:  
Value Percent:  
Step: **NO**  
Remarks:

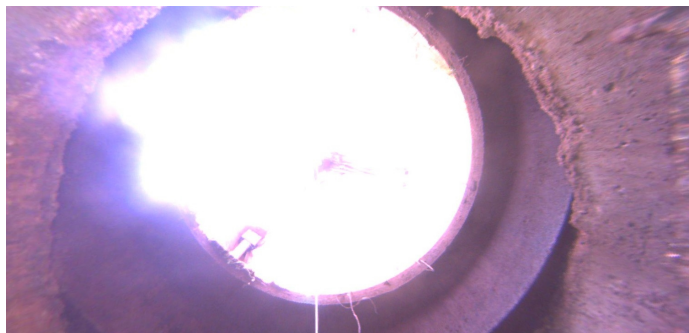
Code: **MGP**  
Description: **General Photo**

Distance (ft): **1.3**  
Structural Grade: **0**  
O&M Grade: **0**  
Clock Start/From:  
Clock To:  
1st Value:  
2nd Value:  
Value Percent:  
Step: **NO**  
Remarks: **UNDERSIDE OF FRAME**

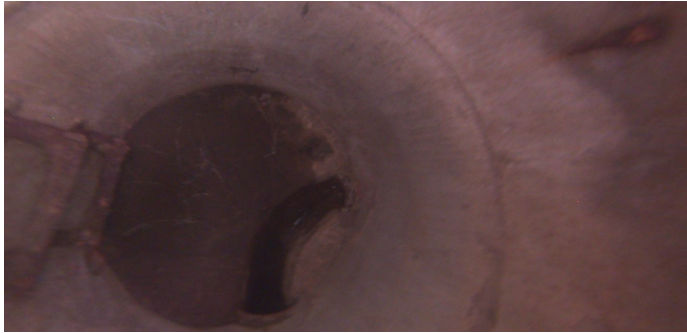
Code: **IW**  
Description: **Infil Weeper**

Distance (ft): **3.7**  
Structural Grade: **0**  
O&M Grade: **2**  
Clock Start/From: **2**  
Clock To:  
1st Value:  
2nd Value:  
Value Percent:  
Step: **NO**  
Remarks:

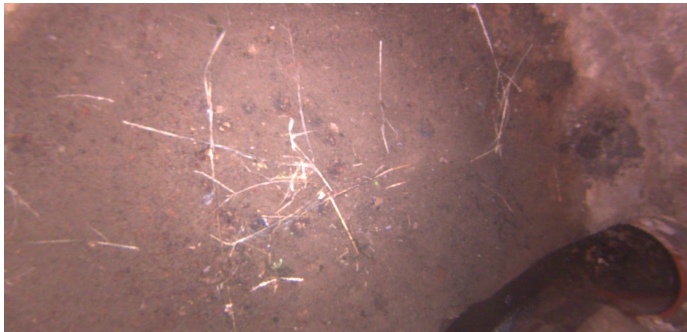
Code: **MGO**  
Description: **General Observation**

Distance (ft): **7.2**  
Structural Grade: **0**  
O&M Grade: **0**  
Clock Start/From:  
Clock To:  
1st Value:  
2nd Value:  
Value Percent:  
Step: **NO**  
Remarks: **END SURVEY**
