# Manhole Inspection Report

Date:	<b>04/17/2018</b>	Weather:		Coding:	<b>RZMACP</b>
MH#:	<b>M-203-033</b>	Owner:	<b>NA</b>	Len. Surveyed:	<b>4.6</b>
P.O.#:		Surveyor:	<b>John Kuglmaier</b>	Rim to Invert:	<b>5.5</b>
Customer:		Cert. #:	<b>U-1215-07002349</b>	Wall Material:	<b>Concrete (reinforced)</b>

Street:	<b>Alley between 37th Ave. and 38th A</b>	Project:	<b>Hobart, IN</b>
City:	<b>Hobart, IN</b>	GPS Northing:	<b>0.0</b>
Location:		GPS Easting:	<b>0.0</b>
Drain Area:	<b>Northwest</b>	GPS Accuracy:	<b>Nearest Meter</b>
Cover Shape:	<b>Circular</b>	Evidence of Surcharge:	<b>No</b>
Cover Size:	<b>23.0</b>	Potential for Runoff:	<b>None</b>
Comments:

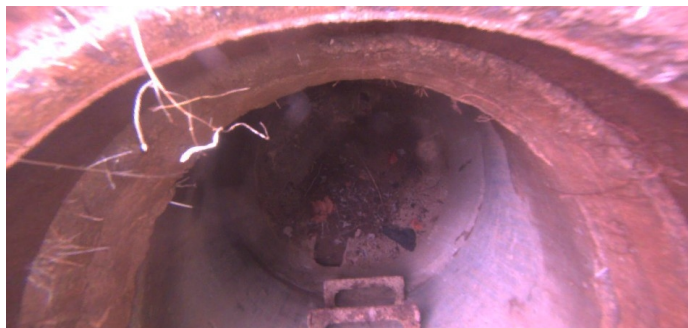
Code: **MGP**  
Description: **General Photo**

Distance (ft): **.0**  
Structural Grade: **0**  
O&M Grade: **0**  
Clock Start/From:  
Clock To:  
1st Value:  
2nd Value:  
Value Percent:  
Step: **NO**  
Remarks:

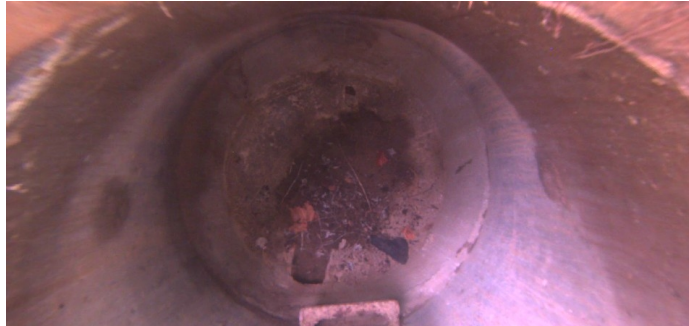
Code: **IS**  
Description: **Infil Stain**

Distance (ft): **.7**  
Structural Grade: **0**  
O&M Grade: **0**  
Clock Start/From: **6**  
Clock To: **1**  
1st Value:  
2nd Value:  
Value Percent:  
Step: **NO**  
Remarks:

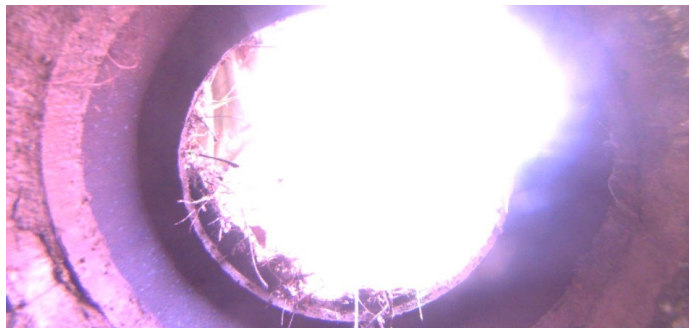
Code: **MGP**  
Description: **General Photo**

Distance (ft): **1.7**  
Structural Grade: **0**  
O&M Grade: **0**  
Clock Start/From:  
Clock To:  
1st Value:  
2nd Value:  
Value Percent:  
Step: **NO**  
Remarks:

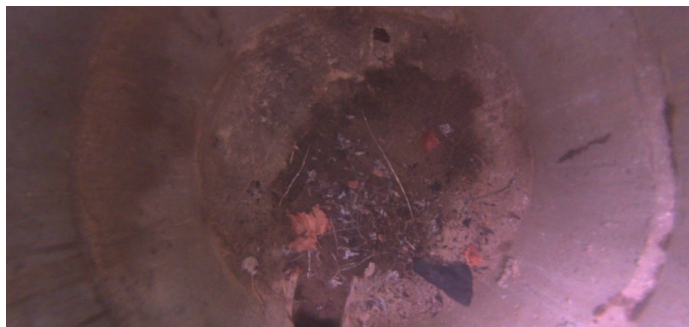
Code: **DAZ**  
Description: **Deposits Attached Other**

Distance (ft): **2.3**  
Structural Grade: **0**  
O&M Grade: **2**  
Clock Start/From: **12**  
Clock To: **12**  
1st Value:  
2nd Value:  
Value Percent: **5.000**  
Step: **NO**  
Remarks: **Mixed materials**

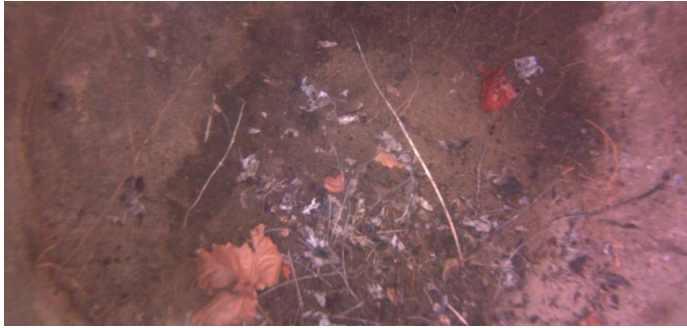
Code:	<b>MGO</b>
Description:	<b>General Observation</b>
Distance (ft):	<b>3.9</b>
Structural Grade:	<b>0</b>
O&M Grade:	<b>0</b>
Clock Start/From:	
Clock To:	
1st Value:	
2nd Value:	
Value Percent:	
Step:	<b>NO</b>
Remarks:	<b>Ins. Comp.</b>
