Manhole Inspection Report

Date:	04/17/2018	Weather:		Coding:	RZMACP
MH#:	M-203-034	Owner:	NA	Len. Surveyed:	11.2
P.O.#:		Surveyor:	Jen Costello	Rim to Invert:	13.0
Customer:		Cert. #:	U-907-5518	Wall Material:	Concrete (reinforced)

Street:	38th Ave. 167' West of Montgomery	Project:	Hobart, IN
City:	Hobart, IN	GPS Northing:	0.0
Location:		GPS Easting:	0.0
Drain Area:	Northwest	GPS Accuracy:	Nearest Meter
Cover Shape:	Circular	Evidence of Surcharge:	No
Cover Size:	23.0	Potential for Runoff:	None
Comments:

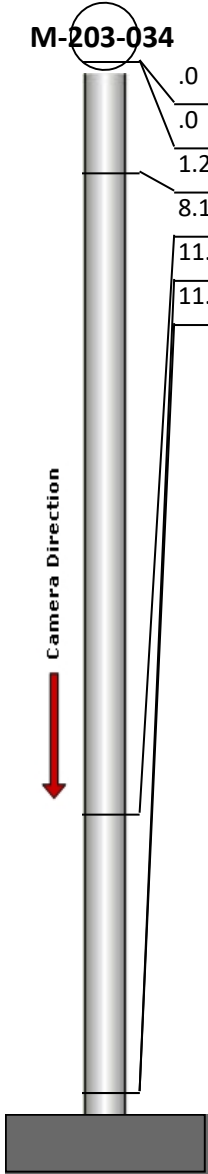
M-203-034				
	.0	MGO	General Observation	10	NA
	.0	SRI	Surface Roughness Increased	21	S 1
	1.2	MGO	General Observation	37	NA
	8.1	IW	Infil Weeper	64	M 2
	11.1	DSZ	Deposits Settled Other	80	M 2
	11.1	SRI	Surface Roughness Increased	91	S 1

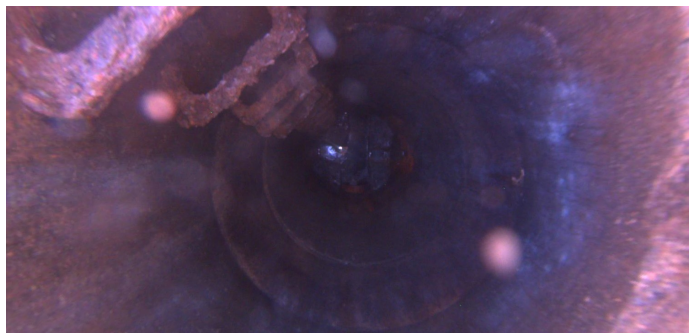
Code: **MGO**
Description: **General Observation**

Distance (ft): **.0**
Structural Grade: **0**
O&M Grade: **0**
Clock Start/From:
Clock To:
1st Value:
2nd Value:
Value Percent:
Step: **NO**
Remarks: **ACCESS MH**

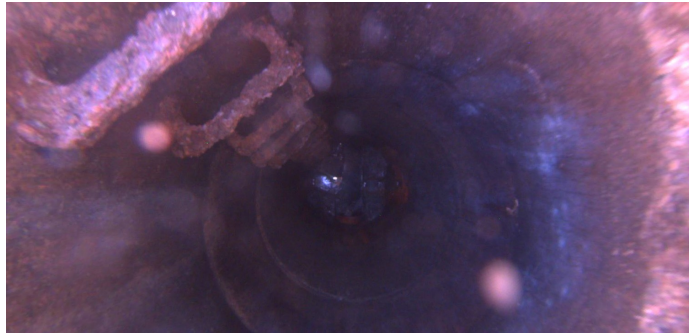
Code: **SRI**
Description: **Surface Roughness Increased**

Distance (ft): **.0**
Structural Grade: **1**
O&M Grade: **0**
Clock Start/From: **12**
Clock To: **12**
1st Value:
2nd Value:
Value Percent:
Step: **NO**
Remarks:

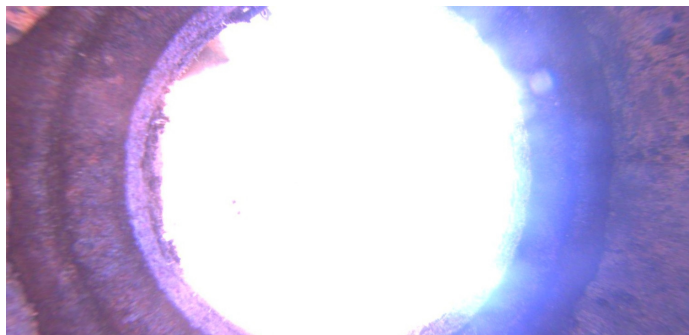
Code: **MGO**
Description: **General Observation**

Distance (ft): **1.2**
Structural Grade: **0**
O&M Grade: **0**
Clock Start/From:
Clock To:
1st Value:
2nd Value:
Value Percent:
Step: **NO**
Remarks: **UNDERSIDE OF FRAME**

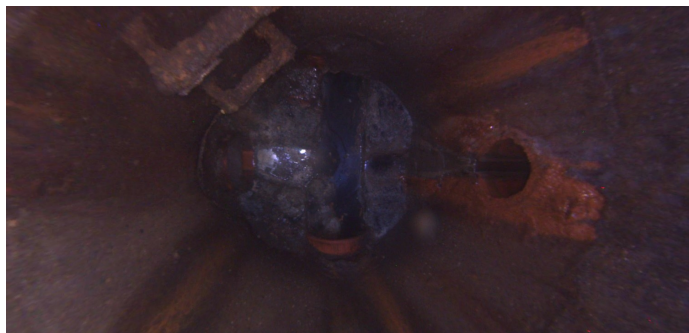
Code: **IW**
Description: **Infil Weeper**

Distance (ft): **8.1**
Structural Grade: **0**
O&M Grade: **2**
Clock Start/From: **12**
Clock To: **12**
1st Value:
2nd Value:
Value Percent:
Step: **NO**
Remarks:

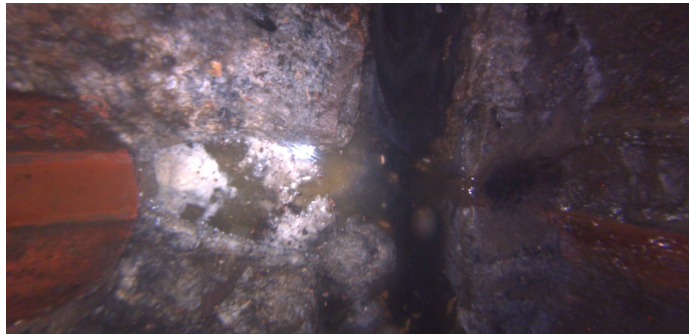
Code: **DSZ**
Description: **Deposits Settled Other**

Distance (ft): **11.1**
Structural Grade: **0**
O&M Grade: **2**
Clock Start/From: **12**
Clock To: **12**
1st Value:
2nd Value:
Value Percent: **5.000**
Step: **NO**
Remarks: **MISC**

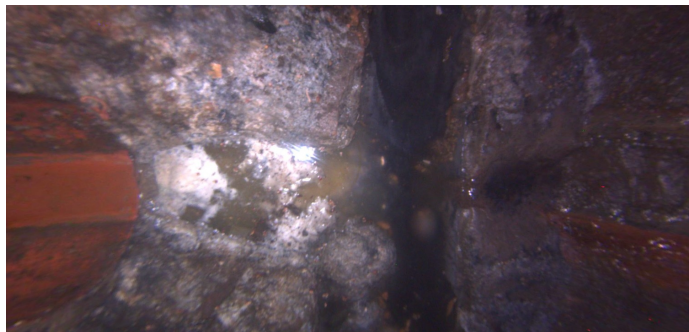
Code: **SRI**
Description: **Surface Roughness Increased**

Distance (ft): **11.1**
Structural Grade: **1**
O&M Grade: **0**
Clock Start/From: **12**
Clock To: **12**
1st Value:
2nd Value:
Value Percent:
Step: **NO**
Remarks:
