Manhole Inspection Report

Date:	10/05/2022	Weather:		Coding:	RZMACP
MH#:	M-203-036	Owner:	NA	Len. Surveyed:	5.1
P.O.#:		Surveyor:	Jen Costello	Rim to Invert:	5.6
Customer:		Cert. #:	U-907-5518	Wall Material:	Concrete (cast in place)

Street:	Alley btw Maitland St&Montgomery	Project:	Hobart, IN
City:	Hobart, IN	GPS Northing:	2294847.795
Location:	Other	GPS Easting:	2892585.77
Drain Area:	Northwest	GPS Accuracy:	Sub-Meter
Cover Shape:	Circular	Evidence of Surcharge:	Yes
Cover Size:	24.0	Potential for Runoff:	None
Comments:

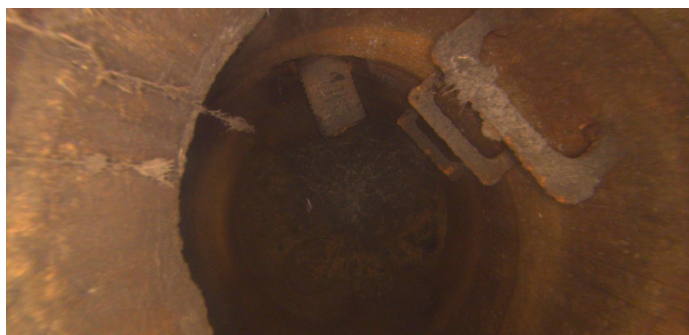
Code: **MGO**
Description: **General Observation**

Distance (ft): **.0**
Structural Grade: **0**
O&M Grade: **0**
Clock Start/From:
Clock To:
1st Value:
2nd Value:
Value Percent:
Step: **NO**
Remarks: **access mh**

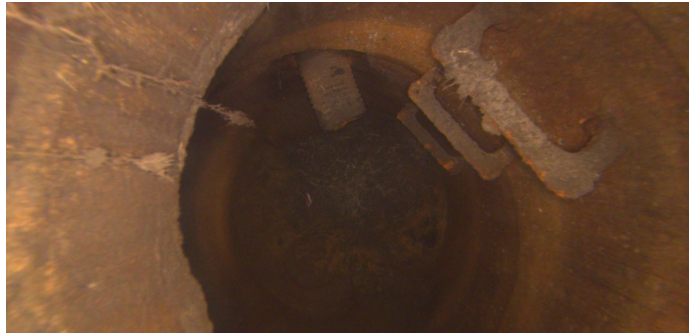
Code: **SRI**
Description: **Surface Roughness Increased**

Distance (ft): **.0**
Structural Grade: **1**
O&M Grade: **0**
Clock Start/From: **12**
Clock To: **12**
1st Value:
2nd Value:
Value Percent:
Step: **NO**
Remarks:

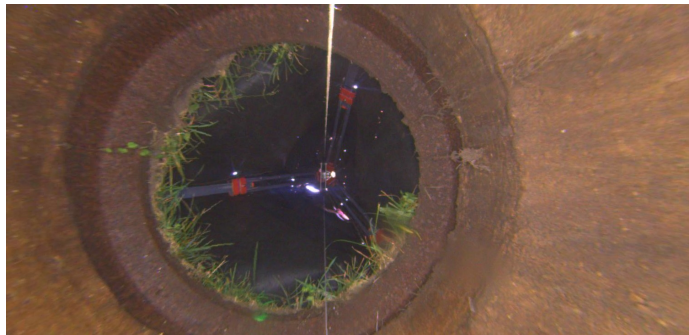
Code: **MGO**
Description: **General Observation**

Distance (ft): **2.1**
Structural Grade: **0**
O&M Grade: **0**
Clock Start/From:
Clock To:
1st Value:
2nd Value:
Value Percent:
Step: **NO**
Remarks: **underside of frame**

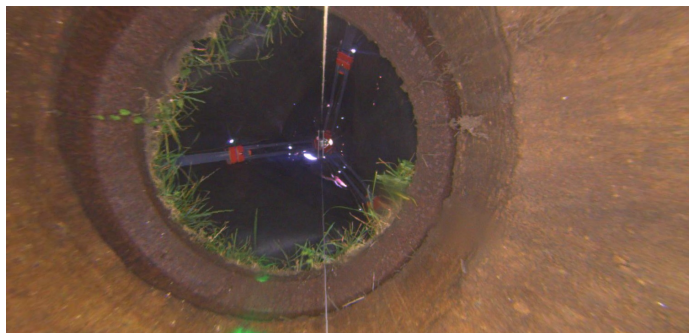
Code: **RFJ**
Description: **Roots Fine Joint**

Distance (ft): **2.1**
Structural Grade: **0**
O&M Grade: **1**
Clock Start/From: **9**
Clock To: **12**
1st Value:
2nd Value:
Value Percent:
Step: **NO**
Remarks:

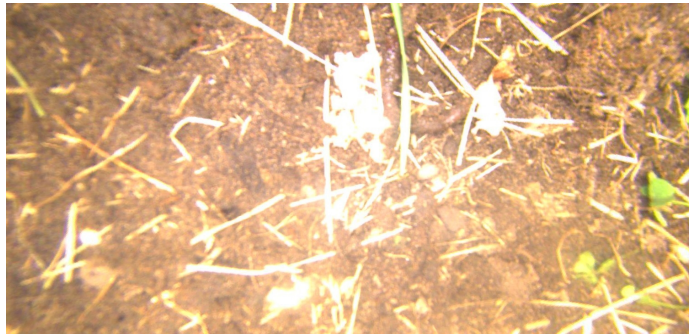
Code: **DSF**
Description: **Deposits Settled Fine**

Distance (ft): **5.1**
Structural Grade: **0**
O&M Grade: **2**
Clock Start/From: **12**
Clock To: **12**
1st Value:
2nd Value:
Value Percent: **5.000**
Step: **NO**
Remarks:

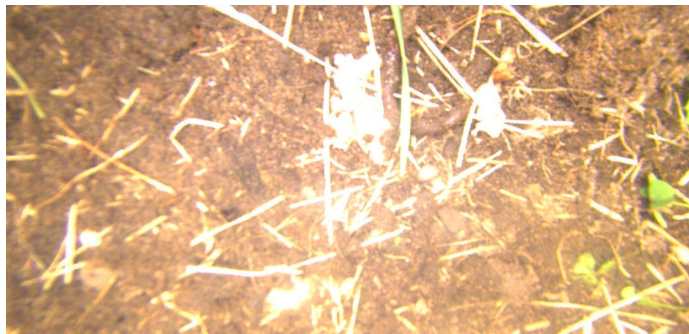
Code: **SRI**
Description: **Surface Roughness Increased**

Distance (ft): **5.1**
Structural Grade: **1**
O&M Grade: **0**
Clock Start/From: **12**
Clock To: **12**
1st Value:
2nd Value:
Value Percent:
Step: **NO**
Remarks:

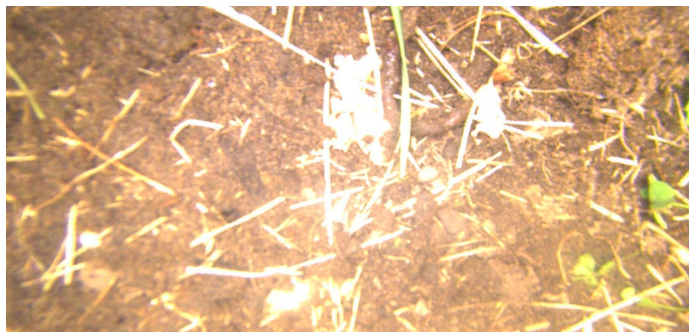
Code: **MGO**
Description: **General Observation**

Distance (ft): **5.1**
Structural Grade: **0**
O&M Grade: **0**
Clock Start/From:
Clock To:
1st Value:
2nd Value:
Value Percent:
Step: **NO**
Remarks: **end of survey**
