Manhole Inspection Report

Date:	04/17/2018	Weather:		Coding:	RZMACP
MH#:	M-203-039	Owner:	NA	Len. Surveyed:	6.5
P.O.#:		Surveyor:	Jen Costello	Rim to Invert:	8.7
Customer:		Cert. #:	U-907-5518	Wall Material:	Concrete (reinforced)

Street:	between Maitland St. and Montgom	Project:	Hobart, IN
City:	Hobart, IN	GPS Northing:	0.0
Location:		GPS Easting:	0.0
Drain Area:	Northwest	GPS Accuracy:	Nearest Meter
Cover Shape:	Circular	Evidence of Surcharge:	No
Cover Size:	23.0	Potential for Runoff:	None
Comments:

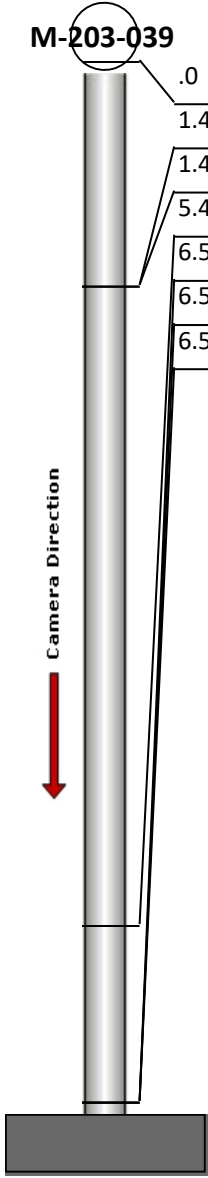
.0	MGO	General Observation	10	NA
	1.4	MGP	General Photo	26	NA
	1.4	SAV	Surface Aggregate Visible	37	S 3
	5.4	MGO	General Observation	58	NA
	6.5	DSF	Deposits Settled Fine	70	M 2
	6.5	SAP	Surface Aggregate Projecting	80	S 3
	6.5	DSF	Deposits Settled Fine	91	M 2

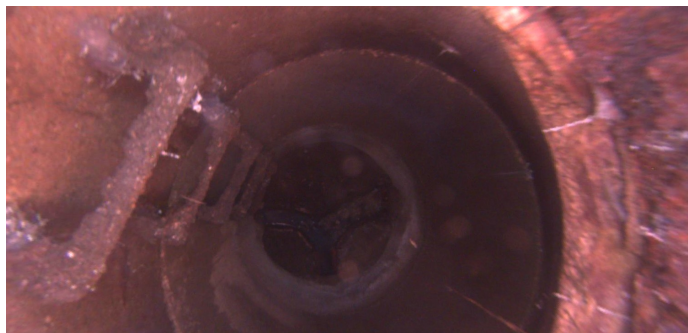
Code: **MGO**
Description: **General Observation**

Distance (ft): **.0**
Structural Grade: **0**
O&M Grade: **0**
Clock Start/From:
Clock To:
1st Value:
2nd Value:
Value Percent:
Step: **NO**
Remarks: **ACCESS MH**

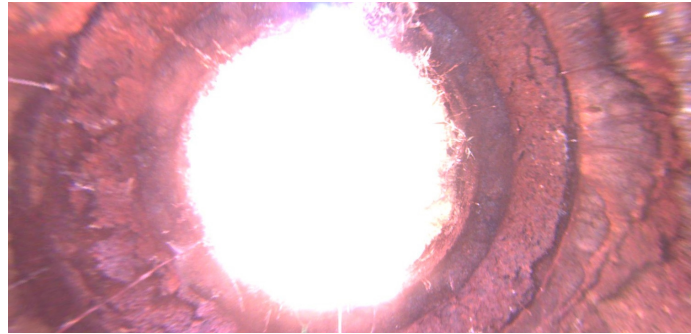
Code:	MGP
Description:	General Photo
Distance (ft):	1.4
Structural Grade:	0
O&M Grade:	0
Clock Start/From:	
Clock To:	
1st Value:	
2nd Value:	
Value Percent:	
Step:	NO
Remarks:	UNDERSIDE OF FRAME

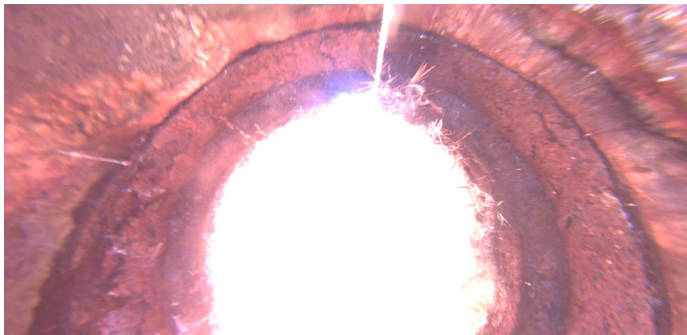
Code:	SAV
Description:	Surface Aggregate Visible
Distance (ft):	1.4
Structural Grade:	3
O&M Grade:	0
Clock Start/From:	12
Clock To:	12
1st Value:	
2nd Value:	
Value Percent:	
Step:	NO
Remarks:

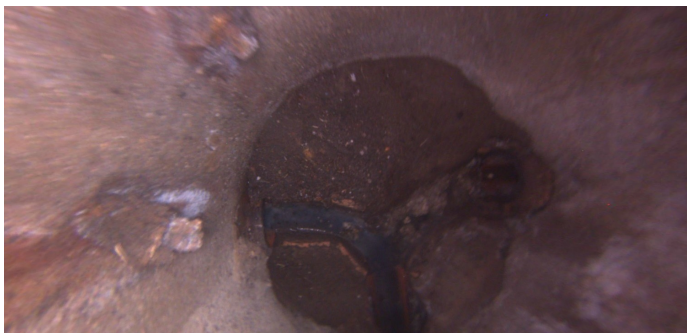
Code:	MGO
Description:	General Observation
Distance (ft):	5.4
Structural Grade:	0
O&M Grade:	0
Clock Start/From:	
Clock To:	
1st Value:	
2nd Value:	
Value Percent:	
Step:	YES
Remarks:	BROKEN STEP

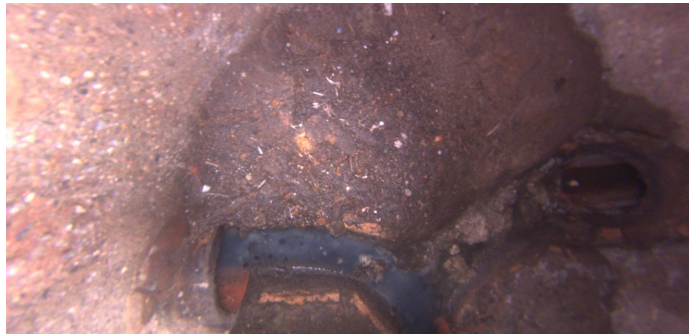
Code: **DSF**
Description: **Deposits Settled Fine**

Distance (ft): **6.5**
Structural Grade: **0**
O&M Grade: **2**
Clock Start/From: **12**
Clock To: **12**
1st Value:
2nd Value:
Value Percent: **5.000**
Step: **NO**
Remarks:

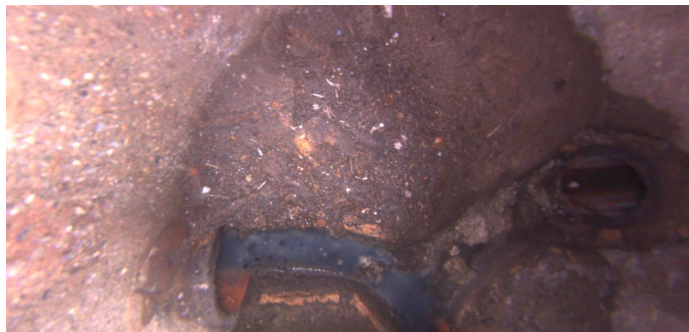
Code: **SAP**
Description: **Surface Aggregate Projecting**

Distance (ft): **6.5**
Structural Grade: **3**
O&M Grade: **0**
Clock Start/From: **12**
Clock To: **12**
1st Value:
2nd Value:
Value Percent:
Step: **NO**
Remarks:

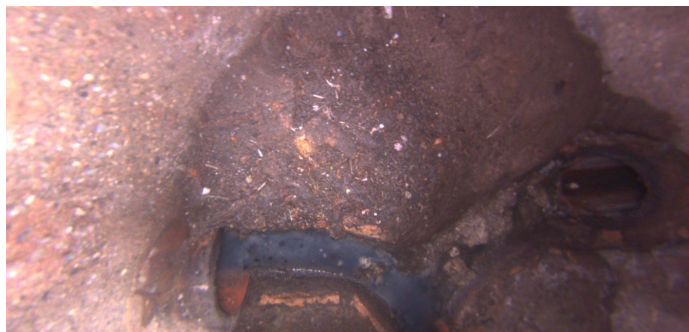
Code: **DSF**
Description: **Deposits Settled Fine**

Distance (ft): **6.5**
Structural Grade: **0**
O&M Grade: **2**
Clock Start/From: **12**
Clock To: **12**
1st Value:
2nd Value:
Value Percent: **5.000**
Step: **NO**
Remarks:
