Manhole Inspection Report

Date:	10/05/2022	Weather:		Coding:	RZMACP
MH#:	M-203-041	Owner:	NA	Len. Surveyed:	9.3
P.O.#:		Surveyor:	Todd Machine	Rim to Invert:	10.2
Customer:		Cert. #:	P0038859-082022	Wall Material:	Concrete (cast in place)

Street:	38th Ave. 164' West of Maitland St.	Project:	Hobart, IN
City:	Hobart, IN	GPS Northing:	2295209.654
Location:	Other	GPS Easting:	2892252.55
Drain Area:	Northwest	GPS Accuracy:	Sub-Meter
Cover Shape:	Circular	Evidence of Surcharge:	No
Cover Size:	24.0	Potential for Runoff:	None
Comments:

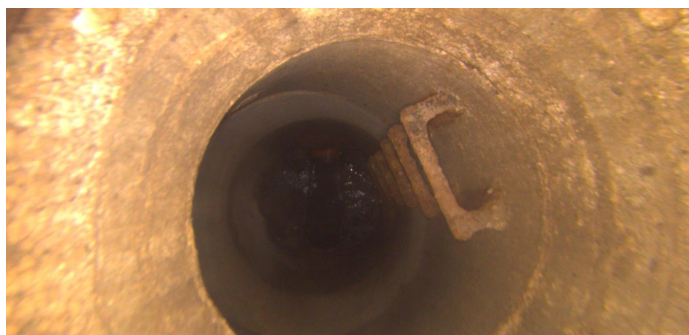
Code: **MGO**
Description: **General Observation**

Distance (ft): **.0**
Structural Grade: **0**
O&M Grade: **0**
Clock Start/From:
Clock To:
1st Value:
2nd Value:
Value Percent:
Step: **NO**
Remarks: **access mh**

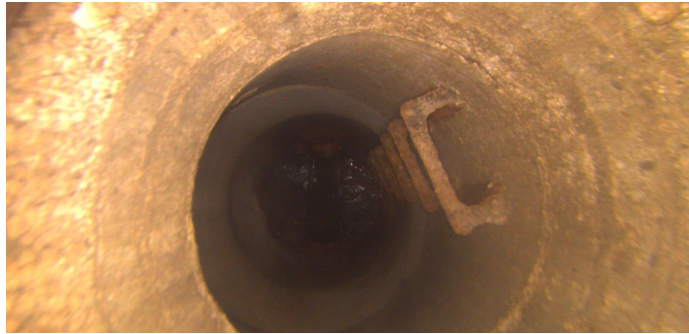
Code: **SRI**
Description: **Surface Roughness Increased**

Distance (ft): **.0**
Structural Grade: **1**
O&M Grade: **0**
Clock Start/From: **12**
Clock To: **12**
1st Value:
2nd Value:
Value Percent:
Step: **NO**
Remarks:

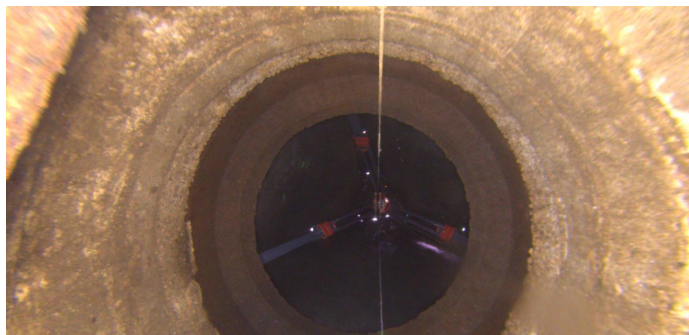
Code: **MGO**
Description: **General Observation**

Distance (ft): **2.5**
Structural Grade: **0**
O&M Grade: **0**
Clock Start/From:
Clock To:
1st Value:
2nd Value:
Value Percent:
Step: **NO**
Remarks: **underside of frame**

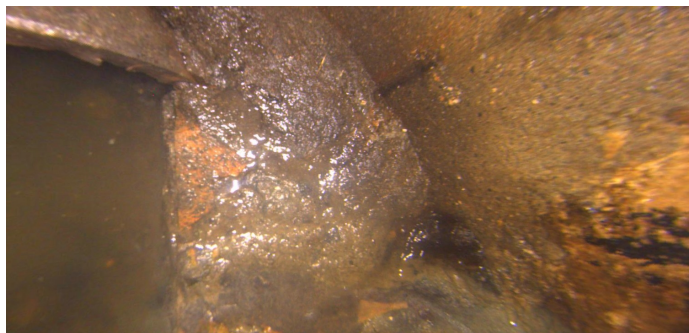
Code: **IW**
Description: **Infil Weeper**

Distance (ft): **8.1**
Structural Grade: **0**
O&M Grade: **2**
Clock Start/From: **2**
Clock To:
1st Value:
2nd Value:
Value Percent:
Step: **NO**
Remarks:

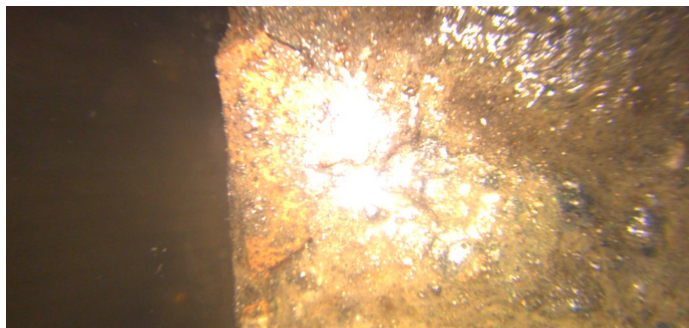
Code: **MGO**
Description: **General Observation**

Distance (ft): **9.3**
Structural Grade: **0**
O&M Grade: **0**
Clock Start/From:
Clock To:
1st Value:
2nd Value:
Value Percent:
Step: **NO**
Remarks: **End Of Survey**
