# Manhole Inspection Report

Date:	<b>04/17/2018</b>	Weather:		Coding:	<b>RZMACP</b>
MH#:	<b>M-203-051</b>	Owner:	<b>NA</b>	Len. Surveyed:	<b>6.4</b>
P.O.#:		Surveyor:	<b>Jen Costello</b>	Rim to Invert:	<b>7.8</b>
Customer:		Cert. #:	<b>U-907-5518</b>	Wall Material:	<b>Concrete (reinforced)</b>

Street:	<b>38th Ave. 167' West of Evergreen St.</b>	Project:	<b>Hobart, IN</b>
City:	<b>Hobart, IN</b>	GPS Northing:	<b>0.0</b>
Location:		GPS Easting:	<b>0.0</b>
Drain Area:	<b>Northwest</b>	GPS Accuracy:	<b>Nearest Meter</b>
Cover Shape:	<b>Circular</b>	Evidence of Surcharge:	<b>No</b>
Cover Size:	<b>23.0</b>	Potential for Runoff:	<b>None</b>
Comments:

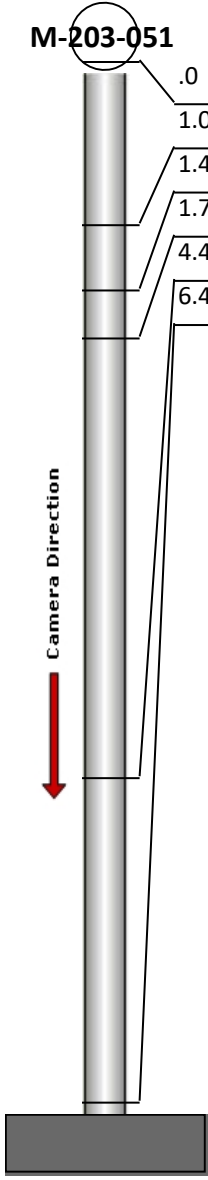
.0	MGO	General Observation	10	NA
	1.0	SRI	Surface Roughness Increased	23	S 1
	1.4	MGP	General Photo	37	NA
	1.7	RFJ	Roots Fine Joint	50	M 1
	4.4	IW	Infil Weeper	66	M 2
	6.4	MGO	General Observation	81	NA

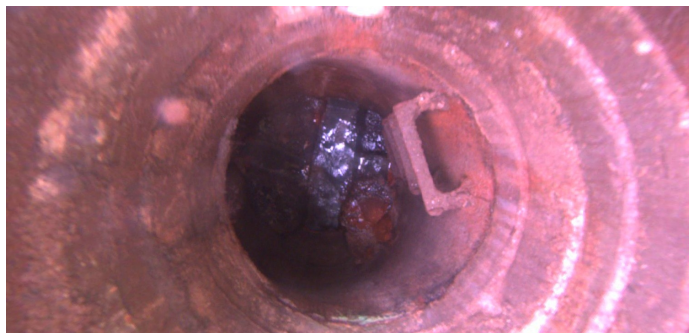
Code: **MGO**  
Description: **General Observation**

Distance (ft): **.0**  
Structural Grade: **0**  
O&M Grade: **0**  
Clock Start/From:  
Clock To:  
1st Value:  
2nd Value:  
Value Percent:  
Step: **NO**  
Remarks: **ACCESS MH**

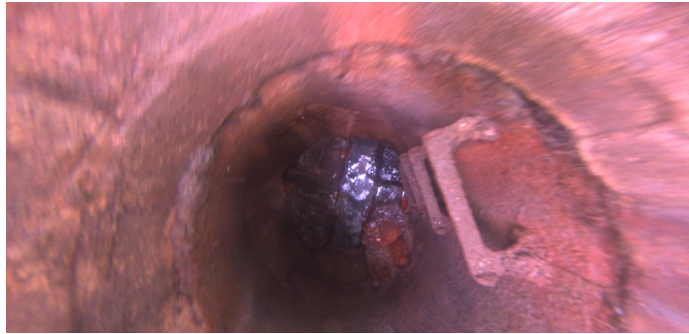
Code: **SRI**  
Description: **Surface Roughness Increased**

Distance (ft): **1.0**  
Structural Grade: **1**  
O&M Grade: **0**  
Clock Start/From: **12**  
Clock To: **12**  
1st Value:  
2nd Value:  
Value Percent:  
Step: **NO**  
Remarks:

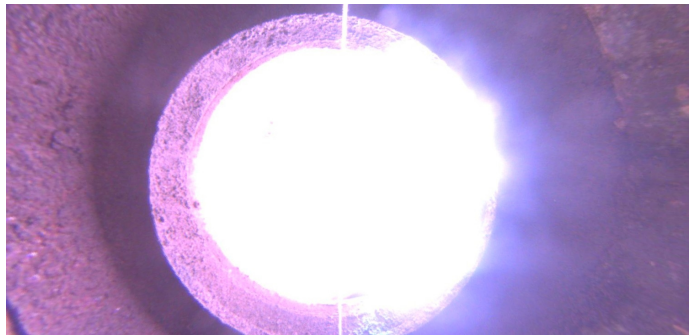
Code: **MGP**  
Description: **General Photo**

Distance (ft): **1.4**  
Structural Grade: **0**  
O&M Grade: **0**  
Clock Start/From:  
Clock To:  
1st Value:  
2nd Value:  
Value Percent:  
Step: **NO**  
Remarks: **UNDERSIDE OF FRAME**

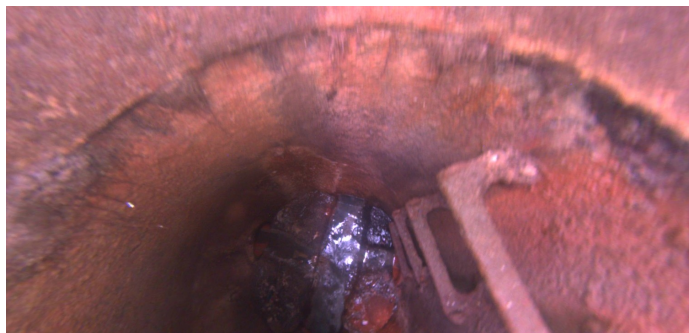
Code: **RFJ**  
Description: **Roots Fine Joint**

Distance (ft): **1.7**  
Structural Grade: **0**  
O&M Grade: **1**  
Clock Start/From: **12**  
Clock To: **12**  
1st Value:  
2nd Value:  
Value Percent:  
Step: **NO**  
Remarks:

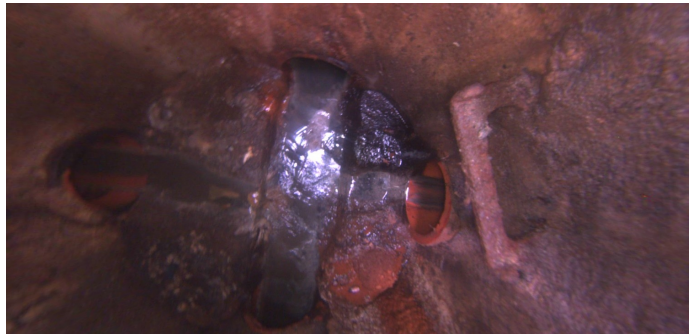
Code: **IW**  
Description: **Infil Weeper**

Distance (ft): **4.4**  
Structural Grade: **0**  
O&M Grade: **2**  
Clock Start/From: **5**  
Clock To:  
1st Value:  
2nd Value:  
Value Percent:  
Step: **NO**  
Remarks:

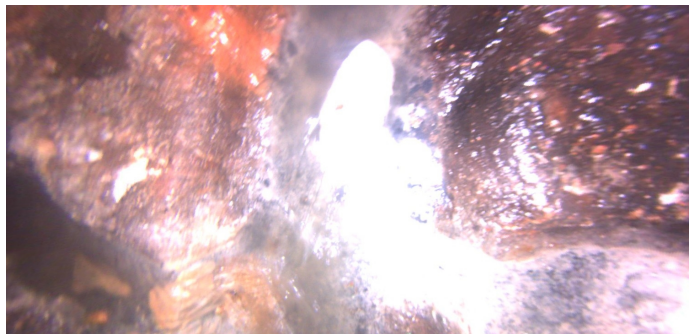
Code: **MGO**  
Description: **General Observation**

Distance (ft): **6.4**  
Structural Grade: **0**  
O&M Grade: **0**  
Clock Start/From:  
Clock To:  
1st Value:  
2nd Value:  
Value Percent:  
Step: **NO**  
Remarks: **END SURVEY**
