Date:	04/17/2018	Weather:		Coding:	RZMACP
MH#:	M-203-052	Owner:	NA	Len. Surveyed:	6.0
P.O.#:		Surveyor:	Jen Costello	Rim to Invert:	7.6
Customer:		Cert. #:	U-907-5518	Wall Material:	Concrete (reinforced)
Street:	between Sandusky St. and Evergree Project:		Hobart, IN		
City:	Hobart, IN	(GPS Northing:	0.0	
Location:		(GPS Easting:	0.0	
Drain Area:	Northwest	(GPS Accuracy:	Nearest Meter	
Cover Shape:	Circular	E	Evidence of Surcharge:	No	
Cover Size: Comments:	23.0	F	Potential for Runoff:	None	
O&M Index:	2.00	O&M Quick:	2100	O&M Rating:	2.00
Structural Index:	1.00	Structural Quic	:k: 1100	Structural Rating:	1.00
Overall Index:	1.50	Overall Quick:	2111	Overall Rating:	3.00

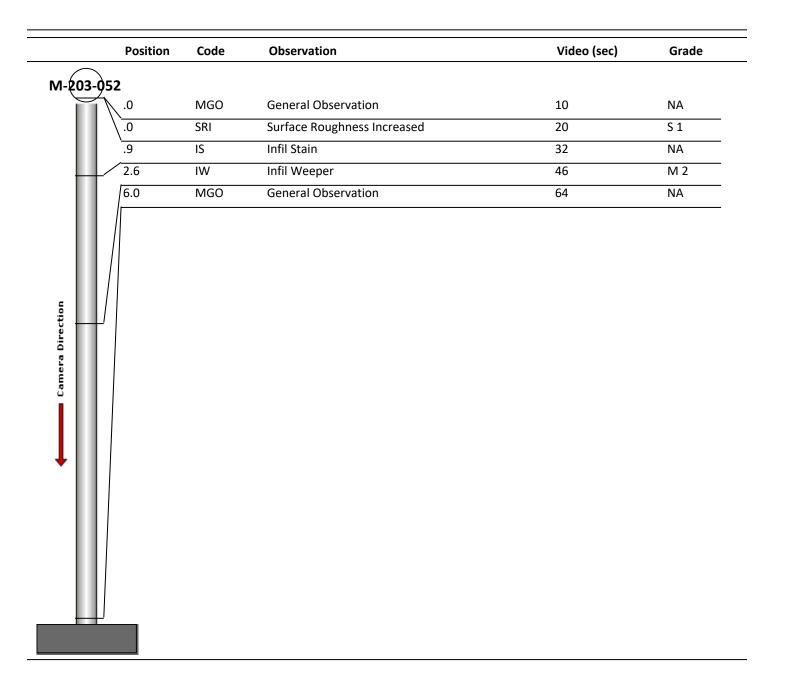
Code: Description:	MGO General Observation
Distance (ft):	.0
Structural Grade:	0
O&M Grade:	0
Clock Start/From:	
Clock To:	
1st Value:	
2nd Value:	
Value Percent:	
Step:	NO
Remarks:	ACCESS MH

Code:SRIDescription:Surface Roughness Increased

Distance (ft):	.0	
Structural Grade:	1	
O&M Grade:	0	
Clock Start/From:	12	
Clock To:	12	
1st Value:		
2nd Value:		
Value Percent:		
Step:	NO	
Remarks:

Code:	IS
Description:	Infil Stain
Distance (ft):	.9
Structural Grade:	0
O&M Grade:	0
Clock Start/From:	1
Clock To: 1st Value:	
2nd Value: Value Percent:	
Step: Remarks:	NO

Code:	IW
Description:	Infil Weeper
Distance (ft):	2.6
. ,	
Structural Grade:	0
O&M Grade:	2
Clock Start/From:	12
Clock To:	12
1st Value:	
2nd Value:	
Value Percent:	
Step:	NO
Remarks:

Code: Description: MGO General Observation

Distance (ft):	6.0
Structural Grade:	0
O&M Grade:	0
Clock Start/From:	
Clock To:	
1st Value:	
2nd Value:	
Value Percent:	
Step:	NO
Remarks:	END SURVEY
