# Manhole Inspection Report

Date:	<b>04/17/2018</b>	Weather:		Coding:	<b>RZMACP</b>
MH#:	<b>M-203-056</b>	Owner:	<b>NA</b>	Len. Surveyed:	<b>4.2</b>
P.O.#:		Surveyor:	<b>Jen Costello</b>	Rim to Invert:	<b>5.4</b>
Customer:		Cert. #:	<b>U-907-5518</b>	Wall Material:	<b>Concrete (reinforced)</b>

**M-203-056**

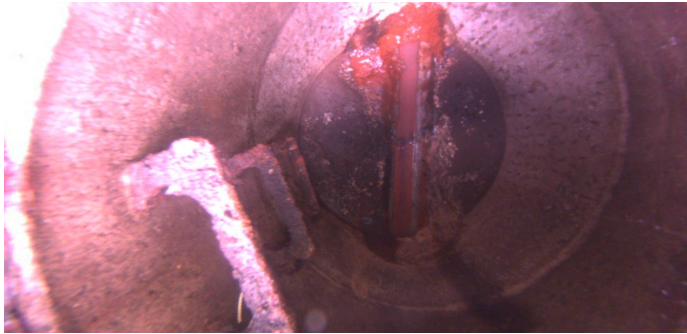
Code:	MGP
Description:	General Photo
Distance (ft):	.0
Structural Grade:	0
O&M Grade:	0
Clock Start/From:	
Clock To:	
1st Value:	
2nd Value:	
Value Percent:	
Step:	NO
Remarks:	ACCESS MH

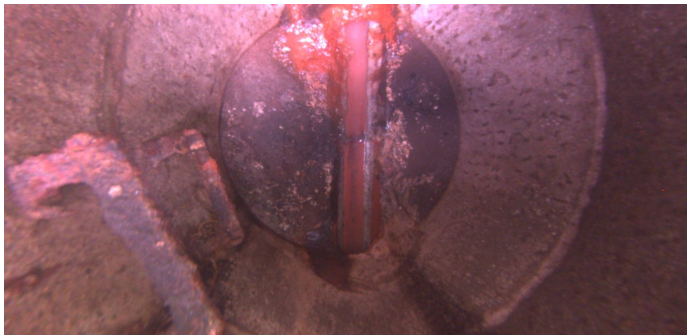
Code:	<b>SRI</b>
Description:	<b>Surface Roughness Increased</b>
Distance (ft):	<b>.0</b>
Structural Grade:	<b>1</b>
O&M Grade:	<b>0</b>
Clock Start/From:	<b>12</b>
Clock To:	<b>12</b>
1st Value:	
2nd Value:	
Value Percent:	
Step:	<b>NO</b>
Remarks:

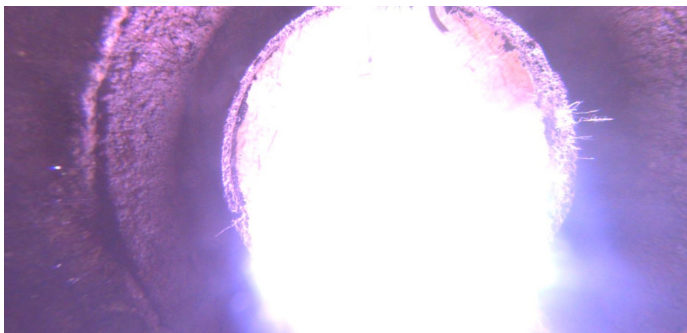
Code:	<b>IW</b>
Description:	<b>Infil Weeper</b>
Distance (ft):	<b>.9</b>
Structural Grade:	<b>0</b>
O&M Grade:	<b>2</b>
Clock Start/From:	<b>5</b>
Clock To:	
1st Value:	
2nd Value:	
Value Percent:	
Step:	<b>NO</b>
Remarks:

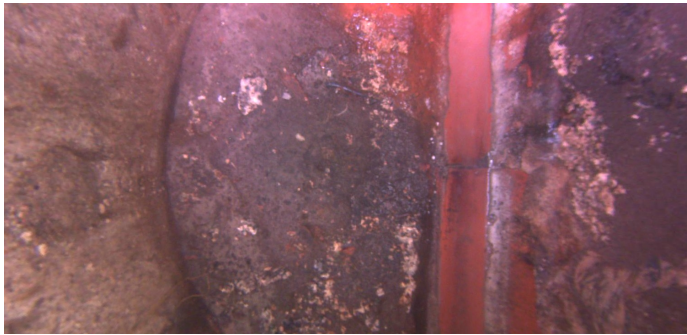
Code:	<b>MGP</b>
Description:	<b>General Photo</b>
Distance (ft):	<b>1.2</b>
Structural Grade:	<b>0</b>
O&M Grade:	<b>0</b>
Clock Start/From:	
Clock To:	
1st Value:	
2nd Value:	
Value Percent:	
Step:	<b>NO</b>
Remarks:	<b>UNDERSIDE OF FRAME</b>

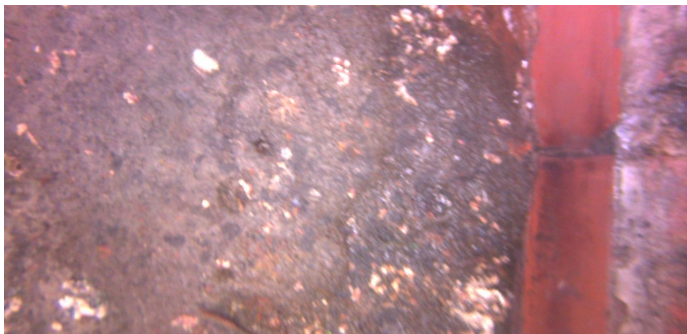
Code:	<b>DSF</b>
Description:	<b>Deposits Settled Fine</b>
Distance (ft):	<b>3.1</b>
Structural Grade:	<b>0</b>
O&M Grade:	<b>2</b>
Clock Start/From:	<b>12</b>
Clock To:	<b>12</b>
1st Value:	
2nd Value:	
Value Percent:	<b>5.000</b>
Step:	<b>NO</b>
Remarks:
