# Manhole Inspection Report

Date:	<b>04/17/2018</b>	Weather:		Coding:	<b>RZMACP</b>
MH#:	<b>M-203-057</b>	Owner:	<b>NA</b>	Len. Surveyed:	<b>2.4</b>
P.O.#:		Surveyor:	<b>Jen Costello</b>	Rim to Invert:	<b>3.4</b>
Customer:		Cert. #:	<b>U-907-5518</b>	Wall Material:	<b>Concrete (reinforced)</b>

Street:	<b>Alley between 37th Ave. and 38th A</b>	Project:	<b>Hobart, IN</b>
City:	<b>Hobart, IN</b>	GPS Northing:	<b>0.0</b>
Location:		GPS Easting:	<b>0.0</b>
Drain Area:	<b>Northwest</b>	GPS Accuracy:	<b>Nearest Meter</b>
Cover Shape:	<b>Circular</b>	Evidence of Surcharge:	<b>No</b>
Cover Size:	<b>23.0</b>	Potential for Runoff:	<b>None</b>
Comments:

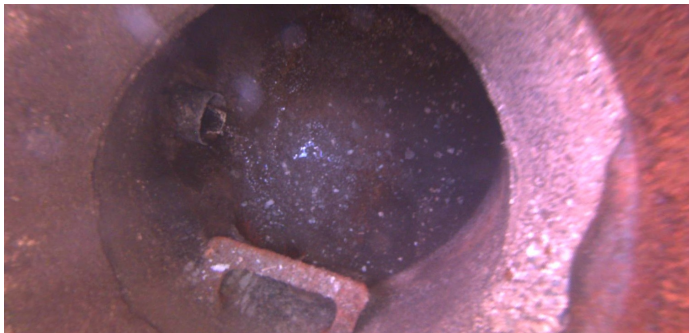
Code: **MGO**  
 Description: **General Observation**

Distance (ft): **.0**  
 Structural Grade: **0**  
 O&M Grade: **0**  
 Clock Start/From:  
 Clock To:  
 1st Value:  
 2nd Value:  
 Value Percent:  
 Step: **NO**  
 Remarks: **ACCESS MH**

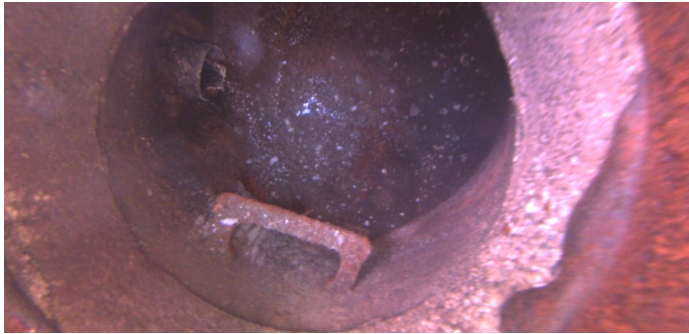
Code: **SSS**  
Description: **Surface Spalling**

Distance (ft): **.0**  
Structural Grade: **2**  
O&M Grade: **0**  
Clock Start/From: **3**  
Clock To: **6**  
1st Value:  
2nd Value:  
Value Percent:  
Step: **NO**  
Remarks:

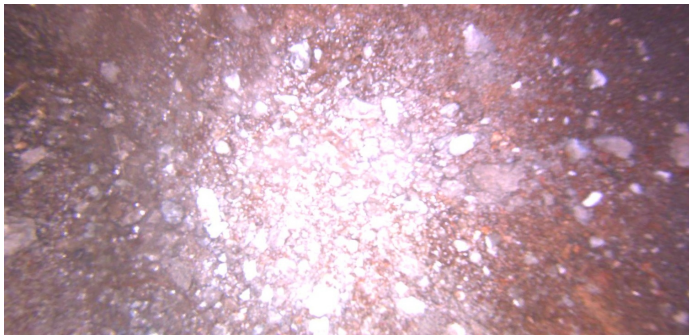
Code: **DSGV**  
Description: **Deposits Settled Gravel**

Distance (ft): **2.4**  
Structural Grade: **0**  
O&M Grade: **2**  
Clock Start/From: **12**  
Clock To: **12**  
1st Value:  
2nd Value:  
Value Percent: **10.000**  
Step: **NO**  
Remarks:

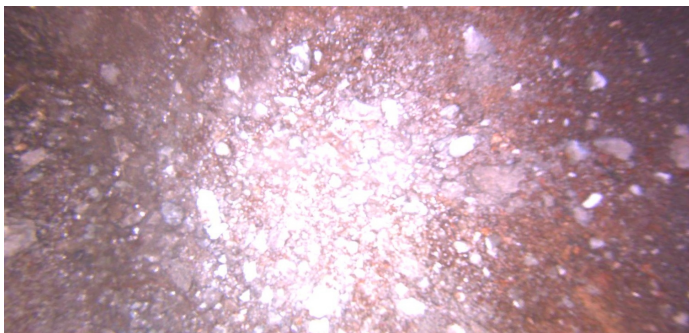
Code: **MGO**  
Description: **General Observation**

Distance (ft): **2.4**  
Structural Grade: **0**  
O&M Grade: **0**  
Clock Start/From:  
Clock To:  
1st Value:  
2nd Value:  
Value Percent:  
Step: **NO**  
Remarks: **END SURVEY**
