# Manhole Inspection Report

| MH#: | <b>M-203-058</b> | Owner: | <b>NA</b> | Len. Surveyed: | <b>3.8</b> |

| Street: | <b>between Sandusky St. and Evergree</b> | Project: | <b>Hobart, IN</b> |

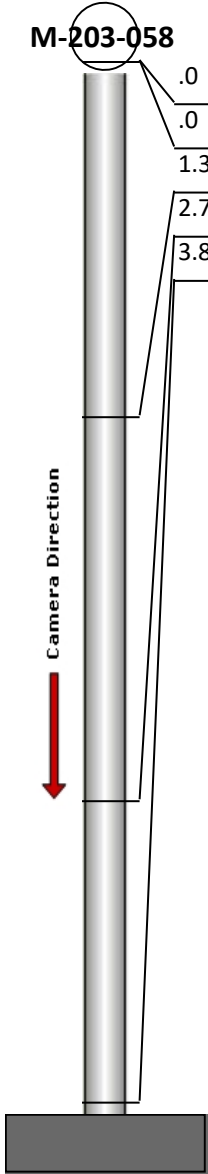
| | Position | Code | Observation | Video (sec) | Grade |
|--|---|---|---|---|---|
| | .0 | MGO | General Observation | 10 | NA |
| | .0 | SAP | Surface Aggregate Projecting | 21 | S 3 |
| | 1.3 | MGO | General Observation | 37 | NA |
| | 2.7 | IW | Infil Weeper | 53 | M 2 |
| | 3.8 | MGO | General Observation | 67 | NA |

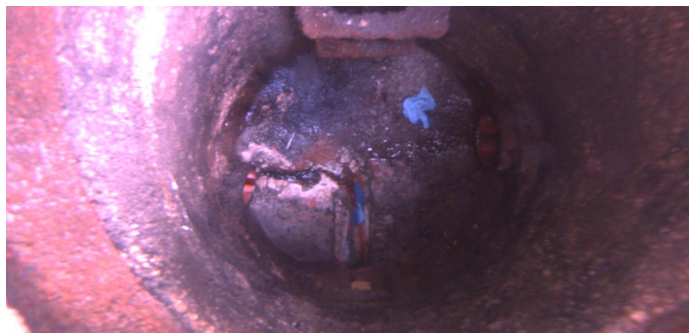
Code: **MGO**  
Description: **General Observation**

Distance (ft): **.0**  
Structural Grade: **0**  
O&M Grade: **0**  
Clock Start/From:  
Clock To:  
1st Value:  
2nd Value:  
Value Percent:  
Step: **NO**  
Remarks: **access MH**

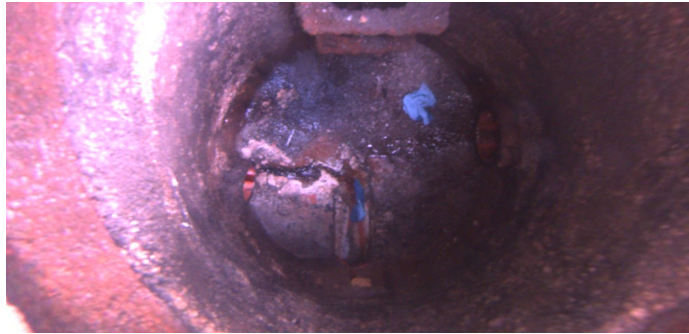
Code: **SAP**  
Description: **Surface Aggregate Projecting**

Distance (ft): **.0**  
Structural Grade: **3**  
O&M Grade: **0**  
Clock Start/From: **12**  
Clock To: **12**  
1st Value:  
2nd Value:  
Value Percent:  
Step: **NO**  
Remarks:

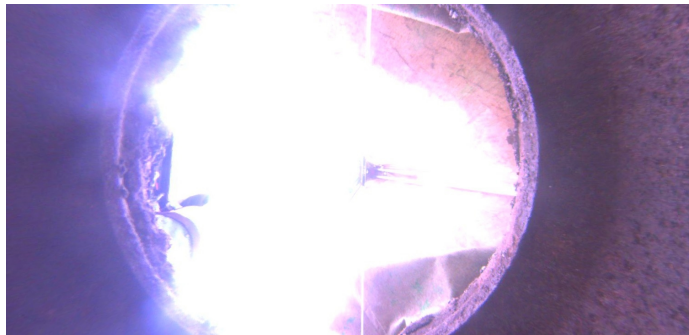
Code: **MGO**  
Description: **General Observation**

Distance (ft): **1.3**  
Structural Grade: **0**  
O&M Grade: **0**  
Clock Start/From:  
Clock To:  
1st Value:  
2nd Value:  
Value Percent:  
Step: **NO**  
Remarks: **UNDERSIDE OF FRAME**

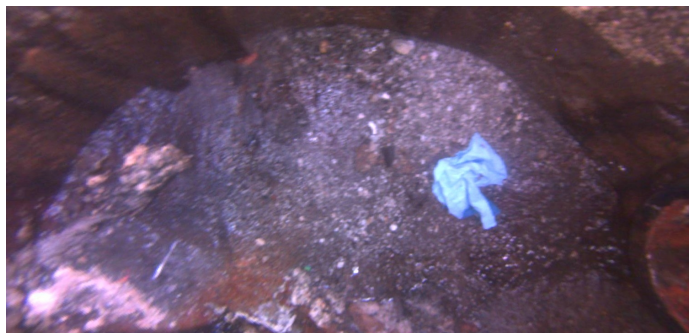
Code: **IW**  
Description: **Infil Weeper**

Distance (ft): **2.7**  
Structural Grade: **0**  
O&M Grade: **2**  
Clock Start/From: **9**  
Clock To: **3**  
1st Value:  
2nd Value:  
Value Percent:  
Step: **NO**  
Remarks:

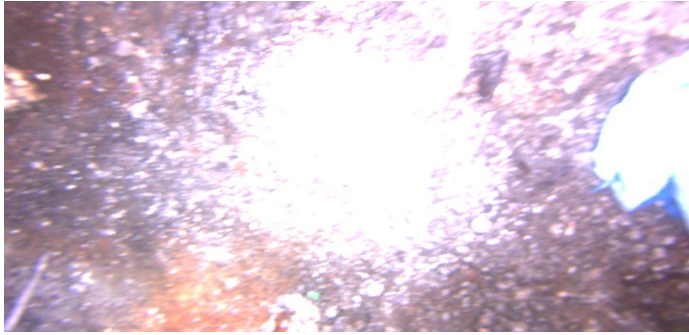
| Code: | <b>MGO</b> |
| Description: | <b>General Observation</b> |
| Distance (ft): | <b>3.8</b> |
| Remarks: | <b>END SURVEY</b> |
