Manhole Inspection Report

Date:	04/17/2018	Weather:		Coding:	RZMACP
MH#:	M-203-060	Owner:	NA	Len. Surveyed:	8.5
P.O.#:		Surveyor:	Jen Costello	Rim to Invert:	10.5
Customer:		Cert. #:	U-907-5518	Wall Material:	Concrete (reinforced)

Street:	38th Ave. 162' West of Sandusky St.	Project:	Hobart, IN
City:	Hobart, IN	GPS Northing:	0.0
Location:		GPS Easting:	0.0
Drain Area:	Northwest	GPS Accuracy:	Nearest Meter
Cover Shape:	Circular	Evidence of Surcharge:	No
Cover Size:	23.0	Potential for Runoff:	None
Comments:

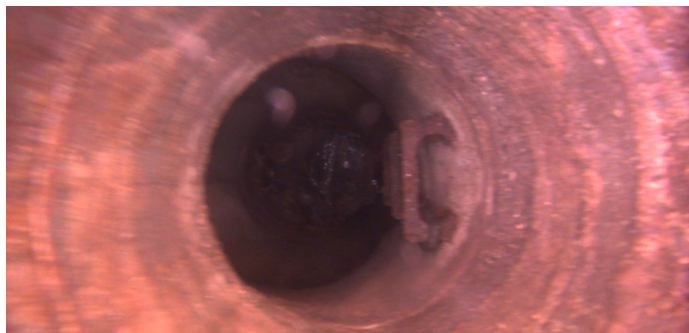
Code: **MGO**
Description: **General Observation**

Distance (ft): **.0**
Structural Grade: **0**
O&M Grade: **0**
Clock Start/From:
Clock To:
1st Value:
2nd Value:
Value Percent:
Step: **NO**
Remarks: **ACCESS MH**

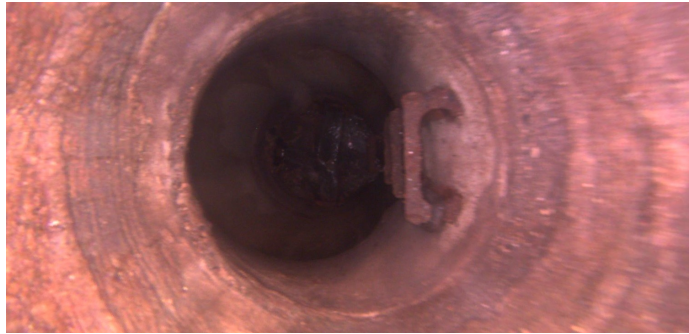
Code: **FM**
Description: **Fracture Multiple**

Distance (ft): **.5**
Structural Grade: **4**
O&M Grade: **0**
Clock Start/From: **8**
Clock To: **12**
1st Value:
2nd Value:
Value Percent:
Step: **NO**
Remarks:

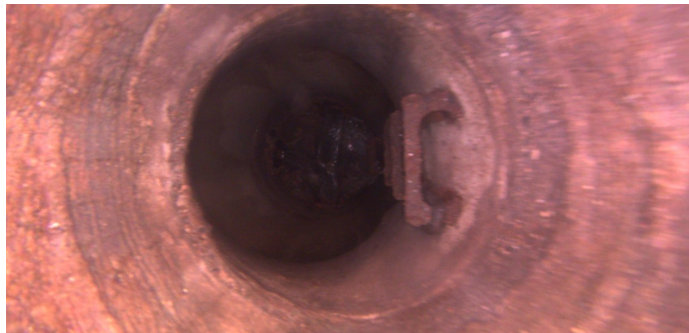
Code: **SAV**
Description: **Surface Aggregate Visible**

Distance (ft): **.5**
Structural Grade: **3**
O&M Grade: **0**
Clock Start/From: **12**
Clock To: **12**
1st Value:
2nd Value:
Value Percent:
Step: **NO**
Remarks:

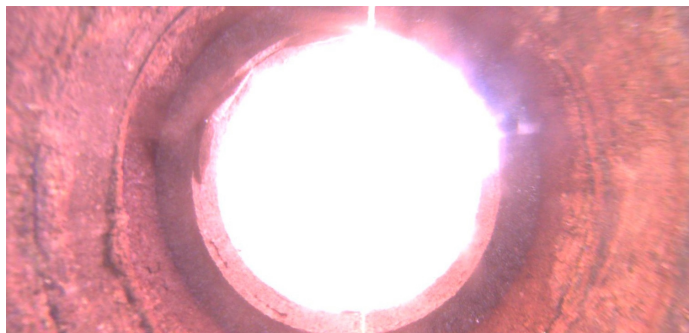
Code: **MGO**
Description: **General Observation**

Distance (ft): **2.1**
Structural Grade: **0**
O&M Grade: **0**
Clock Start/From:
Clock To:
1st Value:
2nd Value:
Value Percent:
Step: **NO**
Remarks: **UNDERSIDE OF FRAME**

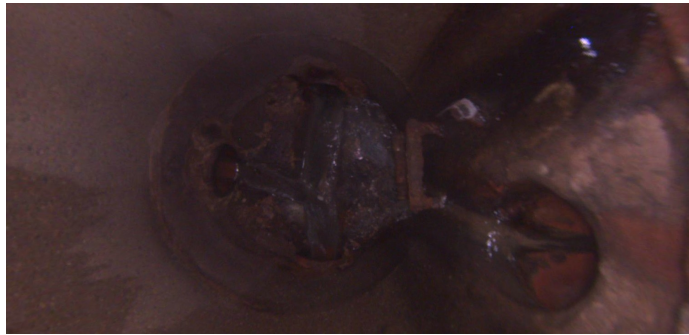
Code: **IW**
Description: **Infil Weeper**

Distance (ft): **4.1**
Structural Grade: **0**
O&M Grade: **2**
Clock Start/From: **12**
Clock To: **12**
1st Value:
2nd Value:
Value Percent:
Step: **NO**
Remarks:

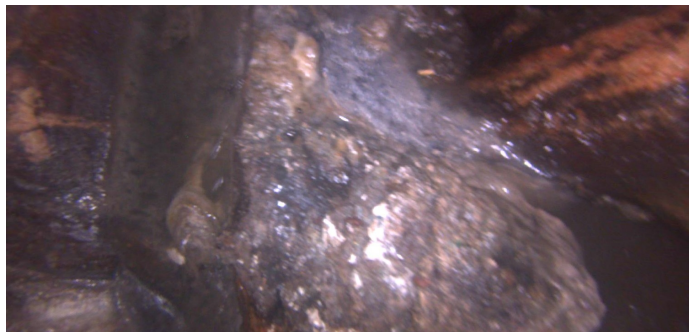
Code: **DSZ**
Description: **Deposits Settled Other**

Distance (ft): **8.5**
Structural Grade: **0**
O&M Grade: **2**
Clock Start/From: **12**
Clock To: **12**
1st Value:
2nd Value:
Value Percent: **10.000**
Step: **NO**
Remarks: **MISC**

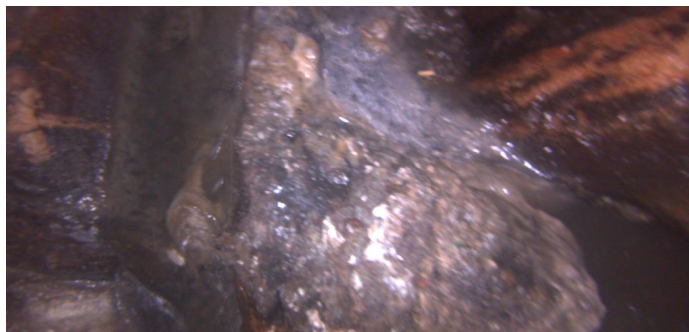
Code: **MGO**
Description: **General Observation**

Distance (ft): **8.5**
Structural Grade: **0**
O&M Grade: **0**
Clock Start/From:
Clock To:
1st Value:
2nd Value:
Value Percent:
Step: **NO**
Remarks: **end survey**
