Manhole Inspection Report

Date:	10/04/2022	Weather:		Coding:	RZMACP
MH#:	M-203-065	Owner:	NA	Len. Surveyed:	6.1
P.O.#:		Surveyor:	Jen Costello	Rim to Invert:	6.7
Customer:		Cert. #:	U-907-5518	Wall Material:	Concrete (cast in place)

Street:	38th Ave. and Sandusky St. to the N	Project:	Hobart, IN
City:	Hobart, IN	GPS Northing:	2295474.973
Location:	Local Rural Streets	GPS Easting:	2891584.198
Drain Area:	Northwest	GPS Accuracy:	Sub-Meter
Cover Shape:	Circular	Evidence of Surcharge:	No
Cover Size:	24.0	Potential for Runoff:	None
Comments:

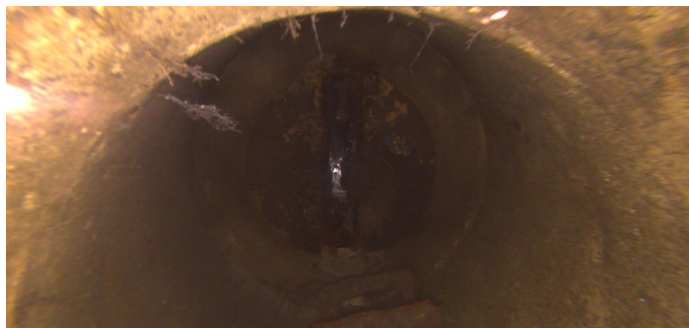
Code: **MGO**
Description: **General Observation**

Distance (ft): **.0**
Structural Grade: **0**
O&M Grade: **0**
Clock Start/From:
Clock To:
1st Value:
2nd Value:
Value Percent:
Step: **NO**
Remarks: **access mh**

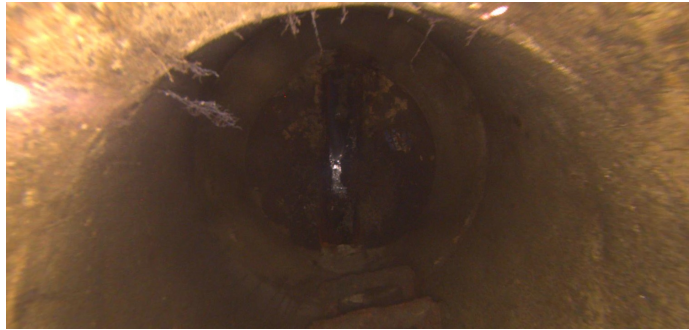
Code: **SRI**
Description: **Surface Roughness Increased**

Distance (ft): **.0**
Structural Grade: **1**
O&M Grade: **0**
Clock Start/From: **12**
Clock To: **12**
1st Value:
2nd Value:
Value Percent:
Step: **NO**
Remarks:

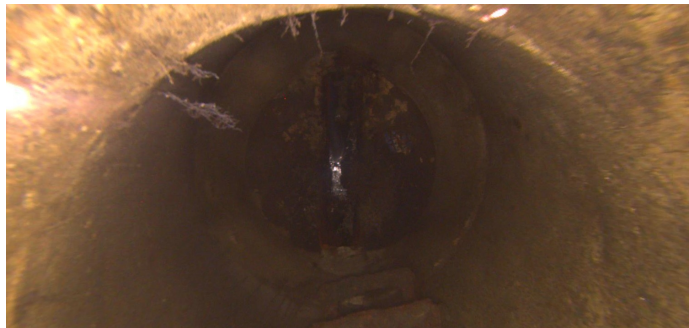
Code: **RFJ**
Description: **Roots Fine Joint**

Distance (ft): **.0**
Structural Grade: **0**
O&M Grade: **1**
Clock Start/From: **10**
Clock To: **2**
1st Value:
2nd Value:
Value Percent:
Step: **NO**
Remarks:

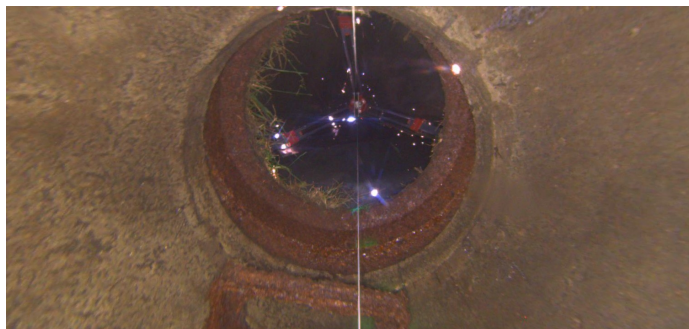
Code: **MGO**
Description: **General Observation**

Distance (ft): **2.6**
Structural Grade: **0**
O&M Grade: **0**
Clock Start/From:
Clock To:
1st Value:
2nd Value:
Value Percent:
Step: **NO**
Remarks: **underside of frame**

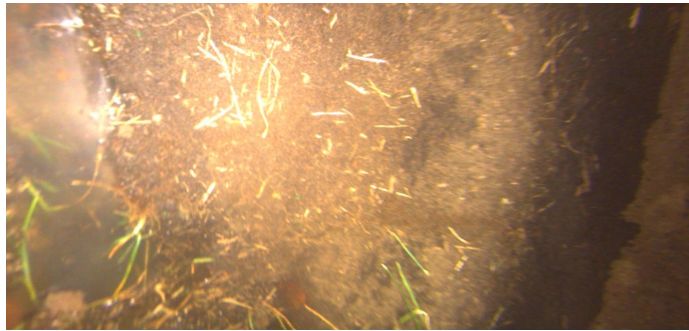
Code: **DSF**
Description: **Deposits Settled Fine**

Distance (ft): **5.4**
Structural Grade: **0**
O&M Grade: **2**
Clock Start/From: **12**
Clock To: **12**
1st Value:
2nd Value:
Value Percent: **5.000**
Step: **NO**
Remarks:

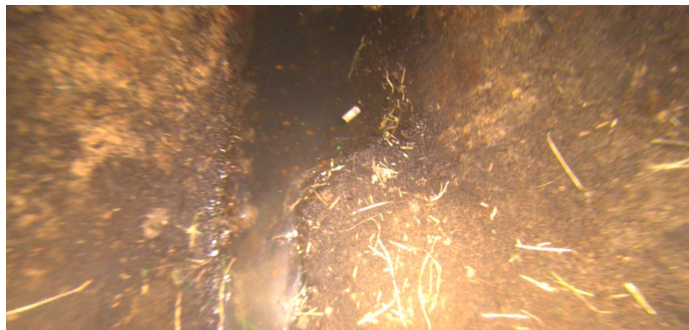
Code: **DSF**
Description: **Deposits Settled Fine**

Distance (ft): **5.4**
Structural Grade: **0**
O&M Grade: **4**
Clock Start/From: **3**
Clock To: **6**
1st Value:
2nd Value:
Value Percent: **30.000**
Step: **NO**
Remarks:

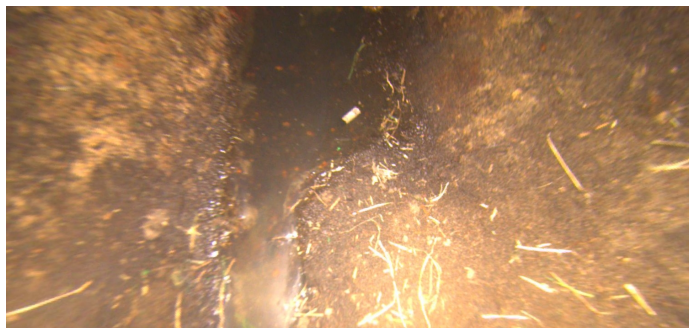
Code: **MGO**
Description: **General Observation**

Distance (ft): **5.4**
Structural Grade: **0**
O&M Grade: **0**
Clock Start/From:
Clock To:
1st Value:
2nd Value:
Value Percent:
Step: **NO**
Remarks: **end of survey**
