Manhole Inspection Report

Date:	04/19/2018	Weather:		Coding:	RZMACP
MH#:	M-203-069	Owner:	NA	Len. Surveyed:	8.3
P.O.#:		Surveyor:	Jen Costello	Rim to Invert:	9.0
Customer:		Cert. #:	U-907-5518	Wall Material:	Concrete (reinforced)

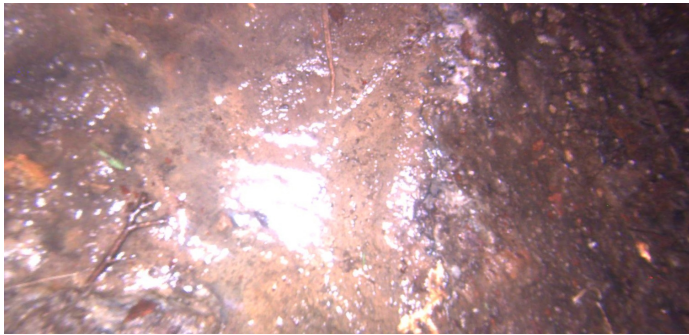
Code:	MGO
Description:	General Observation
Distance (ft):	8.3
Structural Grade:	0
O&M Grade:	0
Clock Start/From:	
Clock To:	
1st Value:	
2nd Value:	
Value Percent:	
Step:	NO
Remarks:	END SURVEY
