# Manhole Inspection Report

Date:	<b>03/26/2018</b>	Weather:		Coding:	<b>RZMACP</b>
MH#:	<b>M-208-007</b>	Owner:	<b>NA</b>	Len. Surveyed:	<b>10.0</b>
P.O.#:		Surveyor:	<b>John Kuglmaier</b>	Rim to Invert:	<b>10.5</b>
Customer:		Cert. #:	<b>U-1215-07002349</b>	Wall Material:	<b>Concrete (reinforced)</b>

Street:	<b>174' South of 58th Pl. East of Vine Ct</b>	Project:	<b>Hobart, IN</b>
City:	<b>Hobart, IN</b>	GPS Northing:	<b>0.0</b>
Location:		GPS Easting:	<b>0.0</b>
Drain Area:	<b>Southwest</b>	GPS Accuracy:	<b>Nearest Meter</b>
Cover Shape:	<b>Circular</b>	Evidence of Surcharge:	<b>Yes</b>
Cover Size:	<b>22.5</b>	Potential for Runoff:	<b>None</b>
Comments:

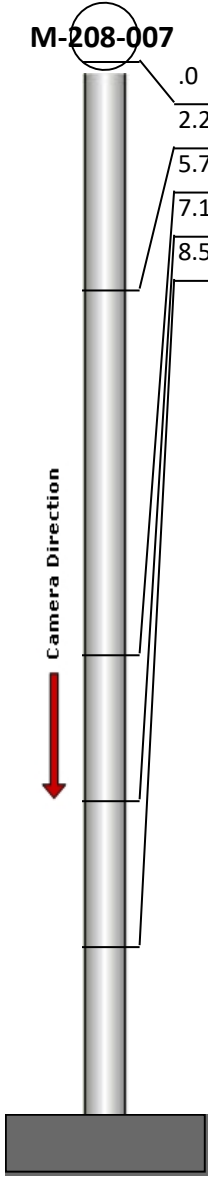
.0	MGP	General Photo	10	NA
	2.2	MGP	General Photo	28	NA
	5.7	DSF	Deposits Settled Fine	49	M 2
	7.1	OBZ	Obstacle Other	64	M 2
	8.5	MGO	General Observation	78	NA

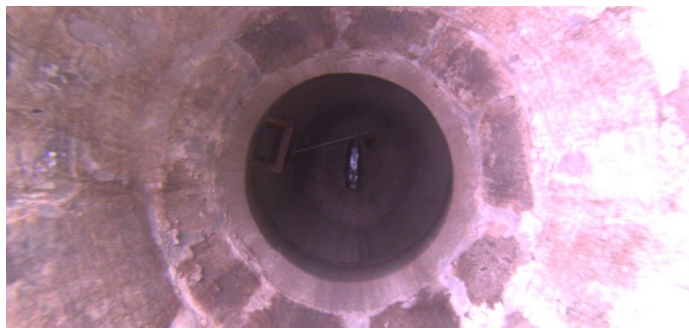
Code: **MGP**  
Description: **General Photo**

Distance (ft): **.0**  
Structural Grade: **0**  
O&M Grade: **0**  
Clock Start/From:  
Clock To:  
1st Value:  
2nd Value:  
Value Percent:  
Step: **NO**  
Remarks:

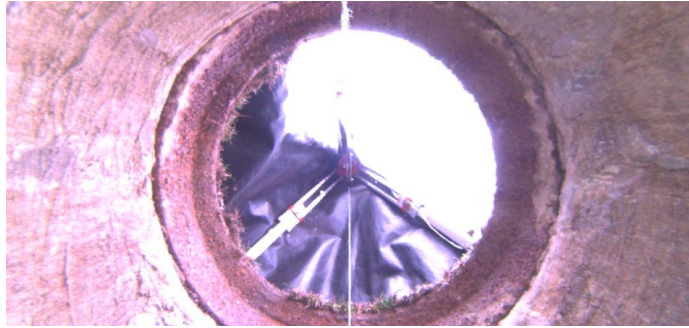
Code: **MGP**  
Description: **General Photo**

Distance (ft): **2.2**  
Structural Grade: **0**  
O&M Grade: **0**  
Clock Start/From:  
Clock To:  
1st Value:  
2nd Value:  
Value Percent:  
Step: **NO**  
Remarks:

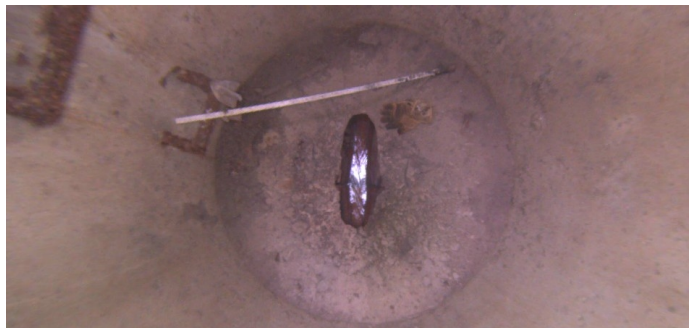
Code: **DSF**  
Description: **Deposits Settled Fine**

Distance (ft): **5.7**  
Structural Grade: **0**  
O&M Grade: **2**  
Clock Start/From: **12**  
Clock To: **12**  
1st Value:  
2nd Value:  
Value Percent: **10.000**  
Step: **NO**  
Remarks:

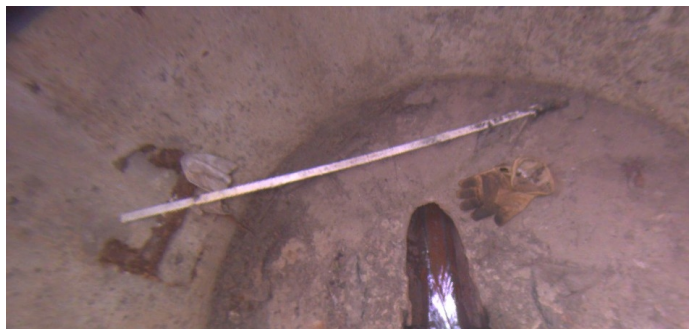
Code: **OBZ**  
Description: **Obstacle Other**

Distance (ft): **7.1**  
Structural Grade: **0**  
O&M Grade: **2**  
Clock Start/From: **10**  
Clock To: **1**  
1st Value:  
2nd Value:  
Value Percent: **5.000**  
Step: **NO**  
Remarks: **Unknown**

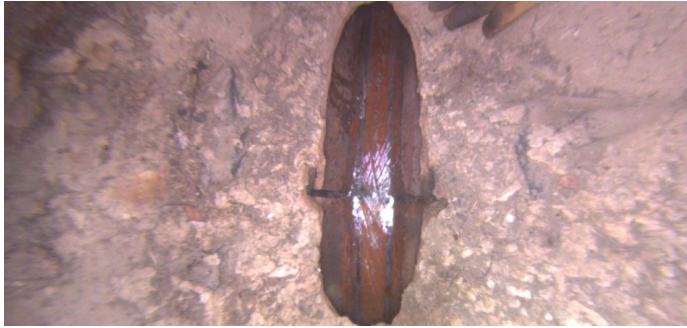
Code:	<b>MGO</b>
Description:	<b>General Observation</b>
Distance (ft):	<b>8.5</b>
Structural Grade:	<b>0</b>
O&M Grade:	<b>0</b>
Clock Start/From:	
Clock To:	
1st Value:	
2nd Value:	
Value Percent:	
Step:	<b>NO</b>
Remarks:	<b>Ins. Comp.</b>
